OLD WATKINS NATIONAL BANK

Lawrence, Kansas

Tech Notes

Interior Metal Storm Windows

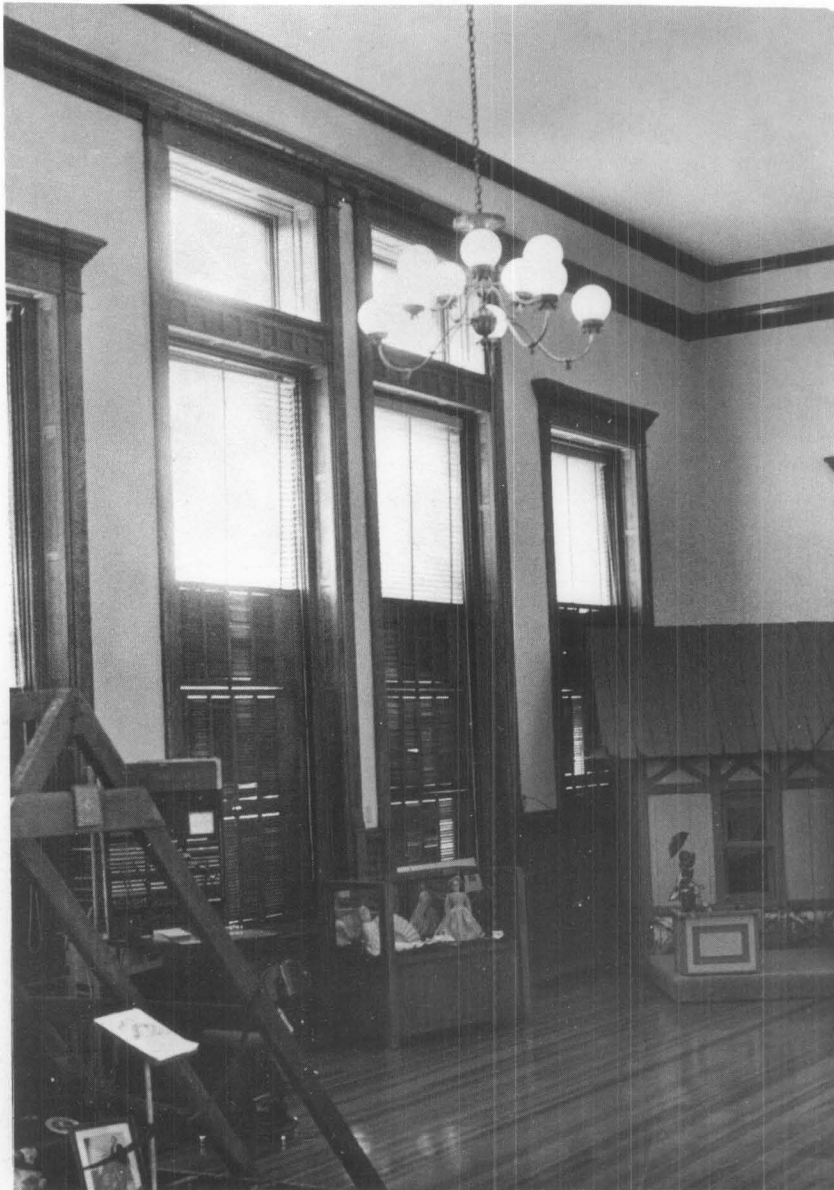
Figure 1. The monumental windows are elegantly detailed on the interior and contribute to the grandeur of the spacious banking rooms. The original interior shutters are still being used for comfort and light control. Photo: Charles E. Fisher

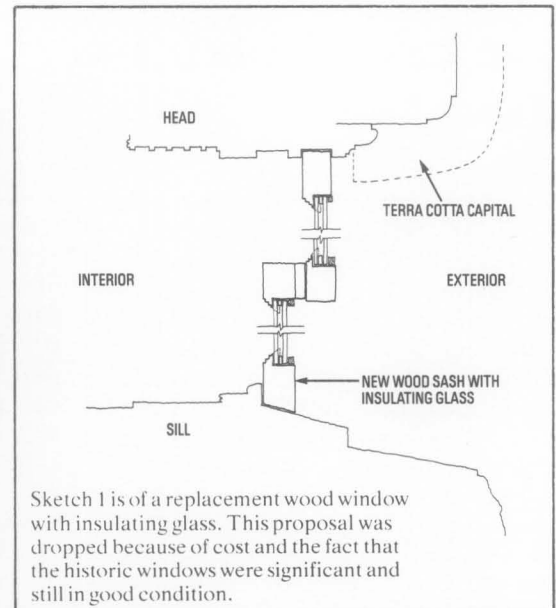
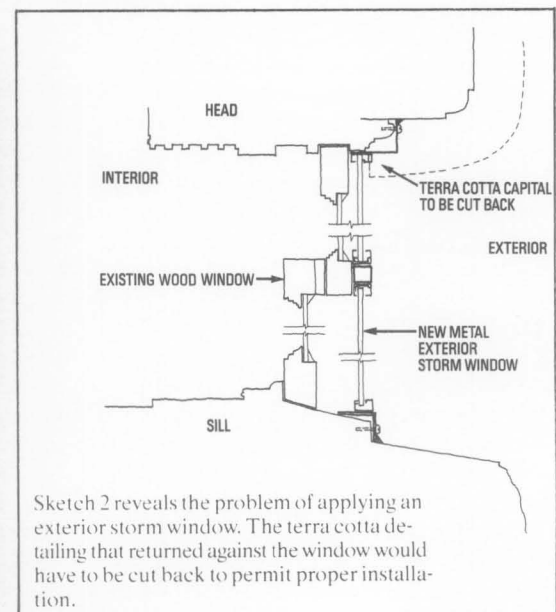
Use of exterior storm windows was initially explored both for energy conservation purposes and as a way to extend the useful life of the original windows (*see figure 2*). Unfortunately, the prices quoted for exterior storm windows by local contractors were around \$65,000, nearly double the budgeted amount. In addition to the high cost of exterior storm windows, one further problem with an exterior storm application arose when it was discovered that the decorative terra cotta capitals adjacent to the upper level window openings returned against the original frames. As a result, the proposed exterior storm windows could not be easily installed in these locations without cutting back or covering portions of the terra cotta (*see figure 3*).

Figure 2. As part of the planning, the architect prepared sketches of 4 possible window treatments to improve the energy performance of the windows.

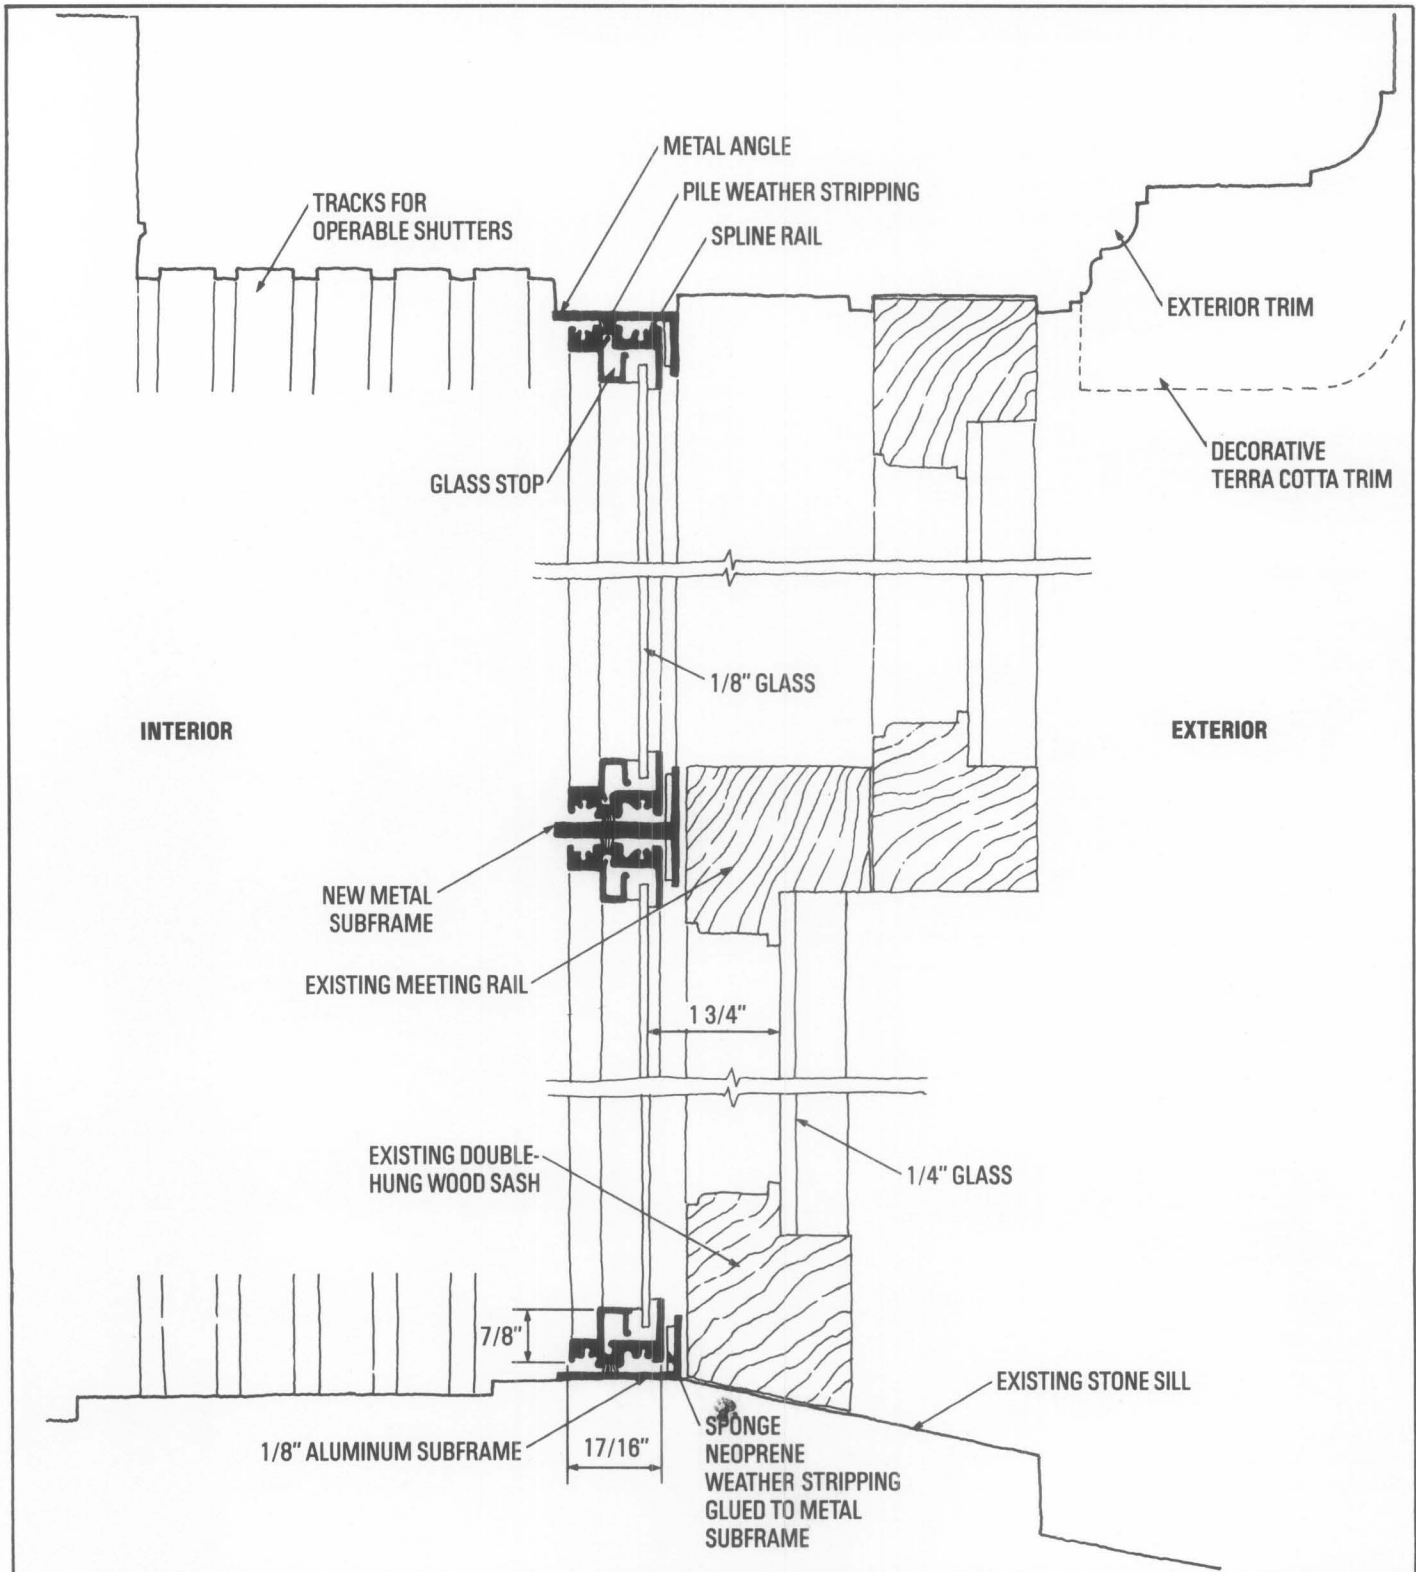
Mounted on pivot pins, the storm window relied on the pile weather stripping which ran continuously along the edge of the frame to serve as the seal between the metal subframe and the metal storm (see figure 4). Neoprene weather stripping was also added to the surface of the subframe to serve as a compression seal with the storm frame. Clear silicone caulk between the wood jamb and the subframe completed the seal.

Figure 4. Section showing the new interior metal storm window set behind the historic wood sash.
Drawing: Martha L. Werenfels

In searching for an interior storm window that met both the functional requirements and the concerns about visual qualities, the architect chose a commercially available metal storm window system. The storm window was designed to fit within the existing wooden jamb, thus resulting in minimal damage to historic material (see figure 4).

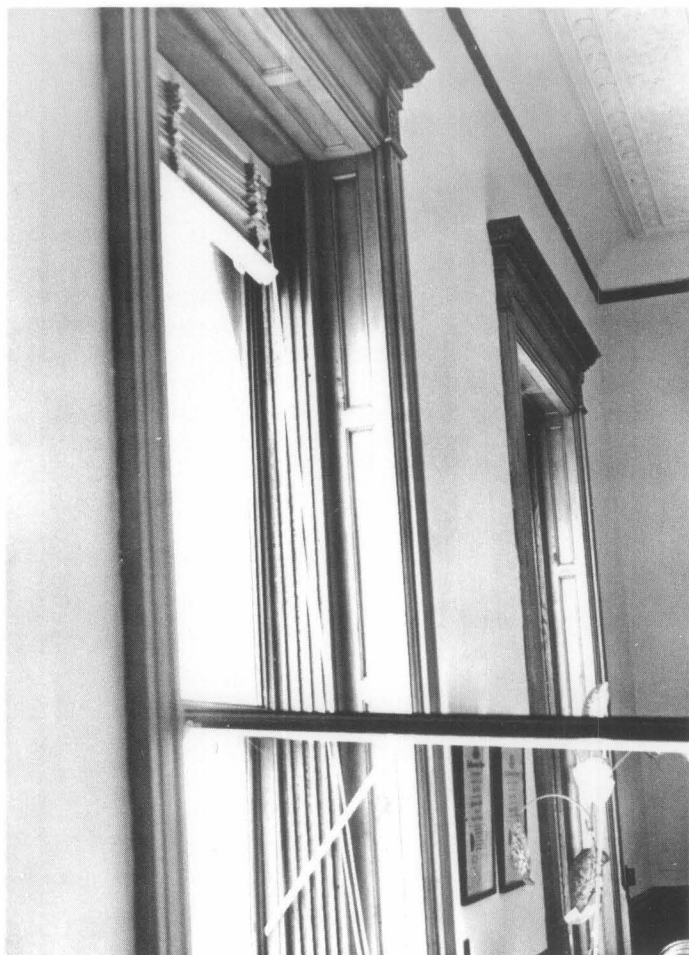
The thin aluminum storm window frame ($\frac{7}{8}$ " wide, $1\frac{1}{2}$ " deep) was attached to a small new subframe by two pins that allowed the windows to pivot open for cleaning and venting in case entrapped condensation was ever a problem (see figure 5).

Figure 5. The interior storm window was designed to fit within the existing wooden jamb. The large size of the windows necessitated the use of operable storm panels, intersecting at the historic meeting rail. Here the lower storm panel is in an opened position for cleaning. Photo: Charles E. Fisher

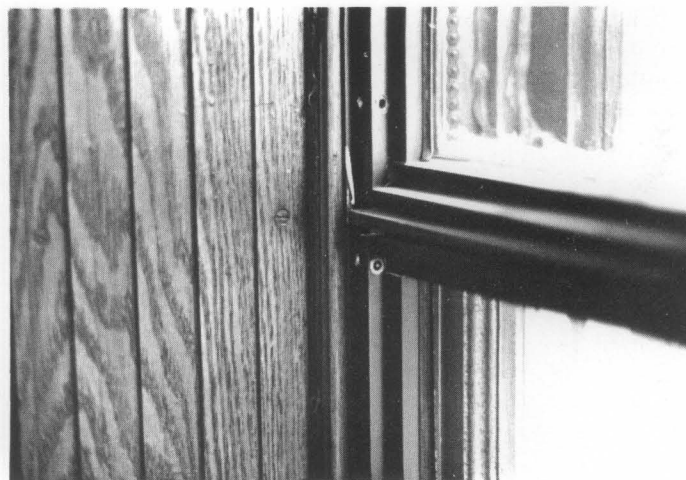
vided a sufficiently wide dead air space for energy conservation purposes, yet still allowed the interior shutters to remain operable (see figure 7).

Figure 7. Continued use of the unique shutter system required that the frame of the interior storm window be narrow. The storm windows are set between the shutters and the historic sash. Photo: Charles E. Fisher

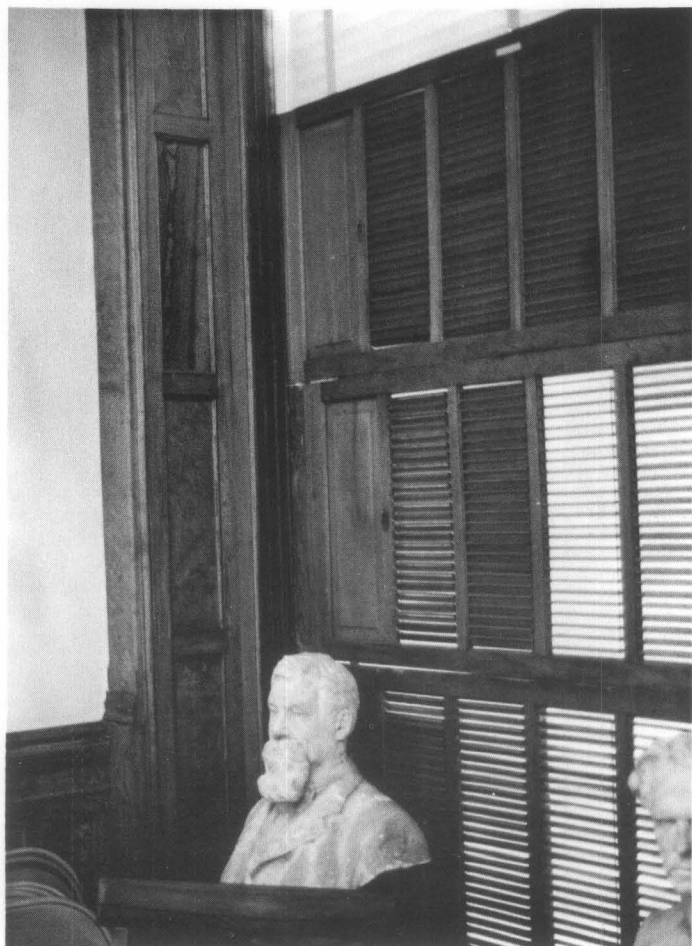
The subframe consisted of a $\frac{1}{8}$ " thick metal angle screwed to the wood jamb, serving as support and as a stop for the storm sash. On the large windows, the metal angle was paired to form a horizontal muntin, in line with the historic meeting rail, to accommodate an upper and lower storm panel, both of which pivoted (see figure 6). The frames were mounted in a location that pro-

Figure 6. The windows were too large for only a single storm panel, necessitating the use of a structural subframe at the mid-section of the window. Both the upper and lower storm panels are operable and come together opposite the historic meeting rail. This element of the storm window is sufficiently thin that is not readily discernible from the outside. Photo: Charles E. Fisher

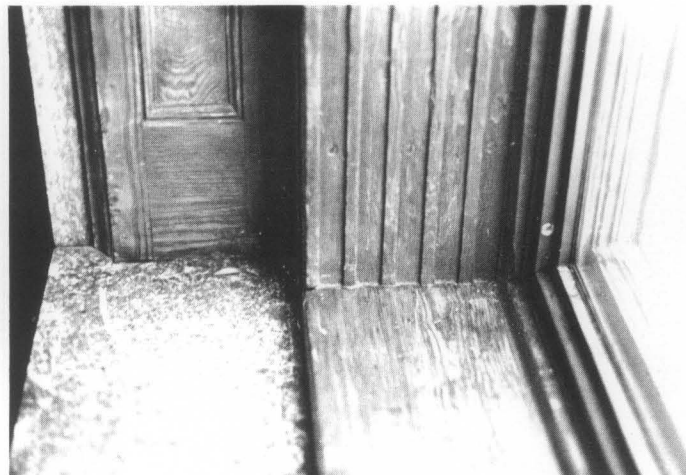
Figure 8. The decorative jamb panel on the left and the interior shutter tracks were unaffected by the installation of the interior storm window shown on the right. Photo: Charles E. Fisher

In summary, the interior storm window solution not only provided the owner with initial cost savings in installation, but it also reduced fuel consumption, met all functional requirements, and carefully addressed historic preservation concerns (*see figure 8*). The thin frame storm window, set within the existing jamb and mounted so as to pivot, was a sensitive solution which is also being used on other projects involving rehabilitations of historically important commercial buildings.
