CHALMERS UNITED CHURCH

Kingston, Ontario

NUMBER 14

Reinforcing Deteriorated Wooden Windows

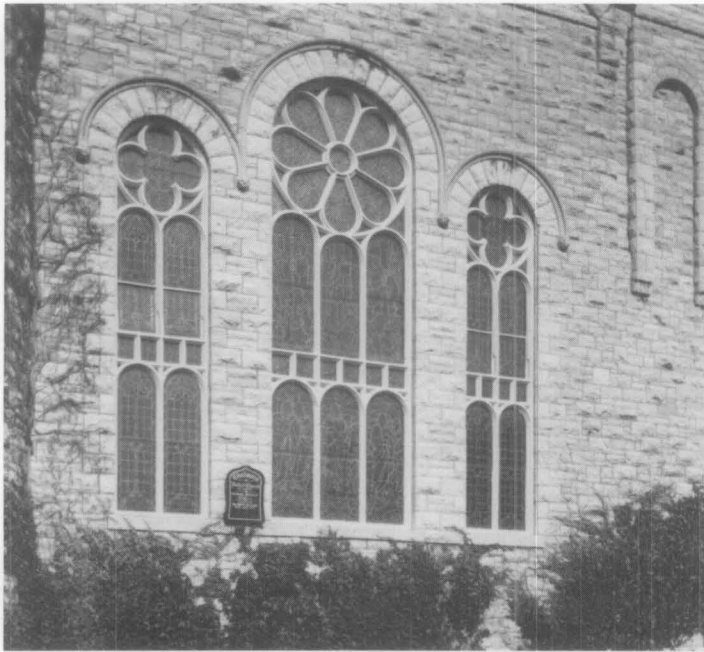
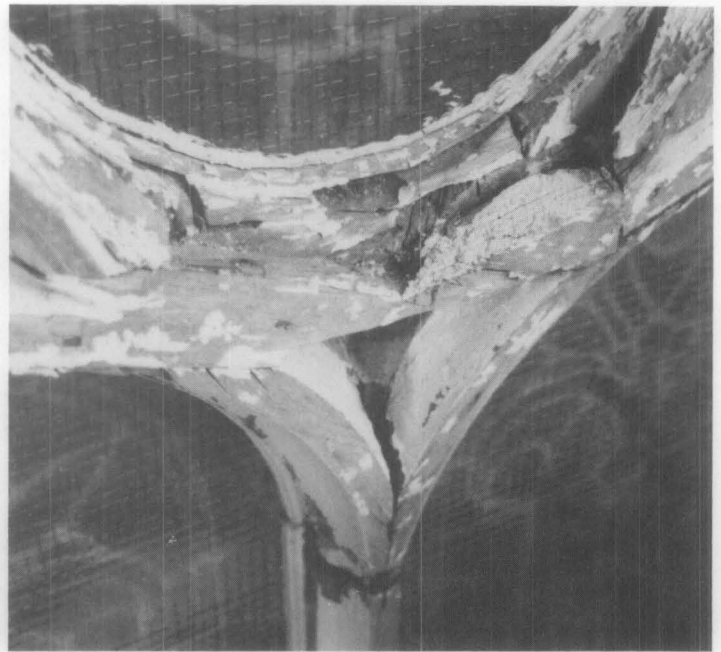
Over time the windows had suffered severely on the southern facade of the church, which is exposed to sun and constant strong winds blowing in from nearby Lake Ontario (*see figure 1*). This wind not only carries dust and dirt, but also has a high moisture content. Because of weathering and the lack of regular maintenance, the wooden frames which secured the stain glass panels had gradually deteriorated. The decay finally became so acute that by 1982 the windows were in imminent danger of collapsing. The parishioners at that point had no choice but to ar-

Figure 1. Considerable deterioration had occurred to the tripartite windows as shown in the close-up view of a portion of the mullion. (The stained glass is protected by individual sheets of wire glass set within the wood mullions)

The first step in the restoration process was the careful removal of the remains of old paint on the wood frame. This exposed the true extent of the deterioration. In some areas, as much as 40-50% of the wood had been lost. The wooden parts of the window frame that were found to be crumbling were saturated and consolidated with a commercially available liquid epoxy.

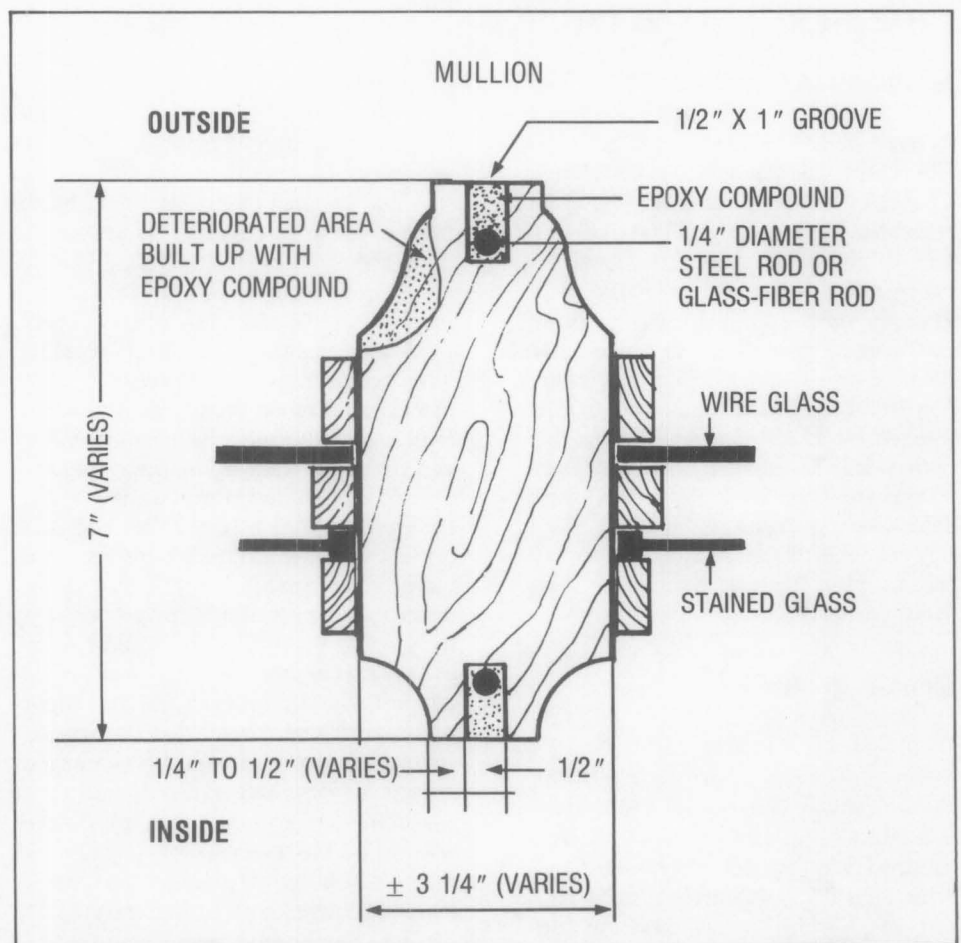
Figure 2. Cross section of the historic mullion shows the manner in which the pre-formed steel reinforcing bars were inserted in order to strengthen the windows. The grooves that were cut for the steel bars were filled with an epoxy compound.

of damage during removal and transportation. Instead of making new mullions, the decayed frame was reinforced in an unusual manner, using a method developed by Paul Stumes, the consulting engineer for the project. The method involved the use of epoxy consolidants along with steel reinforcement rods (see figure 2). To permit the work to take place undisturbed by the weather, a "cocoon" formed out of vinyl sheet was attached to the temporary bracing installed to stabilize the windows while the restoration work was underway (see figure 3).

For reinforcement, $\frac{1}{4}$ " diameter steel bars (the same type used to reinforce concrete) were painstakingly bent to match the curves of the mullions. The shape of the bars had to be accurate, within a tolerance of $\frac{1}{8}$ " in any direction, in order to fit comfortably in the $\frac{1}{2}$ " wide grooves which followed the complex curves of the windows (see figure 5). Because of the deteriorated condition of the wood, the steel bars could not be forced into the grooves without the danger of splitting the frames apart. In a few instances where the steel rods could not be suitably shaped, braided fiberglass strands were used instead.

With the reinforcement in place, the grooves were filled with an epoxy compound, thus completely embedding

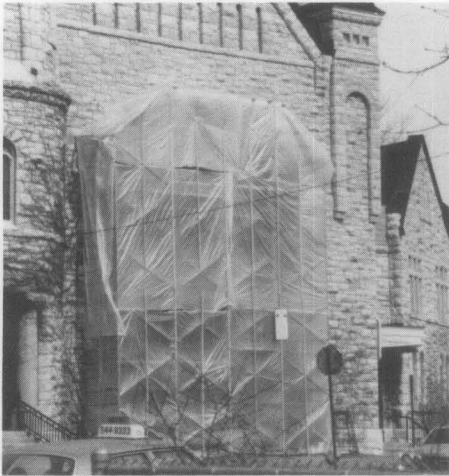
Figure 3. A vinyl cocoon placed over the windows allowed the repair work to be carried out even in inclement weather.

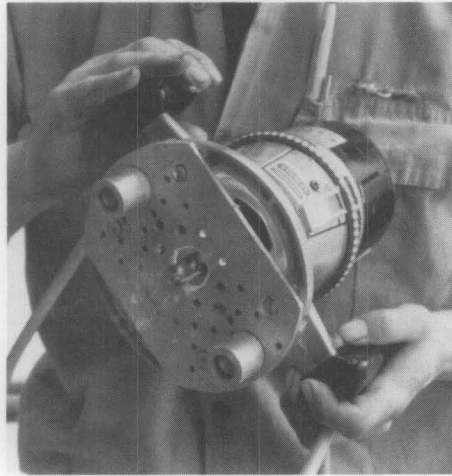
Figure 4. Once the old paint had been carefully removed, grooves were cut in the mullions using an electric router fitted with special guide rollers.

Next, a 1/2" wide groove was cut into the mullions on opposite faces to receive a steel reinforcement rod. The depth of this groove ranged from 3/4" to 1 1/4", depending on the location. This delicate exercise was carried out with utmost care. After some experimentation was carried out on scrap wood, a hand-held electric router was adapted for the job. Special rollers were installed to guide the rotating cut-

ting bit (see figure 4). Notwithstanding the usefulness of this apparatus, the real success of the operation can be attributed to the skill of the craftsman who guided the tool. The wooden mullions varied in size; on a typical $3\frac{1}{4}$ " wide mullion, the outer edge where the groove was cut was $1\frac{1}{2}$ " wide. In cutting a $\frac{1}{2}$ " groove on the outer edge, only $\frac{1}{2}$ " of wood remained on either side. A slight deviation of the tool could have seriously damaged the mullions.

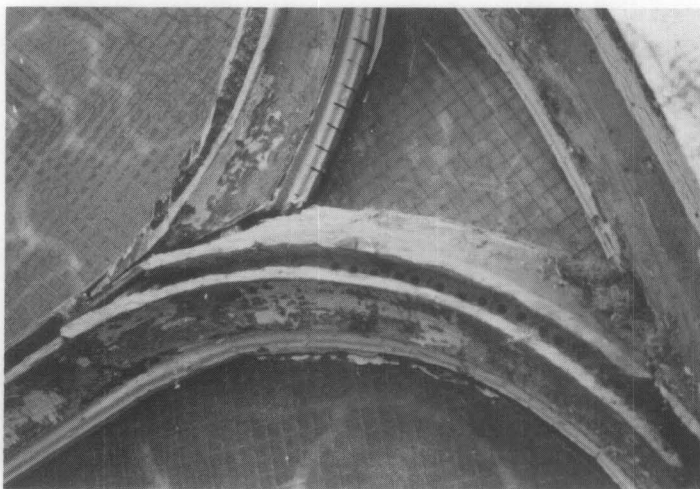
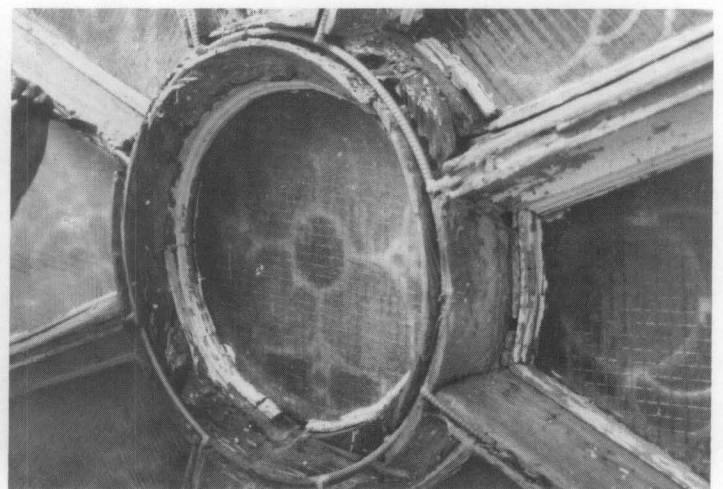
Figure 5. Details of the mullions as the strengthening process was carried out. Left: The grooves had to be carefully cut both because of the deteriorated condition of the wood and due to the relative thinness of the outer edge of the mullion. Right: Reinforcing bars are positioned in the grooves prior to being encased in an epoxy compound.

In many places, due to the advanced decay, the fine details of the mullions crumbled into unrecognizable shapes. In these areas, the original form was recreated using the epoxy

paste like modeling clay. Skillful hands of the craftsman sculpted fill-ins which blended perfectly into the curvature of the wooden mullions. After the epoxy paste hardened, only the color was different from the wood; the shape and the texture were the same. To complete the work, the windows were then primed and painted (see figure 6).
