**BEATTY'S MILL
(CORAL STREET ARTS HOUSE)**
Philadelphia, Pennsylvania

Preservation Tech Notes

NUMBER 21

Replacement Wood Sash Utilizing True Divided Lights and An Interior Piggyback Energy Panel

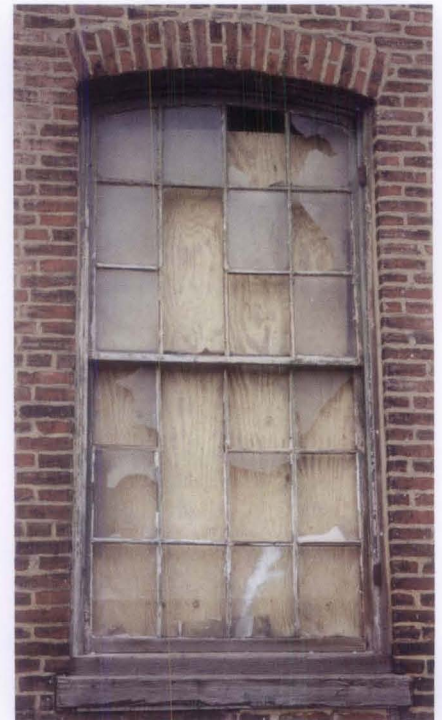
The large double-hung wood windows were one of the most prominent features of the mill. Each measured 48" by 96" with 12 lights of glass in both the upper and lower sash. Characteristic of many mill windows of the time, the sash frames were set in the masonry walls so as to minimize frame exposure on the outside. This provided for more light on the interior. It also enhanced fire safety through minimizing exposed wood on the outside, thus reducing the risk of flames spreading from an adjacent building fire (see figure 2). The outer face of the meeting rail was quite narrow.

The building had suffered many years of neglect, which was reflected in the condition of the windows. A condition survey determined that 40% of the sash were in poor condition; 45% were in fair condition; and only 15% were in good condition. Based on the window survey, the development team elected to replace the

Figure 2. The historic double-hung wood windows had narrow sash and frame members that contributed to the distinctive qualities of the windows.

existing sash with new wood sash. The initial plans included retention of the wood frames, utilizing a combination of dutchman repairs, epoxy consolidation, and epoxy repairs. Upon further investigation, it was determined that even the window frames were too deteriorated to repair.

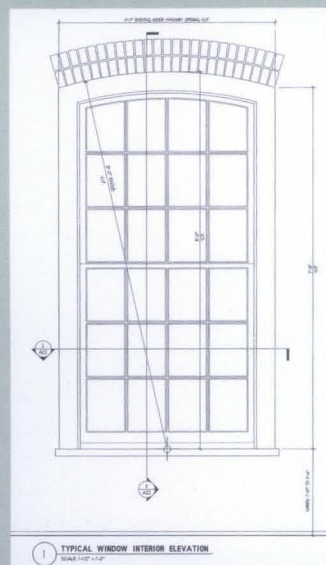
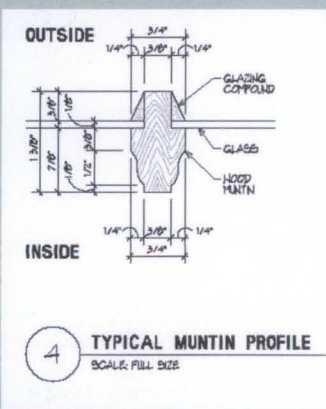
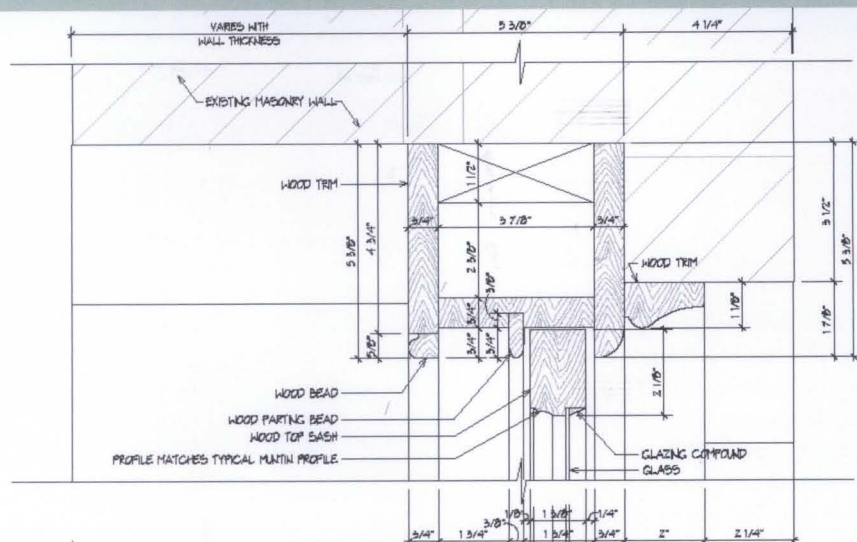
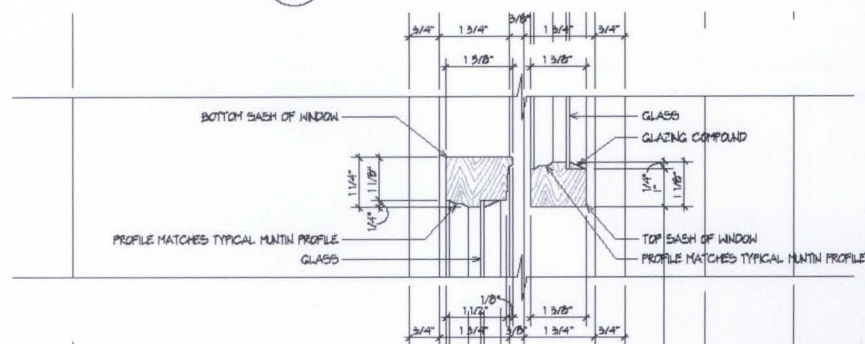
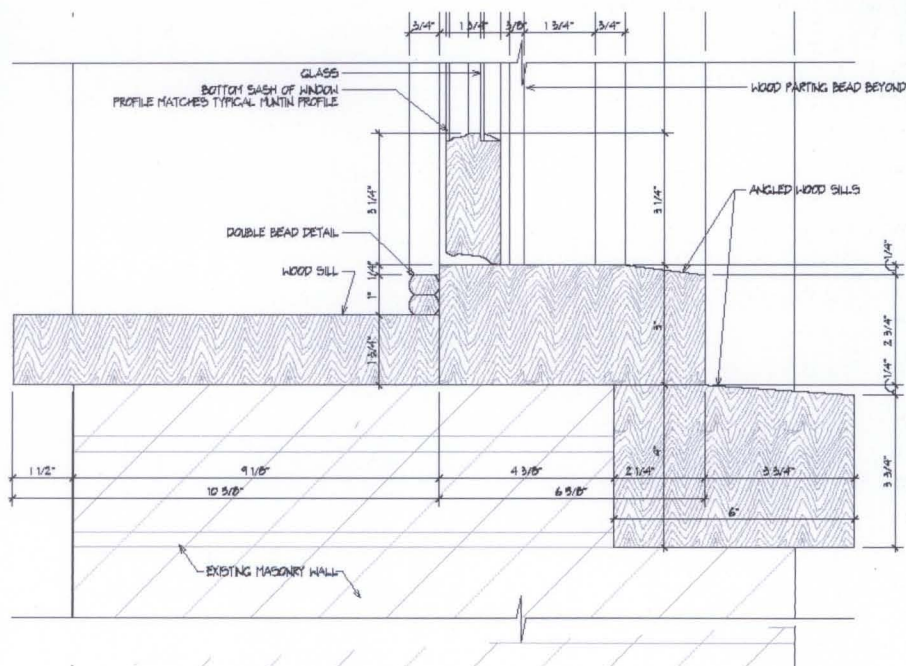
Figure 3. Drawings of the historic windows were prepared by the architectural firm based on field measurements to assist in devising an appropriate replacement window. Drawings: Courtesy of Kitchen & Associates Architectural Services.

The location of this building right on a street corner and the importance of the windows to the historic character of the building led the project team to select a window solution that closely matched both the detail and appearance of the historic windows. By selecting a new custom wood window, the narrow site lines of the historic windows could be closely replicated, the historic glass to wood ratio readily maintained, and other historic details easily reproduced (see figure 3).

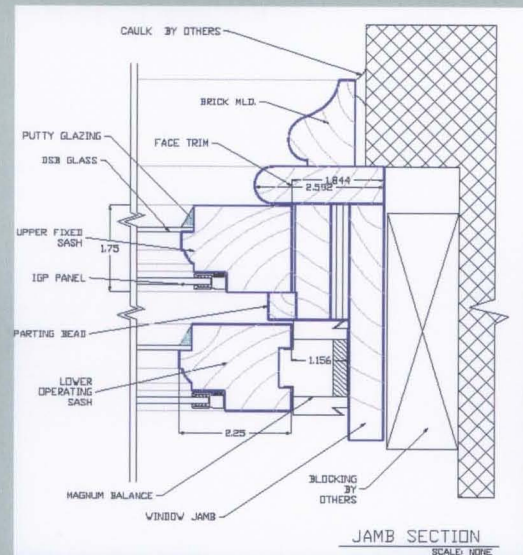
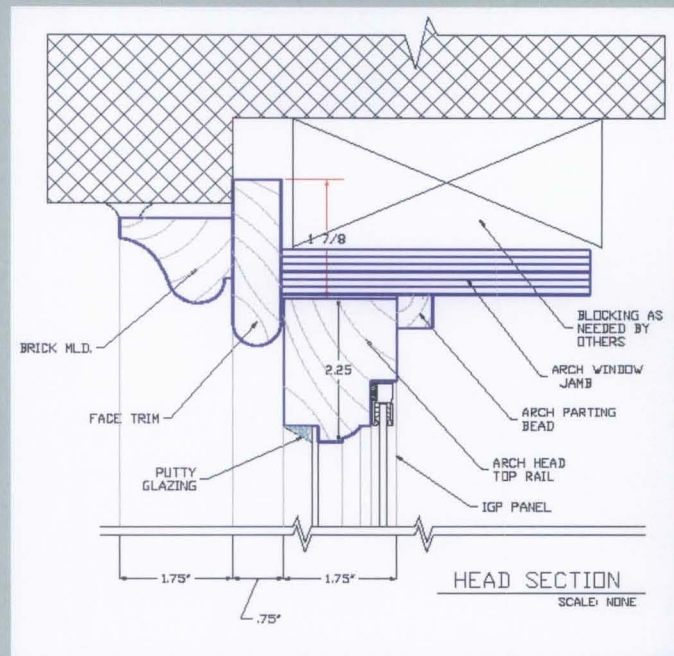
Figure 4. While using contemporary sash balances, the wood replacement windows had many traditional features such as putty glazing for the true wood muntins. Note the sash is rabbeted on the room side to a depth that permits the glazing panel to be set flush. Drawings: Courtesy of Seaquay Architectural Millwork.

To help retain the historic sightlines, the deteriorated frames were removed, permitting the new frames to be set close to the masonry (see figure 4). The alternate approach of retaining the existing frames, abutting new frames to them, and covering the outer face of the exposed portion of the older frames would have resulted in reduced glass exposure and a beefier frame appearance to the finished windows.

Several features of the new window were different than the historic windows in order to accommodate the dual glazing. The inside of the rails and stiles of the sash were rabbeted on the room side to a depth that permits the glazing panel to be set flush. To retain the depth of the original muntin and to accommodate the glazing panel on the inside, the thickness of the sash was increased to 1 3/4". In the bottom rail, weep holes were provided between the glazing panel and the outer glass, to allow water to drain from condensation that might on occasion develop between the two layers of glass.

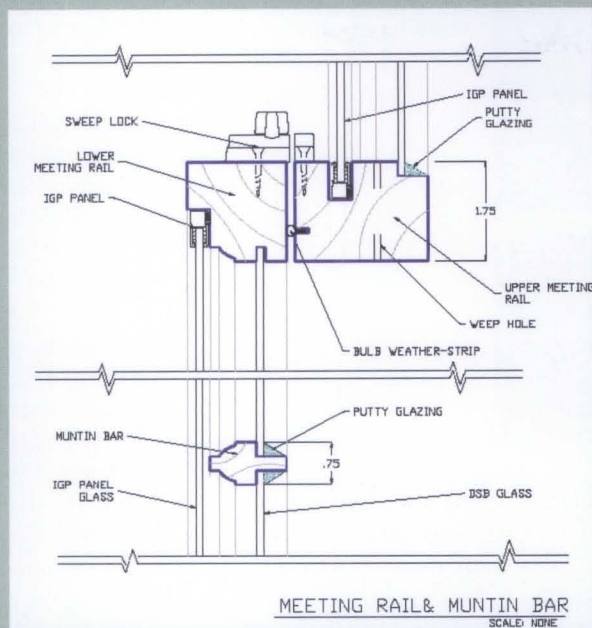
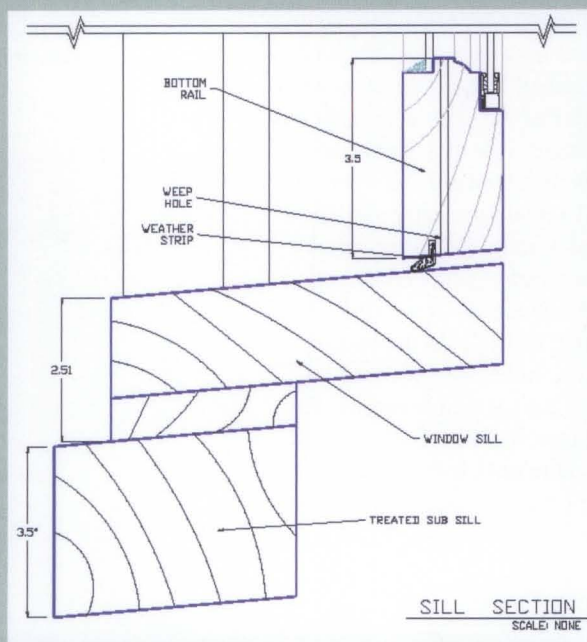
Figure 5. For the new windows to meet ASTM Standards, the face width of the meeting rail was increased 1/2 inch. To both accommodate the piggyback energy panel and match the historic muntins, the thickness of the wood sash was increased from 1 3/8" to 1 3/4". These two changes had minimal visual impact, considering the size of the windows. Drawings: Courtesy of Seaquay Architectural Millwork.

Somewhat more problematic was how close the bottom rail (meeting rail) of the new upper sash could match the narrow width of the existing window. Specifications for the project required that the replacement window meet three ASTM Standards: ASTM E283, the standard test for determining the rate of air leakage through an exterior window; ASTM E331, the test of water penetration; and ASTM E330, the standard test for structural performance of an exterior window. To meet ASTM E330 with the design pressure rating for the window set by the architect, a 1 3/4" wide meeting rail was needed (see figure 5). This was an increase of 1/2 inch over the historic sash. Fortunately because of the size of the window, this increase was considered acceptable, as the meeting rail still appeared relatively narrow even with the 1/2 inch increase.

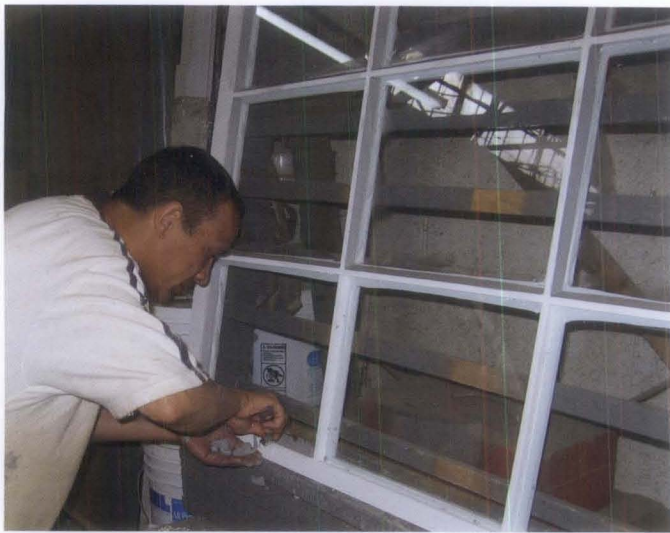
Figure 6. The outer glass was installed in the traditional manner, using exterior glazing putty. Photo: Charles Fisher.

The windows were then assembled and sanded. The outer glass was installed in the factory after the assembled sash were primed. Exterior glazing putty manufactured by C.R. Lawrence was applied in the traditional manner (see figure 6). Since the upper sash were to be fixed in the operable windows, weatherstripping and block and tackle balances were provided only for the lower sash. Each window was provided with two sweep locks and two sash lifts for the operable lower sash. Of the 188 replacement windows, 111 were single hung and 77 were fixed (see figure 7).

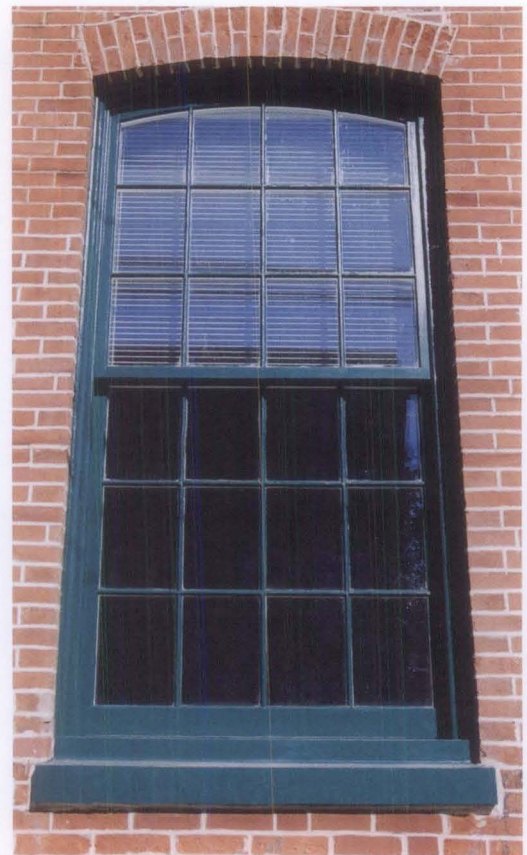
Figure 7. The new window's joinery, individual glass lights, reflective qualities, and painted wood finish all help to capture the appearance of the original units.

The new windows in Beatty's Mill successfully matched the historic units while providing enhanced energy conservation. There is little difference between the new and historic windows in terms of the characteristic features (see figures 2 and 7). The integral wood muntins, individual panes of glass, reflective qualities of the glass, glazing putty, and painted wood surfaces, along with the benefits of using a custom-wood window manufacturer that could duplicate

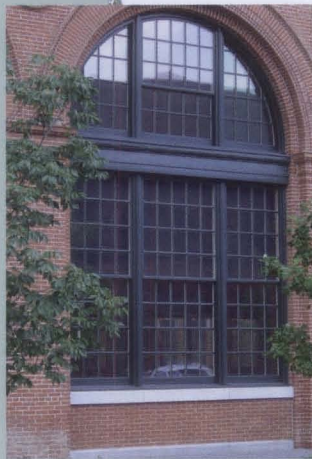
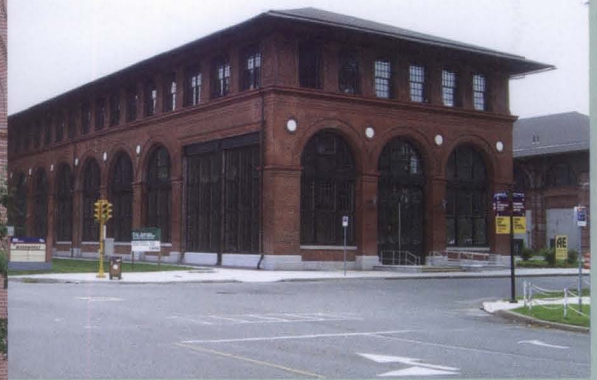
Figure A. Building 10 (headquarters of Urban Outfitters), former Philadelphia Naval Shipyard. New wood windows were made to match the original units, including true divided-lights, while incorporating a piggyback interior energy panel. Photos: Seaquay Architectural Millwork.

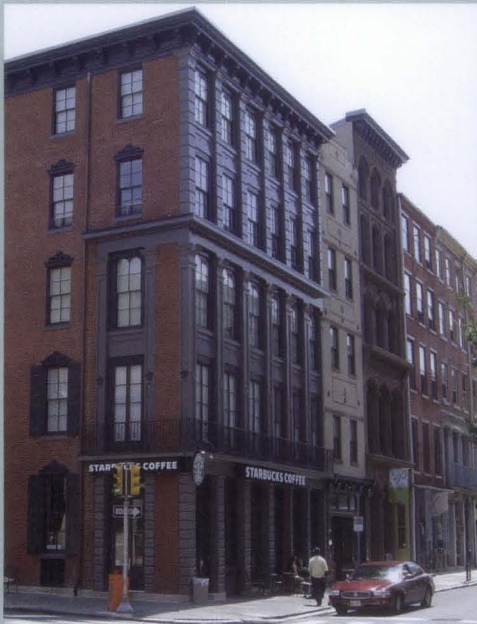
Figure B. 61-63 North Arch Street, Philadelphia (commercial and residential). Most of the historic windows were missing or severely deteriorated prior to the rehabilitation of this corner building. Based on surviving units, new non-clad wood windows were milled with matching true divided lights and piggyback energy panels. Photo: NPS file.

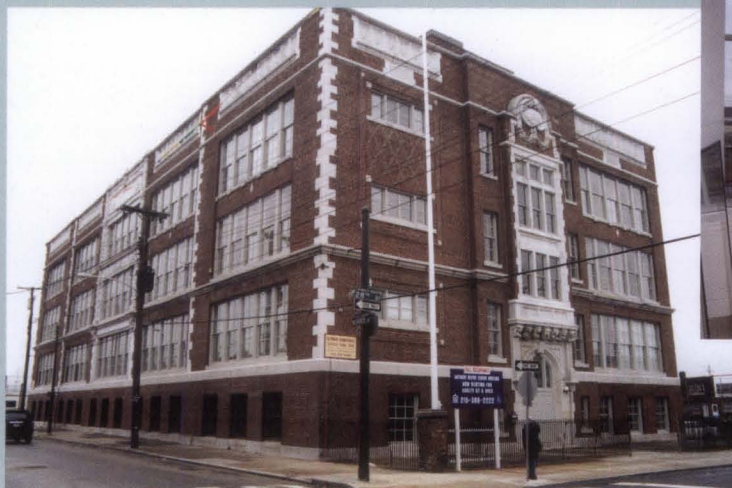
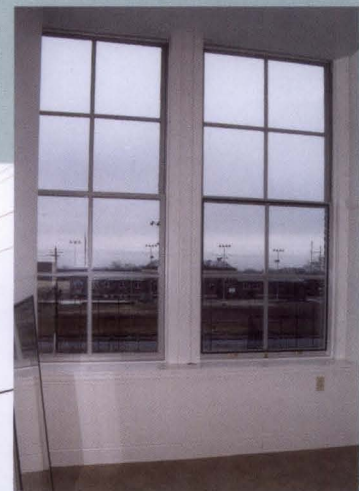
Figure C. Anthony Wayne School (affordable senior housing), former Philadelphia school. The predominant window type is a wood unit with four-over-four glass lights as shown in the lower right-hand photograph. The replicated wood window on the right is shown with the energy panels installed, while both sash in the left window have yet to receive the panels shown in the left forefront.

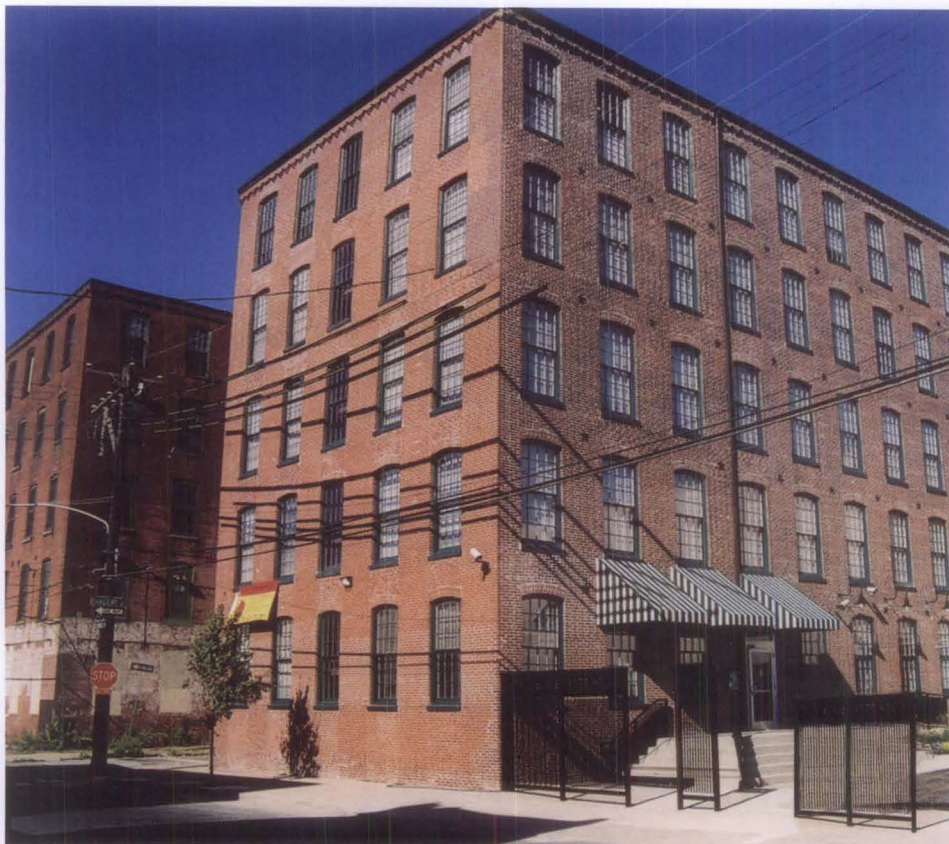
Figure 8. Upon completion of the work, the former mill now serves as low-income housing and artist live/work space. The new wood windows provide improved energy performance and enhance the visual qualities of the historic building.
