J. ARONSTEIN

HAZARDOUS FPE CIRCUIT BREAKERS **AND PANELS**

(Updated as of May 25, 2007)

Information for Inspectors and Homeowners

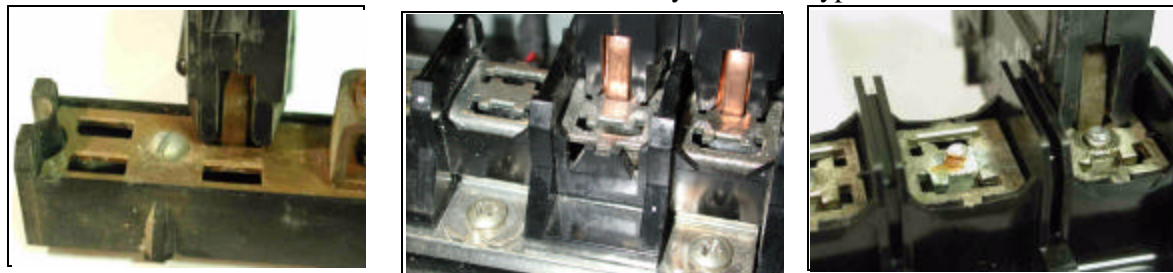
FIGURE 2 - THREE DIFFERENT FPE STAB-LOK® SOCKET DESIGNS

Of the three types illustrated, the one shown in Figure 2-C is known to have a high probability of deteriorating and overheating of the stab socket structures when subjected to significant current flow. Each individual stab socket plate is connected to its bussbar via a post (spacer), and the assembly is held together by an 8-32 steel screw. FPE panels with this construction are prone to overheating failure. The seven panels of the present study that showed evidence of serious overheating were constructed this way. One example is shown in Figure 3.

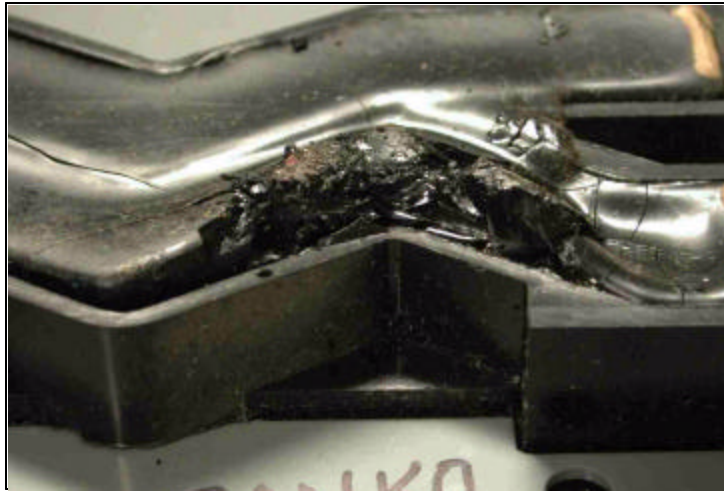
FIGURE 3 - OVERHEATING AT THE CONTACT BETWEEN THE BUSSBAR AND THE STAB SOCKET ASSEMBLY CAUSED THIS DAMAGE TO THE INSULATION.

(This view is of the backside of the panel. The damage cannot not be seen unless the panel is taken out of the enclosure.)

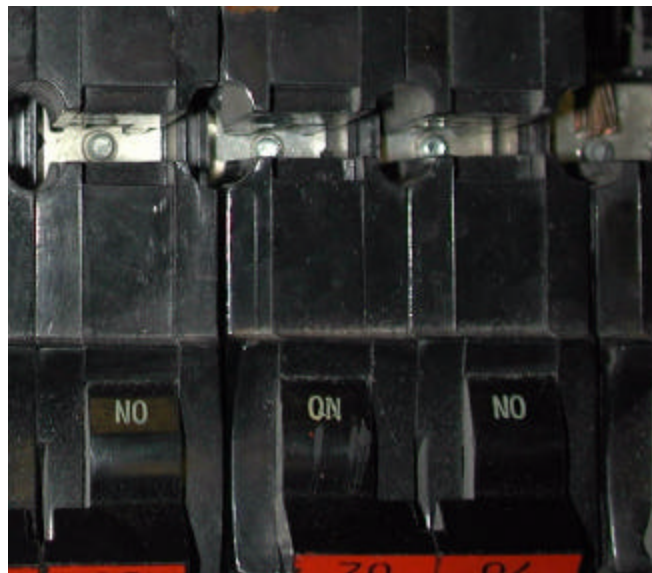
Inspectors can, however, determine if a particular FPE panel has this type of construction, and, to a limited extent, whether it has failing bussbar interconnections that have previously overheated. With the panel cover off, for this type of panel, you can see the ends of the screws holding the stab socket plate as shown in Figure 5. (Note: If you see slotted screwheads, that's a different type of panel construction.) The stab socket plates and the visible ends of the screws should have a bright metallic look. Darkening, discoloration, or signs of corrosion most likely indicate past episodes of abnormal overheating.

FIGURE 5 - THE ENDS OF THE SCREWS HOLDING THE STAB SOCKET PLATES ARE VISIBLE BETWEEN THE TWO ROWS OF BREAKERS. THIS IDENTIFIES IT AS A PANEL OF THE TYPE SHOWN IN FIGURE 2-C

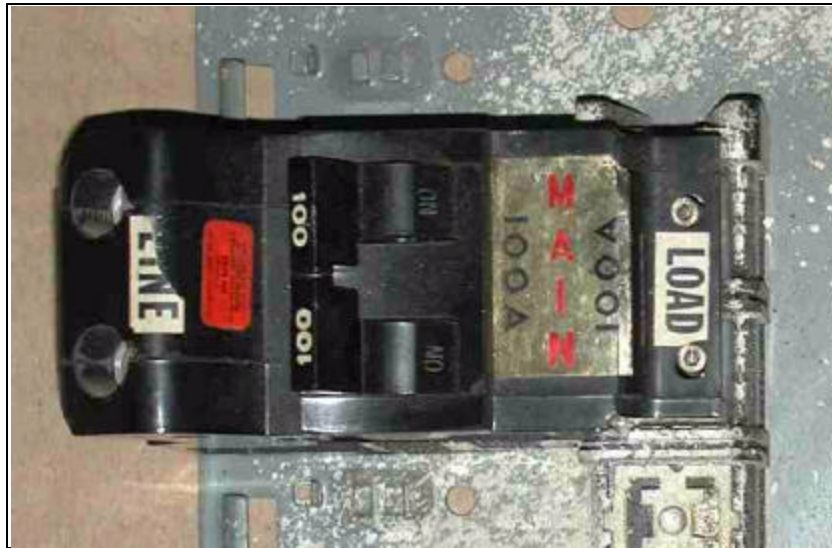
Some FPE Stab-Lok® panels have 100-amp main breakers that feed into the bussbars through the same plate and post system. In this design, the two main breaker output terminals do not have the stab type contact. Instead, each one is screwed down to a plate the same size as the stab socket plate, but which has a threaded hole in it instead of the stab openings. As with the plate and post assembly, the screws clamping the main breaker terminals are size 8-32, which is absurdly small for clamping the terminals of a 100-amp main breaker.

To put the diameter of the 8-32 screw in perspective, it is the same size as used on common receptacles for connecting #14 or #12 copper wire (for 15- and 20-amp circuits), and has a diameter of only about 5/32". An FPE panel and main breaker of this type is shown in Figure 6. The main breaker's output terminal mounting screws and the tiny Allen-wrench that fits them are shown in Figure 7.

FIGURE 6 - FPE 100-AMP MAIN BREAKER CONNECTS TO THE BUSBARS THROUGH THE PLATE & POST CONFIGURATION, USING ONE SOCKET-HEAD 8-32 SCREW AT EACH TERMINAL TO ATTACH TO THE CONTACT PLATE.

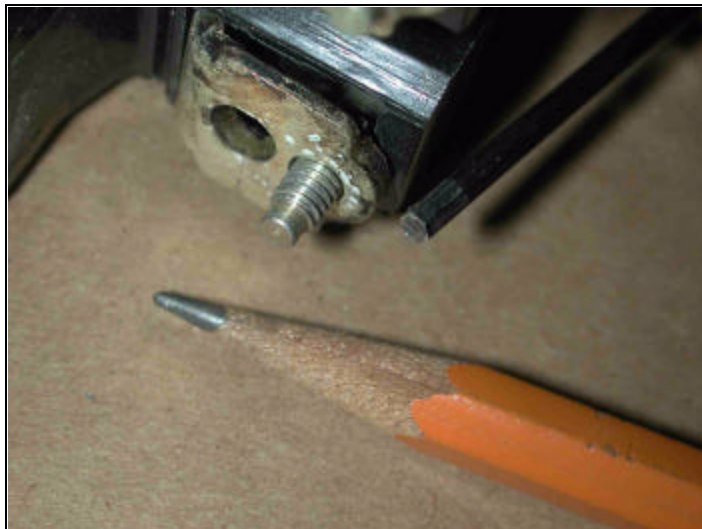
FIGURE 7 - ONE LOAD-SIDE CONTACT AND ITS 8-32 CLAMPING SCREW, ON THE FPE 100-AMP MAIN BREAKER OF FIG. 6. THE SCREW-HEAD TAKES A 3/32" ALLEN WRENCH, WHICH IS ONLY SLIGHTLY LARGER THAN THE LEAD OF THE #2 PENCIL.

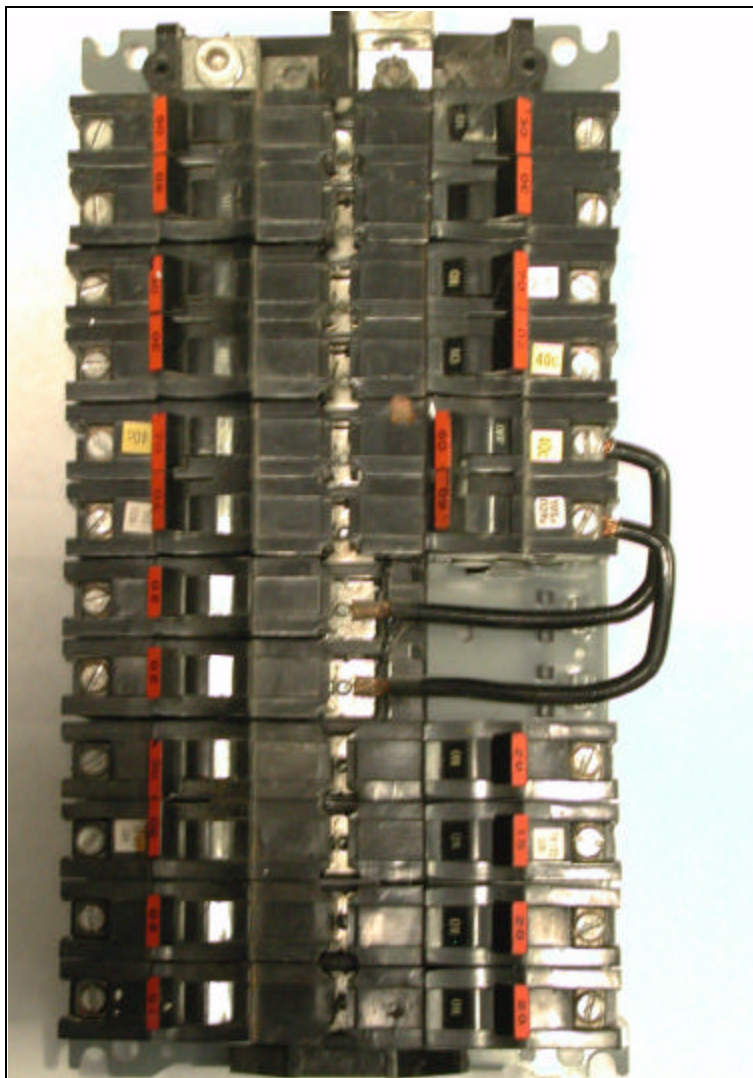
FIGURE 8 - FPE STAB-LOK® "RULE-OF-SIX" (SPLIT-BUS) PANEL WITH NO MAIN BREAKER. THE JUMPER CABLES ON THE RIGHT SIDE FEED THE LOWER SECTION.

There are many different design variations, but the essential element is that in these "rule of six" panels there is no main breaker, and, typically, the lower section of the panel is fed from jumpers coming from the output of one of up to six double-pole breakers in the upper section. The FPE Stab-Lok® double pole breakers have a relatively high probability of jamming when called on to trip, however, as previously demonstrated by the test results presented in Section 2. That means that the home with an FPE "rule-of-six" panel has an unacceptably high probability of having one or more circuits that are totally unprotected, in which the maximum current flow is only limited by what the transformer on the pole can deliver. This is likely to be of the order of 1,000 Amps or more.

On first glance, the FPE Stab-Lok® panel previously shown in Figure 8 looks normal. In fact, however, it clearly demonstrates several of the hazardous failure modes discussed in the previous sections. It is one of 28 collected for the recent testing. It is from a home built in 1974, whose new owners had determined in 1999 that it should be replaced. Their decision to replace it was in part prompted by information available on the internet regarding FPE breaker problems.⁷ According to the homeowner, who sent it to me for examination and testing, *"We recently had it replaced and found the breaker to the dryer fried in just the way described. Our electrician was astonished. Two others we had bids from dismissed our concerns with contempt."*⁸

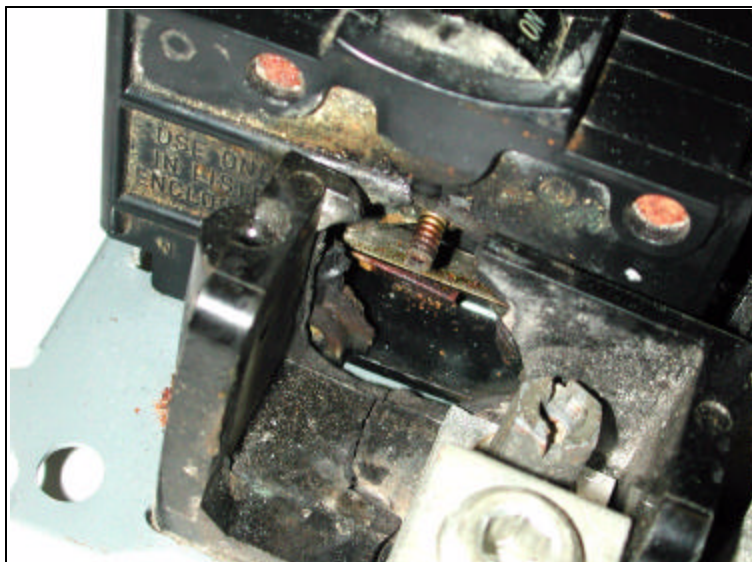
Viewing the panel from the front, some subtle signs of overheating (as previously discussed) are evident. These are subtle compared to the view looking down at the top right (dryer) breaker, as in Figure 9. The main service cable connector has been rotated out of the way for better visibility of the damage. The plastic insulator is burnt and cracked. The breaker's internal mechanism can be seen through the hole burned through its side. Figures 10 and 11 show the damage to the separate items.

**FIGURE 9 - VIEW DOWN TOWARD UPPER RIGHT OF PANEL SHOWN IN FIG. 8.
THE FPE STAB-LOK® TWO-POLE 30-AMP BREAKER FED THE CLOTHES DRYER.**

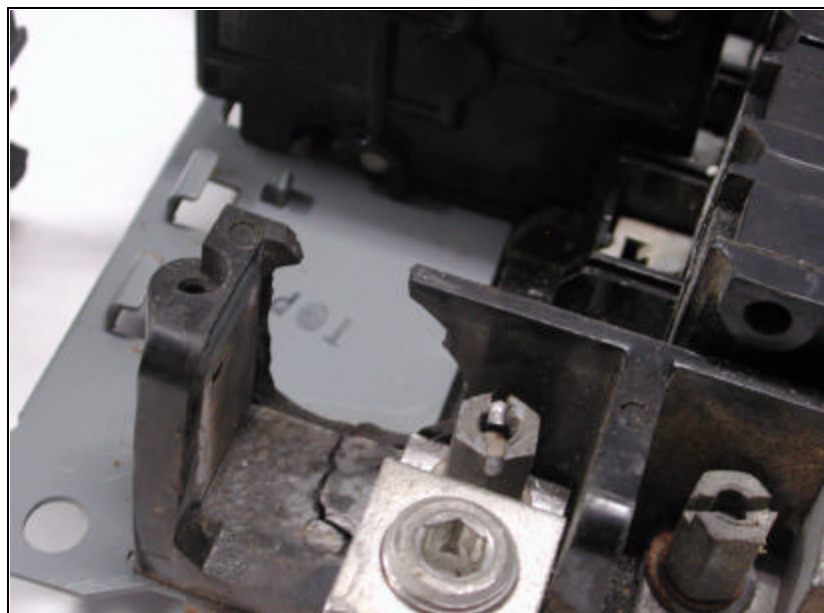
FIGURE 10 - THE DAMAGE TO THE INSULATING STRUCTURE OF THE PANEL (FIG. 8) IS MORE CLEARLY VISIBLE WITH THE BREAKER REMOVED.

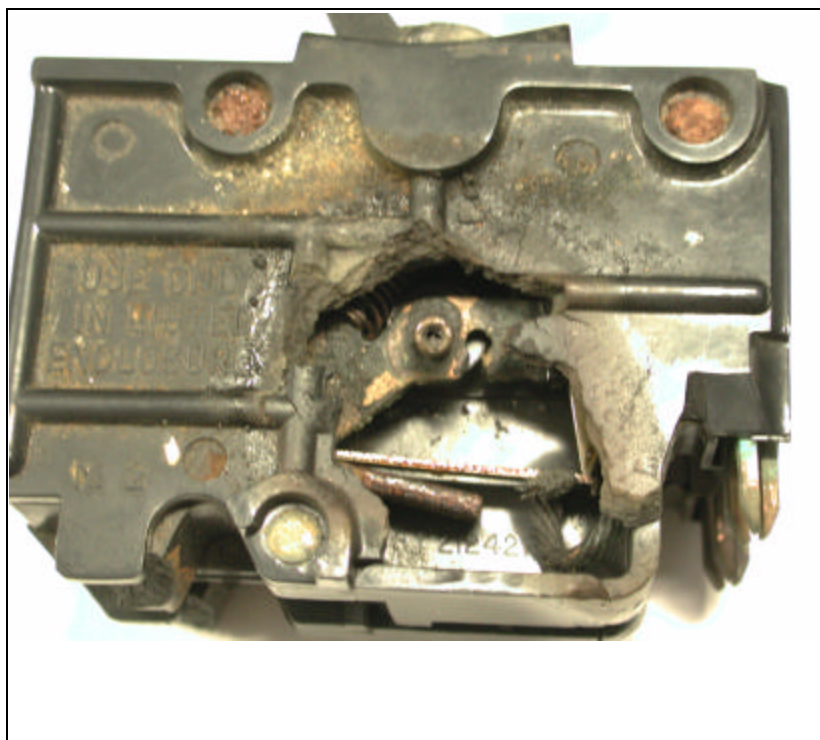
FIGURE 11 - THE FAILED FPE STAB-LOK® DRYER BREAKER (UPPER RIGHT, FIG. 8)

The damage to the breaker, from some previous short circuit or failure event, is exactly as had been demonstrated in the tests done for CPSC.^{2,3,4} Those tests demonstrated that, when an FPE breaker jammed and the current exceeded about 300% of the breaker's rating, the side of the breaker disintegrated and/or ignited from the heat being generated within the breaker. This is due to resistive heating of the breaker's internal current-carrying components, mainly the bimetal element and the flexible copper braid that connects to it. This is not an arcing failure, although the damage to the insulating materials of the breaker and panel sets the stage for an arcing fault to occur.

There are additional problems in this panel. Overheating damage occurred to the insulation on the backside of the panel. Further, in addition to the dryer breaker that failed (jammed) in the home, two other two-pole breakers from this same panel failed in the lab testing. All this in a panel that looked OK from the front!
