## **Performance of Glass/Cladding of High-Rise Buildings in Hurricane Katrina**

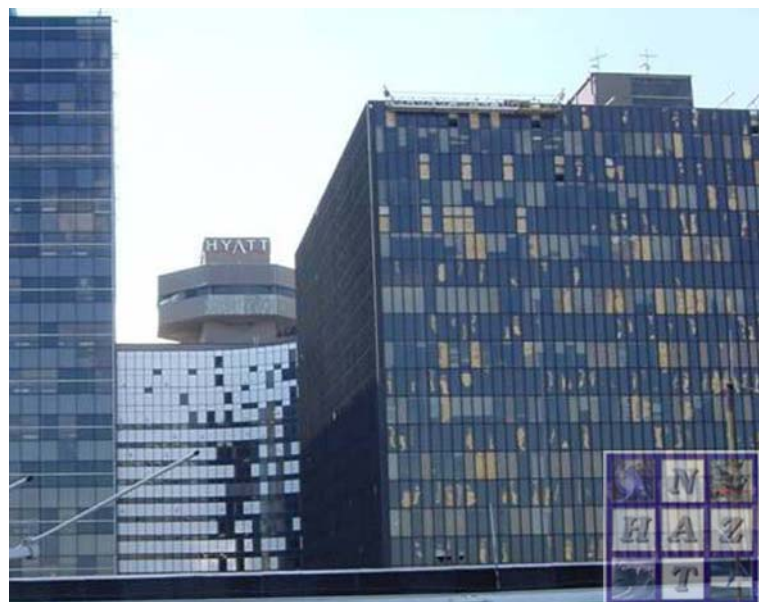
**Figure 2** Damage to Hyatt Regency Hotel and Amoco Building as seen from the roof of City Hall

The Amoco Building sustained a large amount of glass and cladding damage as well as damage to the rooftop penthouse (See Figures 2 and 5). A large percentage of the windows were broken and boarded up with plywood. Of the windows that were not covered, many of them showed pitting where a missile had impacted the window. The roof of the Amoco Building originally had a layer of loose pea gravel several inches thick that covered the built-up roof surface completely.

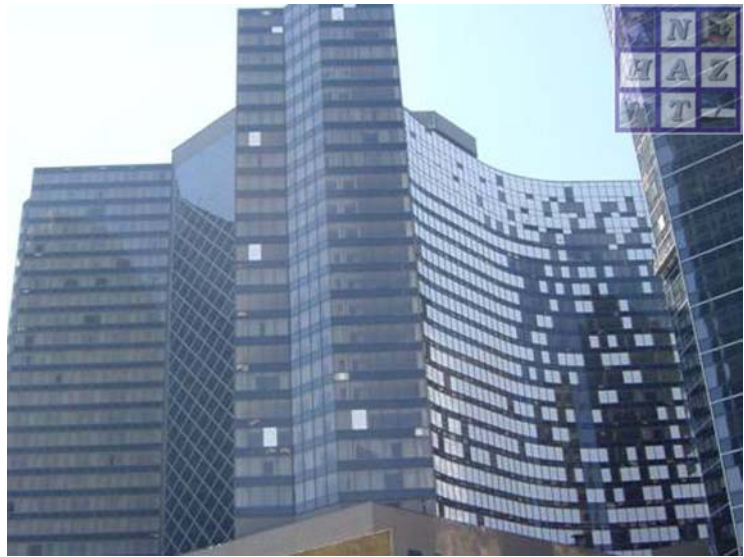
The Hyatt Regency Hotel, located near the Superdome, suffered significant glass and cladding damage, especially on the north face of the hotel (See Figure 3). Nearly every window on the north face of the hotel was broken as it experienced not only high winds during the storm, but also wind with debris accelerating through the canyon formed by the upwind buildings. Some of the falling glass during its downwards trajectory damaged glass at lower levels, initiating a domino effect causing more damage to windows below. Along with the glass damage, the building roof was also significantly damaged. Large portions of the roofing material were torn up and missing. There was evidence of abrasions on certain faces of the various roof structures, including the round center tower, and evidence of façade elements ripped off at several corners. The debris found on the property included gravel, fasteners, and large pieces of glass likely from upwind buildings. In addition, the inside of the hotel was heavily damaged with walls torn down and room contents scattered everywhere (See Figure 4).

**Figure 3** East and north faces of Hyatt Regency Hotel.

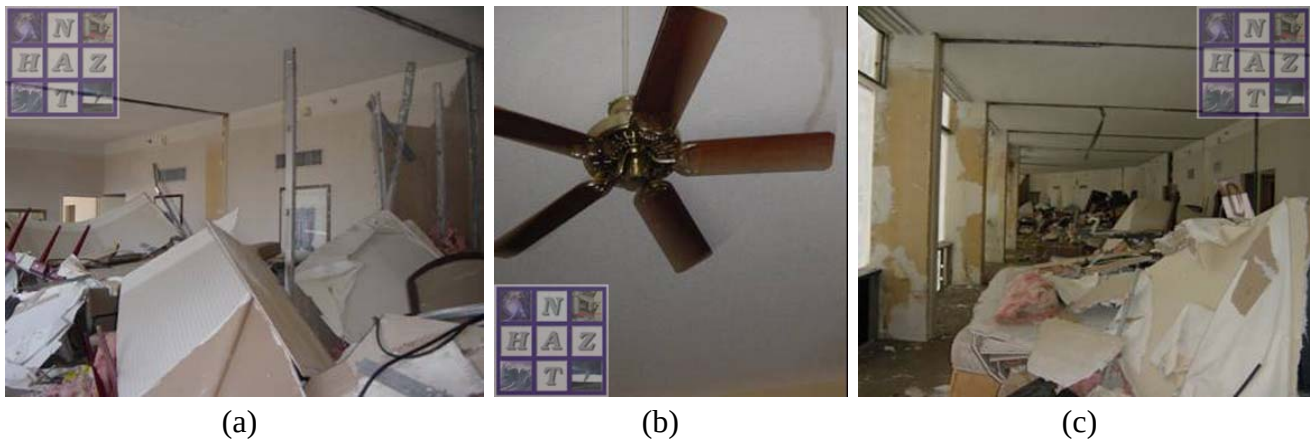
**Figure 4** Inside view of the top, north floor of the Hyatt Hotel: (a) East, (b) Ceiling fan pushed

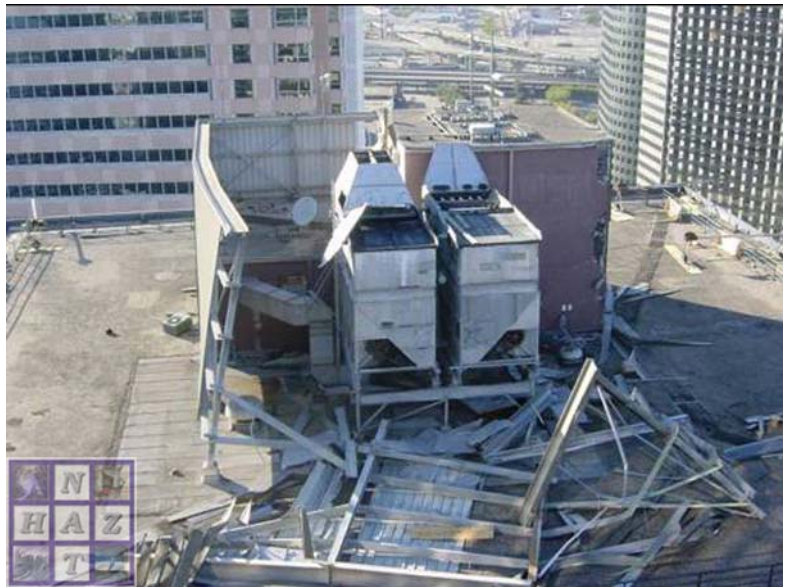
The wind blew off much of the gravel, piling some up along the south parapet and exposing sections of tar. The penthouse structures on the roof suffered considerable damage, as their large beams had been blown off supports and their connections torn out of the cinder block wall. The four columns that supported the penthouse had all been pushed away from the supports - one was missing from the rooftop. It appeared that the bolts that held the steel columns to the concrete bases had been sheared off. Most of the penthouse cladding had been blown off; some large components were found on an adjoining low-rise building south of the Amoco Building.

**Figure 5** Rooftop penthouse on Amoco Building was nearly destroyed

Another cause of damage can be contributed to poor connections and lack of redundancy. This applies mostly to roof top structures. Nearly all of the damaged penthouses had missing siding at the corners associated with high levels of suction. For example, the round tower on the roof of the Hyatt was missing siding on the corners of the north face. Also, miscellaneous fasteners were found on the roof of the Hyatt among the debris. Another example of inadequate connections and bracings was the penthouse on the Amoco Building.

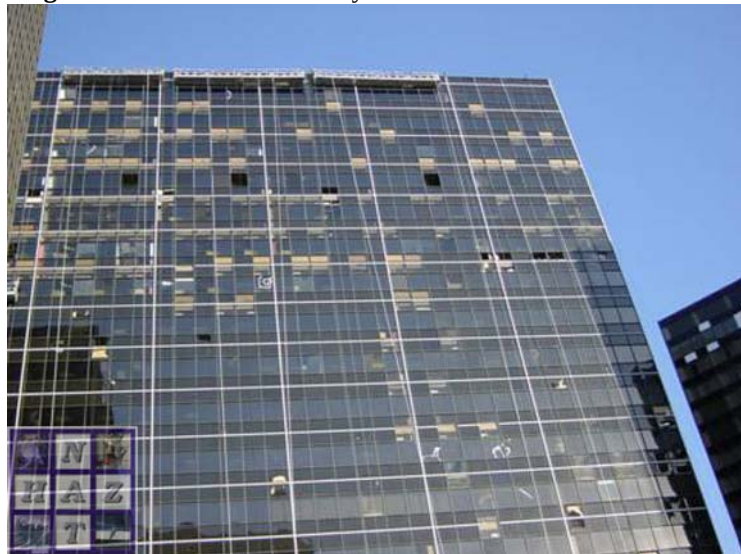
The building known as 1250 Poydras also suffered damage to the glass and cladding, especially on the north face (See Figure 6). The old gravel roof of this building had been replaced two years ago; however, the roofing membrane had bubbled up in the northeast corner. Additionally, a roof drain had been pulled up. The penthouse was in good condition with exception of the loss of one large door. Overall the roof of 1250 Poydras performed satisfactorily. However, some debris from different sources was found.

**Figure 6** West face of 1250 Poydras.

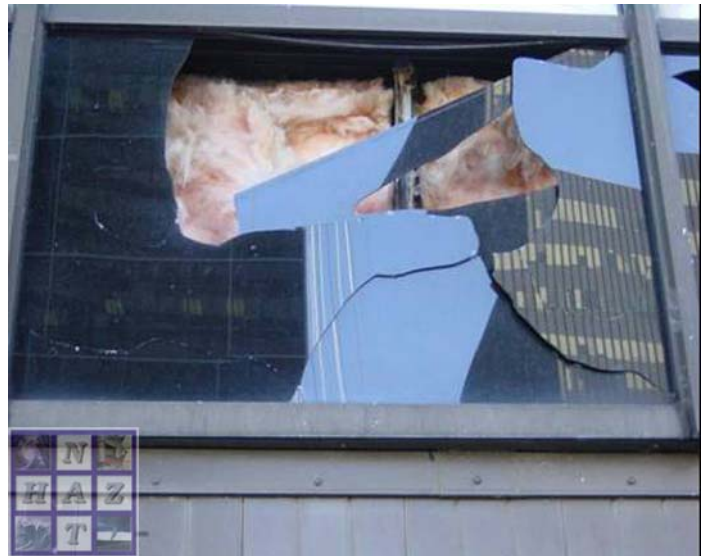
The gathered evidence suggests that the majority of the damage was likely caused by wind-borne debris. The wind-borne debris included pea gravel, rooftop appurtenances, siding, and penthouse structures which became airborne and caused significant damage to the glass and cladding of the surrounding buildings. The finding of gravel, glass shards, pitted glass and other debris on or inside buildings supports this scenario. The breakage patterns to the spandrel glass supports the missile impact theory due to the appearance of impact-induced pitting with cracks that spread from the impact point (See Figure 7 and 8). Given the orientation of the buildings in relation to the damaged areas and the availability of wind-borne debris from upwind buildings, it is

**Figure 7** Broken window on north face of Hyatt Regency Hotel, likely caused by missile impact.

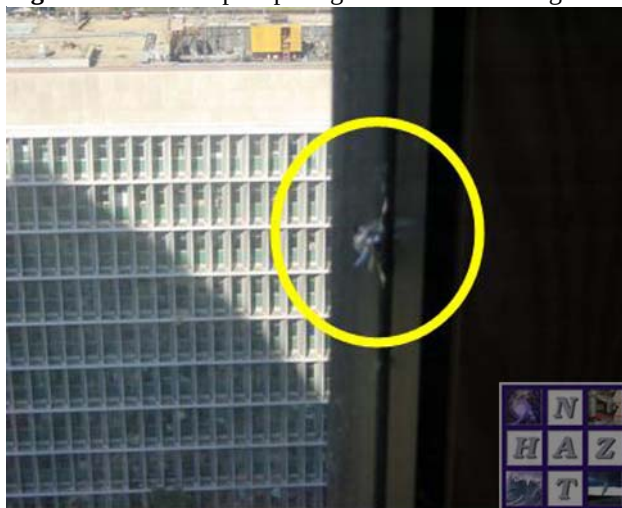
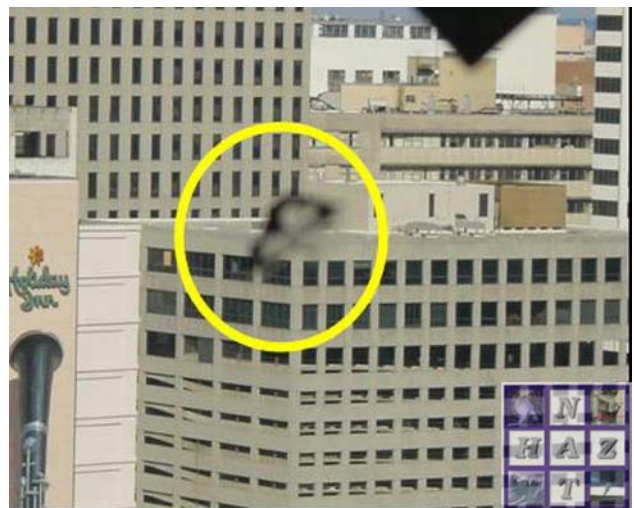
**Figure 8** Missile impact pitting on Amoco Building.
