# LYNDHURST GATEHOUSE

Tarrytown, New York

WINDOWS NUMBER 3

# Exterior Storm Windows: Casement Design Wooden Storm Sash

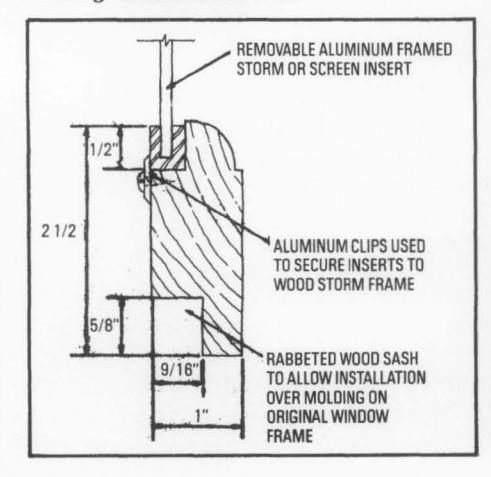
Physical damage and visual changes to historic windows should be minimized when installing exterior storm windows. Figure 1. The single casement, wooden storm window had two removable panels for screen and glass inserts. This custom design fulfilled a variety of requirements established for the project with minimum physical damage and visual changes to the historic windows. Drawing: Martha L. Werenfels

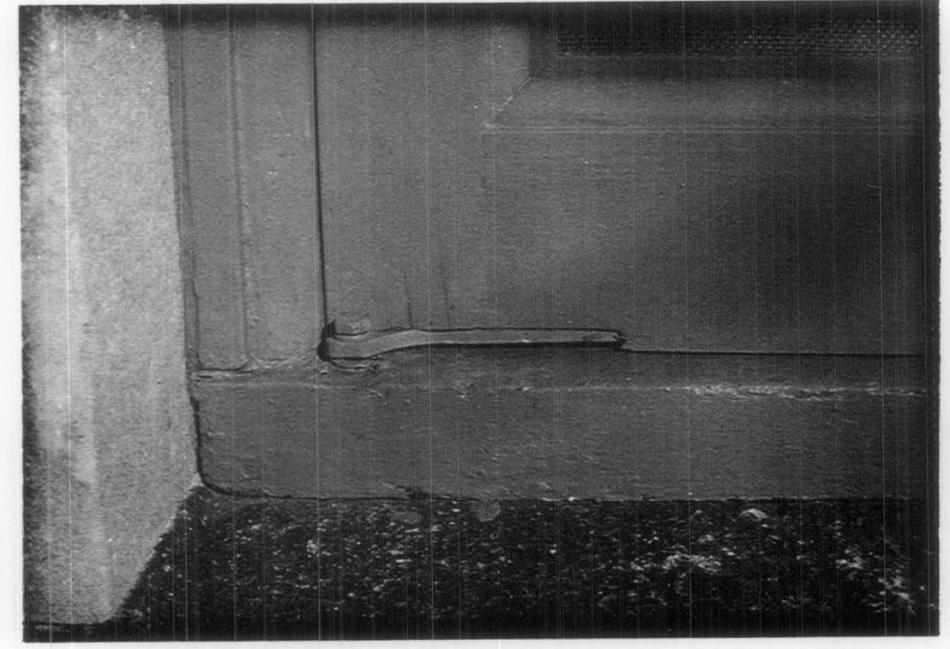
Figure 3. The only feature of the storm window that required expensive custom work was the pin-in-socket hinges (bottom one shown in photograph). Commercially available hardware could have been used; however this project sought to minimize physical damage to historic woodwork and thus tested a prototype design. Stainless steel was used for reduced maintenance costs. Photo: Richard Bierce, AIA
