# FLORIDA STATE CAPITOL

# Tech Notes

# WINDOWS NUMBER 7

# Window Awnings

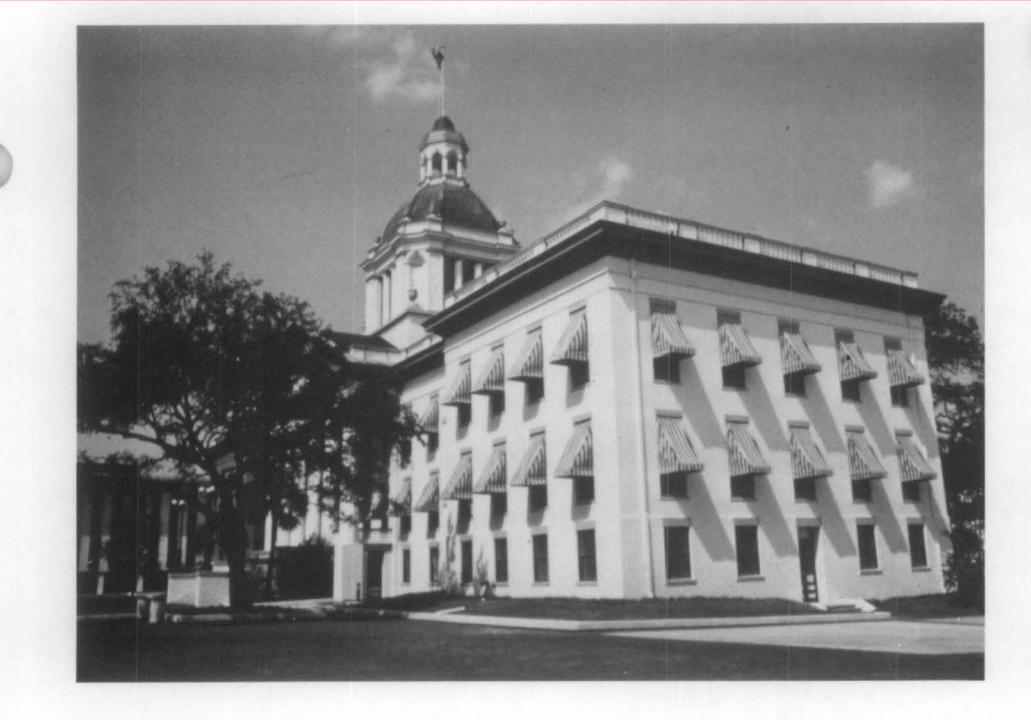
Figure 1. Large awnings were specified for all but the north elevation in order to reduce solar gain. Drawing: Courtesy, Shepard Associates, Architects and Planners, Inc.

Since the primary facades of the Capitol faced east and west, awnings were needed on the two main floors on all but the north side (*see figure 1*). Solar heat gain, which originally would have consumed 54% of the required cooling load, was now estimated to be 31.5% of the equipment load, and allowed a downsizing of the HVAC system by 25 tons. In typical first floor offices, the exposed glass surface would now only account for 46% of the required cooling load down from 72%. On the second floor, there was a similar change from 56% down to 30%.

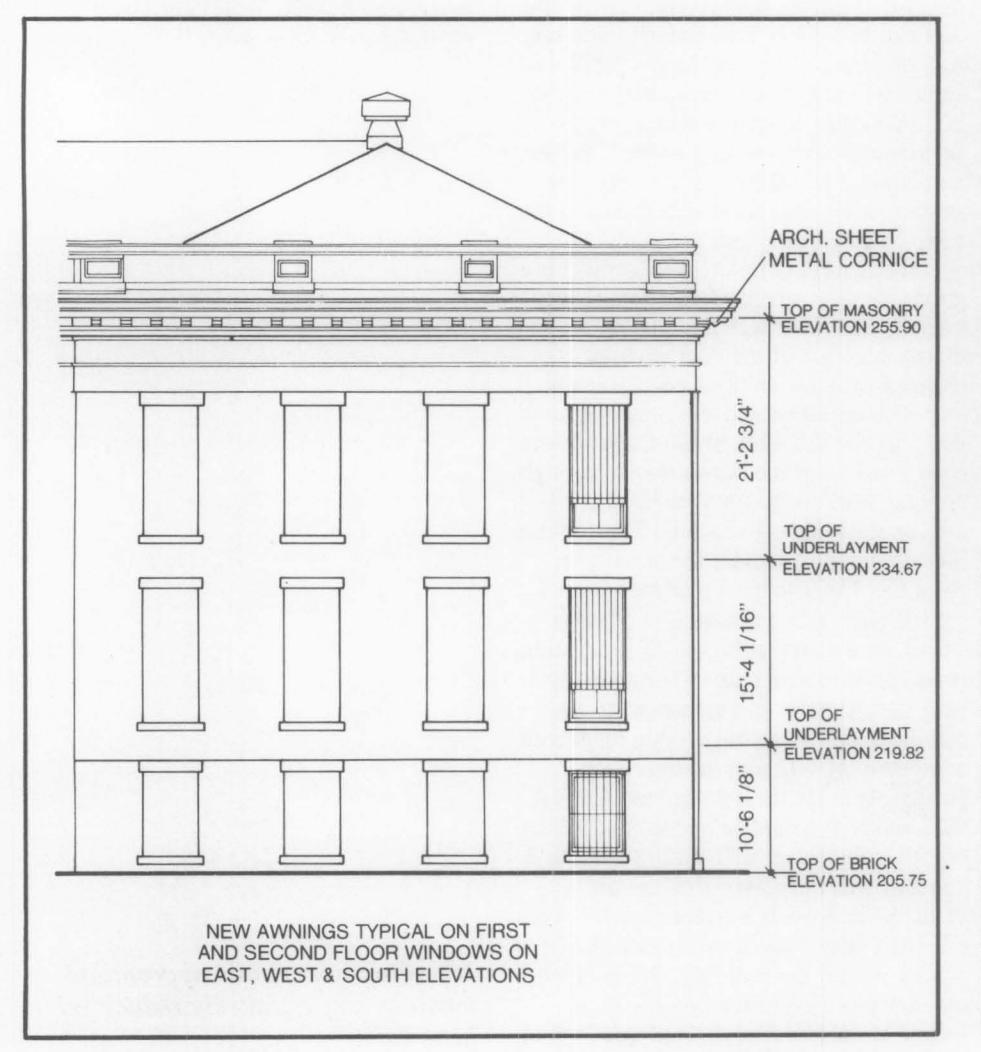
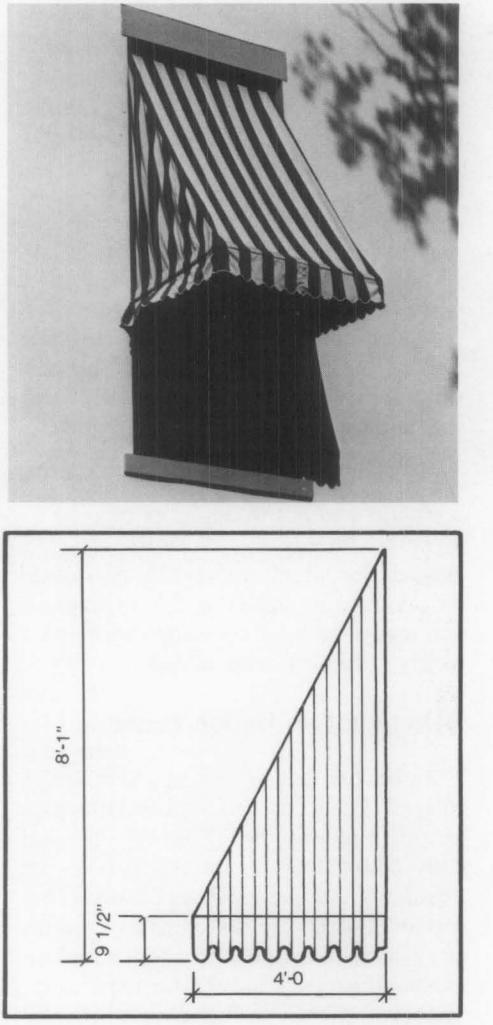
Figure 2. Early photographs were used in determining the appropriate design and size of the new awnings shown in the photograph. Drawing: Courtesy, Shepard Associates, Architects and Planners, Inc.; Photo: Courtesy, Florida Bureau of Historic Preservation.

The awnings were fabricated to the architect's design of 4' wide by 4' deep with a height of 8'-1" and a  $9\frac{1}{2}$ " scalloped valence (*see figure 2*). The 100% acrylic fabric has vertical stripes four inches apart. Regrettably the production of the acrylic weave did not allow for pure color separation, and as a result the striping is in reality red and a very light pink; still the impression of red and white is maintained.

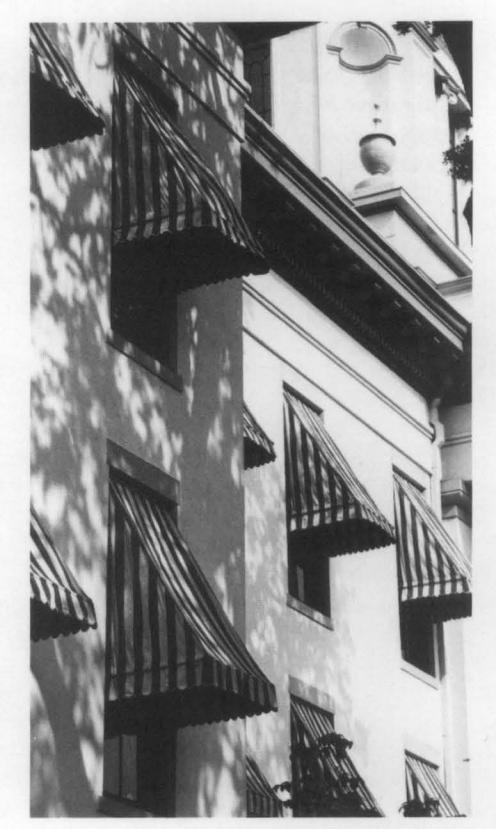
Figure 3. By reducing the glare and solar gain, the awnings have eliminated the need to purchase and maintain interior shades and draperies in various offices. Photo: Courtesy, Florida Bureau of Historic Preservation. tion and as a result of the downsizing of the HVAC system.

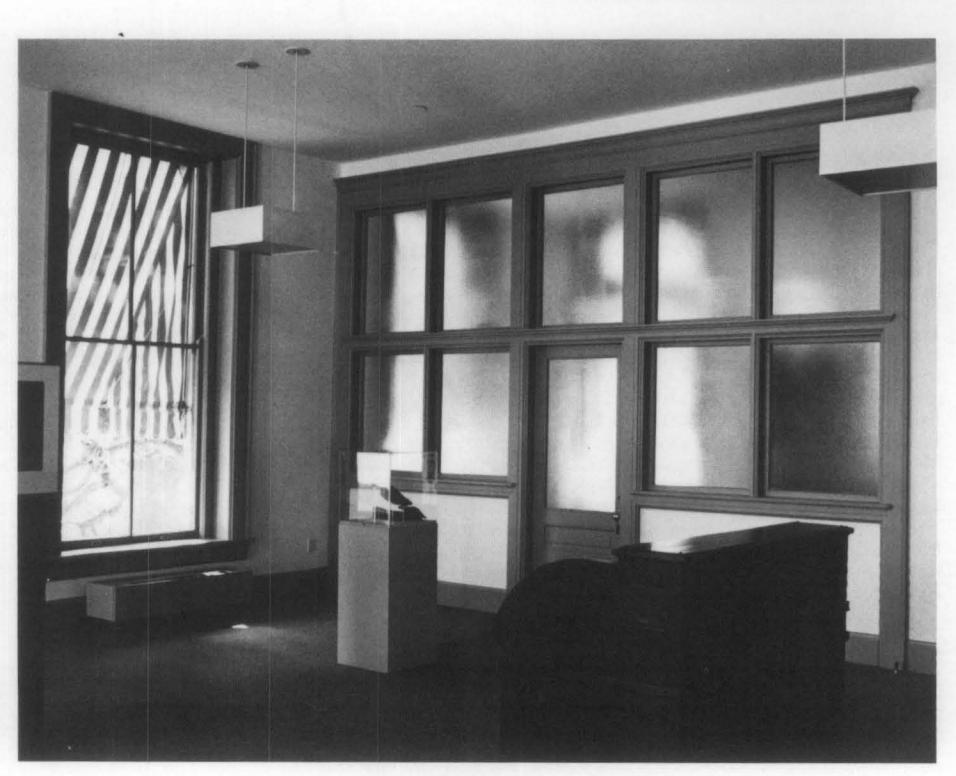
The decision to make the frames rigid to prevent retraction of the awnings on the Florida State Capitol did prove to be unwise, since seasonal high winds, exacerbated by large adjacent new construction, caused greater damage than had been anticipated. To correct this condition, the windows, which had been screwed shut and sealed, were easily reopened; the awnings were rigged so that they can be drawn back in high winds; and various sleeves and pins were removed from the frames, returning them to their original operable condition. Now whenever inclement weather is anticipated or more sunlight is required in certain rooms, maintenance personnel can easily retract the awnings. The awnings now are performing admirably and this highly distinctive historic feature has generated considerable local interest (see figure 4).

Figure 4. While the awnings were installed in order to save on energy costs, the restoration of this highly decorative and colorful feature enhances the historic appearance of the building. Photo: Courtesy, Florida Bureau of Historic Preservation.
