## COLCORD BUILDING Oklahoma City, Oklahoma

# Tech Notes

NUMBER 8

### Thermal Retrofit of Historic Wooden Sash Using Interior Piggyback Storm Panels

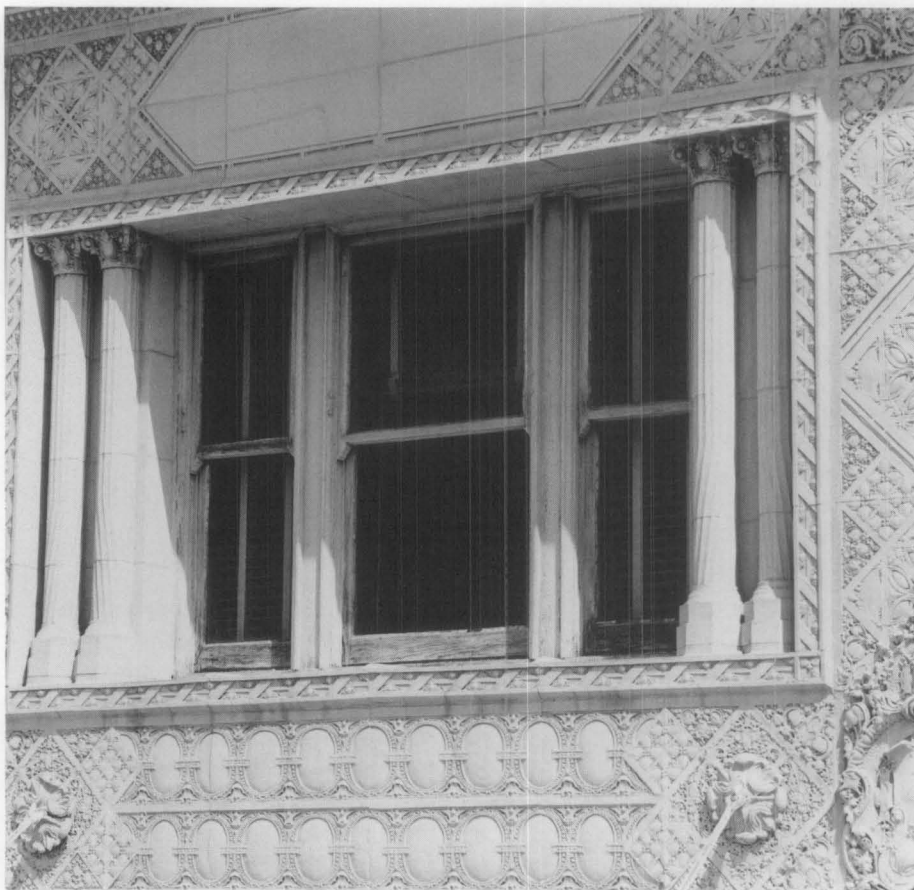
**Figure 1. Deeply recessed windows with ornamental terra-cotta surrounds were character-defining features of the building which the owner wanted to retain. Photo: Jack Graves, AIA**

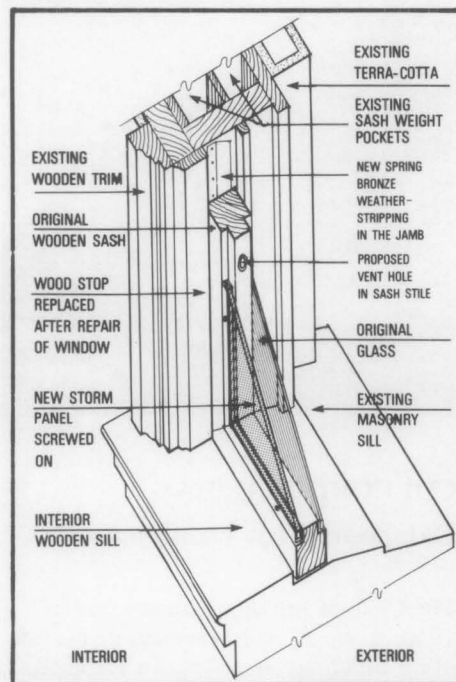
This approach would necessitate routing or cutting out a portion of the historic wooden sash and would add to the weight of the sash due to the attached storm panel. The sash rails and stiles measured 1-7/8" deep by 2" wide and were in sound condition. They were therefore capable of tolerating the required cut—3/8" deep by 1/2" wide. The issue of the additional weight of the storm panels was directly related to the choice of materials selected for the piggyback units. Since acrylics are purported to be 40% lighter than glass and 15% more thermally efficient for the same thickness, the architect investigated their use. Because of expense and the tendency of acrylic to bow or discolor due to sun

**Figure 2. Cutaway view of the proposed retrofit solution showing how the historic sash would receive a recessed storm panel through routing or cutting an inside rabbet. Drawing: Sharon C. Park, AIA**

While researching new window units, the architect found a commercially available wooden replacement window that incorporated a removable storm panel piggybacked onto the single glazed sash. This second layer of glazing was recessed on the inside of the primary wooden sash, allowing the double-hung window to operate without interference from the applied panel. The architect applied this concept to the Colcord Building's windows and proposed to retrofit a recessed storm panel to each existing sash, provided it would not structurally weaken the sash in the process (see figure 2).

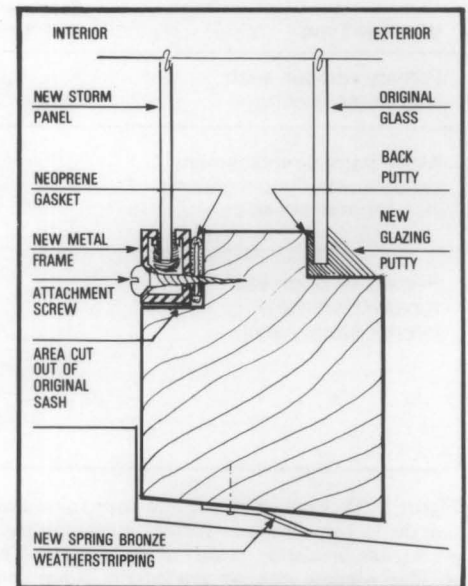
**Figure 3.** The completed retrofit shows the storm panel screwed onto the historic window.  
Photo: Tamara Coombs

As the panels would only be removed for maintenance purposes, the architect determined that the panels simply could be screwed in place, using a neoprene gasket set on the back side of the panel as a seal (see figure 3). Should the panels ever need to be removed, an electric screw gun would do the job quickly (see figure 4).

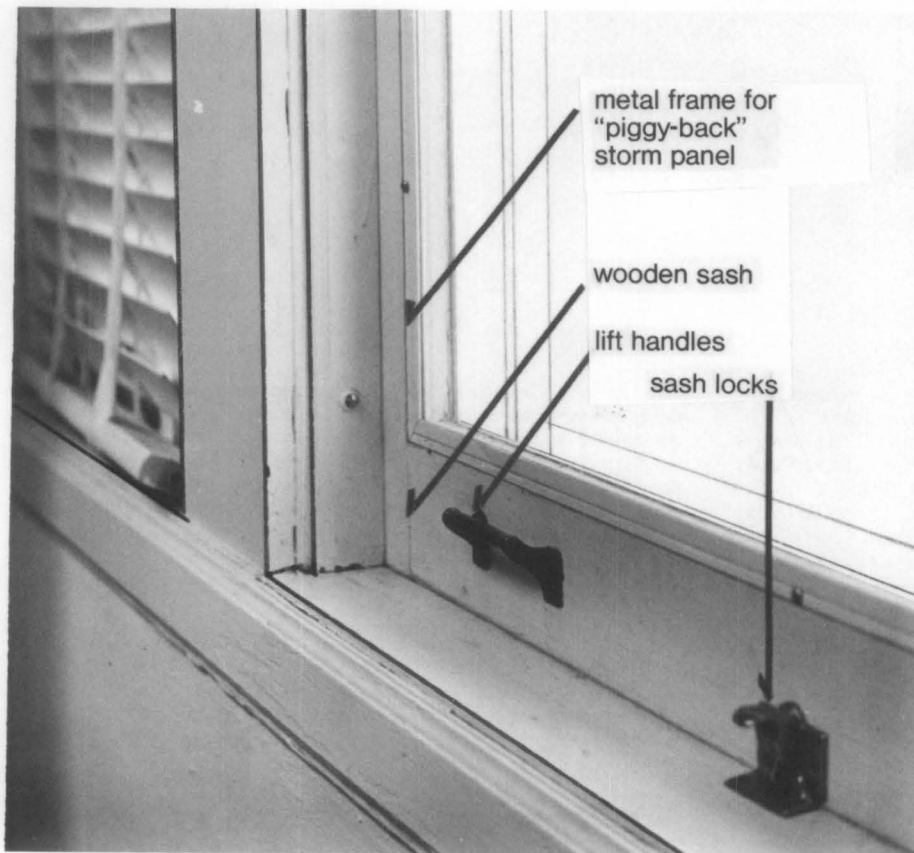
**Figure 4.** The applied interior storm panel was screwed in place. Note the use of the neoprene gasket, which provides an air seal between the storm panel and the historic wooden window.  
Drawing: Sharon C. Park, AIA
