**STRUCTURAL APPRAISAL FOR FIRE**  
**DAMAGED BUILDINGS**

BY  
Dr. Rizgar Salih Amin  
(BSc,MSc,PhD)

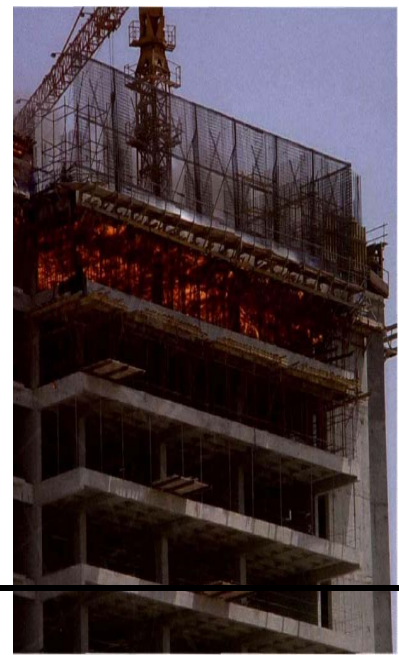
a large fire broke out on a ten-storey reinforced concrete frame building, which occurred during construction. The fire swept through the three upper storeys while the soffit formwork for the slabs was still in place. Although the damage was widespread, it was confined to the outer 20-30 mm of the

underside of the slab and some columns. Tests on samples of the reinforcement showed that the steel had not been significantly affected and hence, the slabs could be economically repaired. The damaged concrete was removed by hydro-demolition or manually, and was reinstated using sprayed concrete.

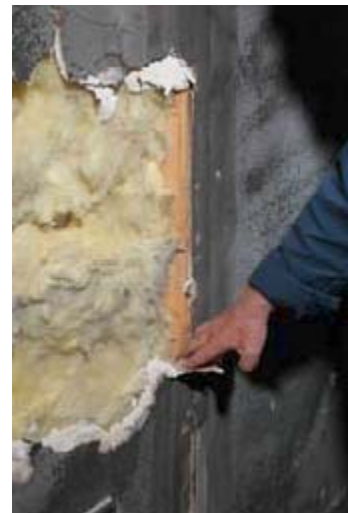
Case study- Sorting House, Manchester 2000, A fire broke out in this four storey timber framed building containing luxury apartments. The fire started on the top floor in one of the apartments, where it was contained. The fire was fairly serious, consuming all the furnishings within the room and blowing out the windows. Luckily the fire brigade managed to extinguish the fire before it spread to the other apartments within the building. Upon carrying out an assessment of the fire damage to the property, the main structural elements were completely unaffected by the fire and the only damage that had occurred was aesthetic.
