# **An Analytical Study of Some Physical Properties of Wire and Cable Samples Collected from Older Homes**

Underwriters Laboratories Inc.  
333 Pfingsten Road, Northbrook, IL 60062

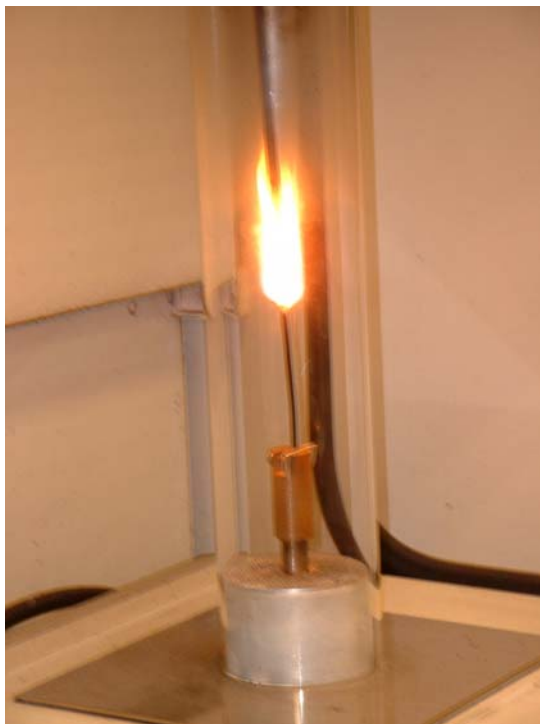
Oxygen Index Apparatus

4. Limiting Oxygen Index - Limiting oxygen index (LOI) tests were conducted to determine the minimum oxygen concentration necessary to support combustion in accordance with ASTM D2863 [1]. Ambient oxygen concentration was varied by precisely controlled combination with nitrogen. LOI tests were conducted on unaltered wire by using a methane torch to ignite the wire. If the flame produced a candle-like burn that did not appear as though it would extinguish, the concentration of oxygen was reduced by 1%. If the flame extinguished itself, the concentration of oxygen was increased by 1%. The critical value for the oxygen index concentration was determined to be the oxygen concentration range where the flame extinguished at the lower concentration and produced a candle-like burn at the higher concentration. The conductor was left in the insulation to maintain sample rigidity.

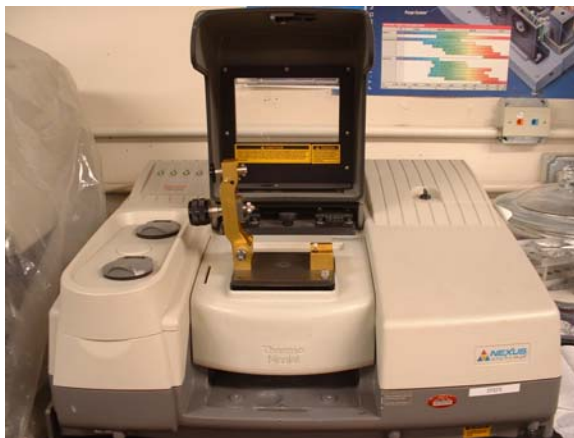
6. FT-IR Measurements – Chemical composition information of the wire insulation was characterized in the solid state using a Nicolet Nexus 470 FT-IR (Fourier transform infrared) with a Golden Gate KRS-5 diamond ATR accessory. Spectral response of the materials was measured from  $400 - 4000\text{ cm}^{-1}$  wavenumber range with a  $4\text{ cm}^{-1}$  resolution; 32 scans were averaged per recorded spectra.

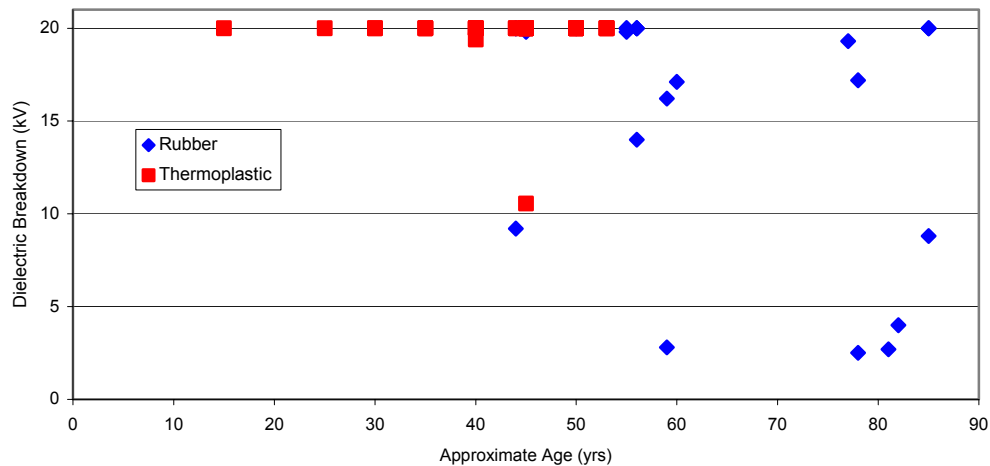
Fig. 1 - Dielectric Test Results vs Age

Figures 1 and 2 show the results of the dielectric and dielectric / bend tests respectively when plotted versus age of the wire. The trends clearly show a reduction in dielectric strength and bend strength with age; however, this may be largely due to the inherent property characteristic differences between older rubber insulations and newer thermoplastic insulations. In general, thermoplastic insulations performed very well with age.

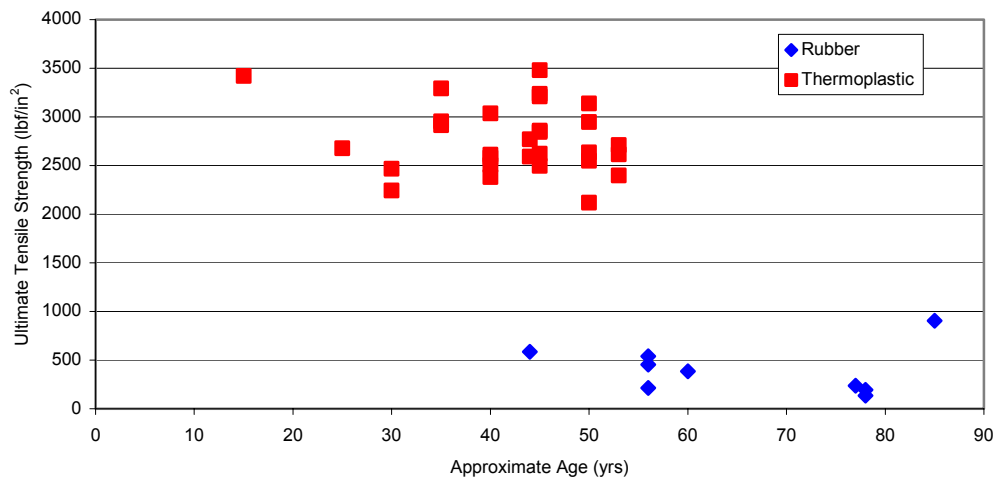
**Fig. 3 - Ultimate Tensile Strength vs Age**

Figures 3 and 4 show the results of the ultimate tensile strength and elongation tests respectively when plotted versus age of the wire. Very clear distinctions are evident between thermoplastic and rubber samples. Although the elasticity of many of the older rubber samples was quite low, others appear to have retained much of their original strength, even with age. As with the dielectric and bend tests, the thermoplastic samples performed very well, with little if any loss of elasticity with age.

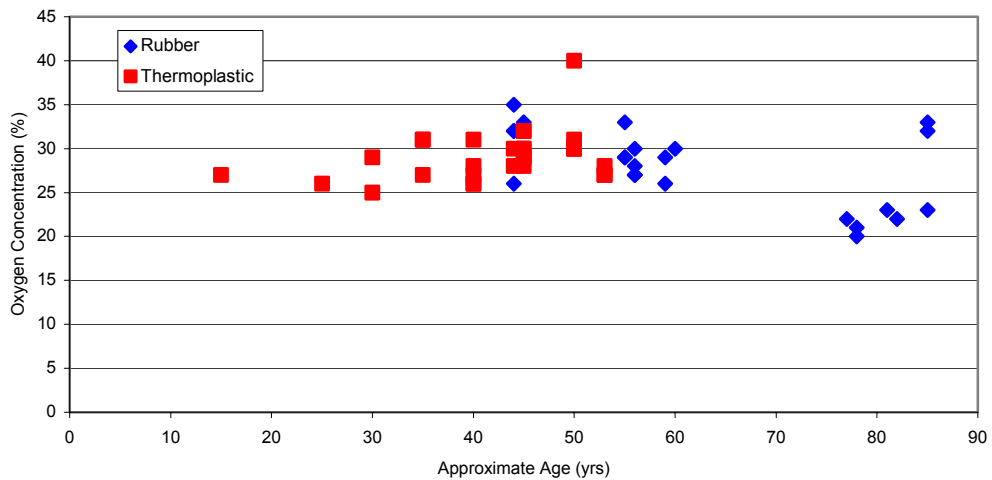
**Fig. 5 - Limiting Oxygen Index vs Age**

Figures 5 and 6 show the results of the limiting oxygen index measurement and oxygen bomb calorimeter test when plotted versus age of the wire. Trends in this combustibility data are less conclusive than with the electrical and mechanical response data. Differences between the thermoplastic and rubber samples may again be due to the inherent differences in the physical proprieties of the two different materials.
