HISTORIC INTERIOR SPACES

NUMBER 3

Preserving Historic Corridor Doors and Glazing in High-Rise Buildings

Chad Randl
Technical Preservation Services
National Park Service

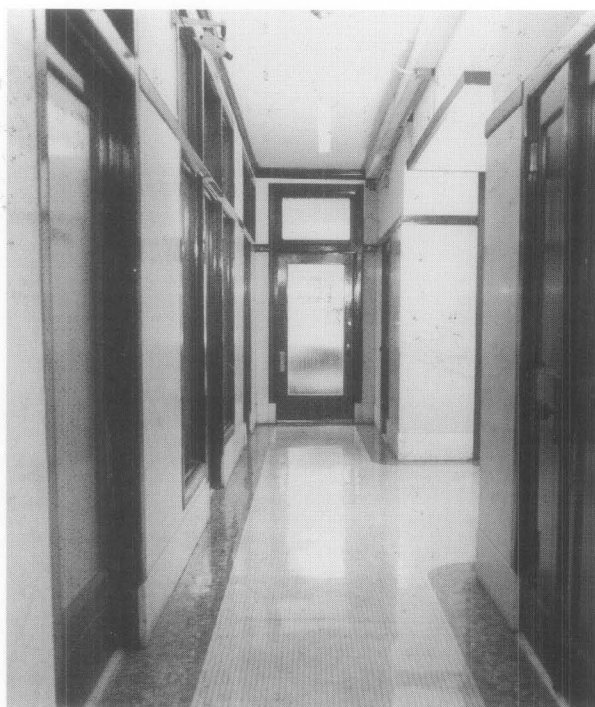
Figure 1. Historic corridor features such as doors, transoms and sidelights often do not meet current fire resistance regulations. Photo: Fisher Building, Frank Merrill Photography.

building undergoes a major rehabilitation or change in occupancy classification, the owner is usually required to bring the structure into compliance with modern codes written primarily for new construction. Among other provisions, current building codes often require that assemblies and materials provide a specified level of fire resistance. Historic doors, transoms and sidelights are common corridor features that are unlikely to meet such resistance ratings (*see figure 1*).

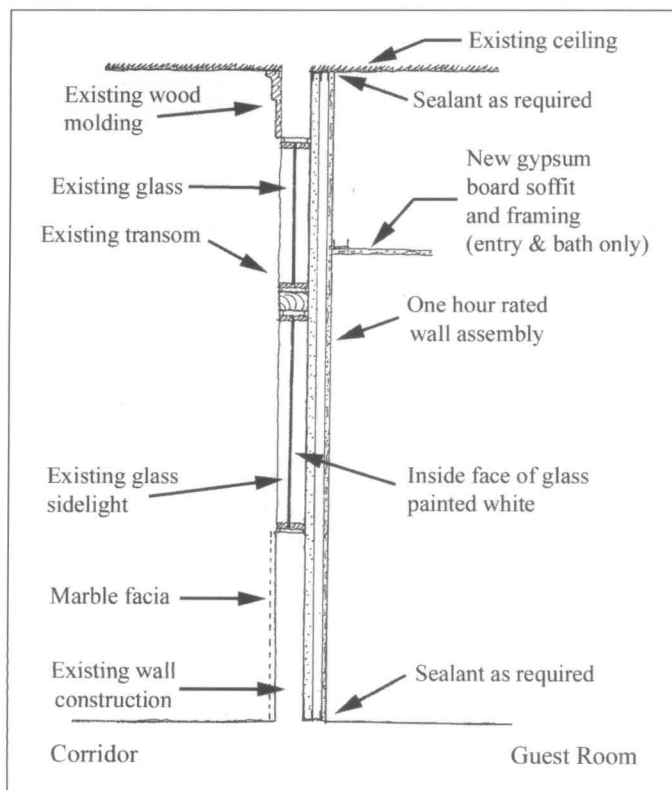
Figure 2. Typical Reliance Building corridor section showing additional wall assembly built behind historic glass sidelight and transom. Drawing: Antunovich Associates.

To retain the transoms and sidelights while complying with code requirements, the architects designed a non-combustible assembly that was integrated into the existing wall on the hotel room side (see figure 2). The 3-1/8" thick wall consisted of two gypsum boards separated by steel studs and sealed to the existing ceiling and doorframe. Back painting the glass white obscured the new wall assembly from the corridor.

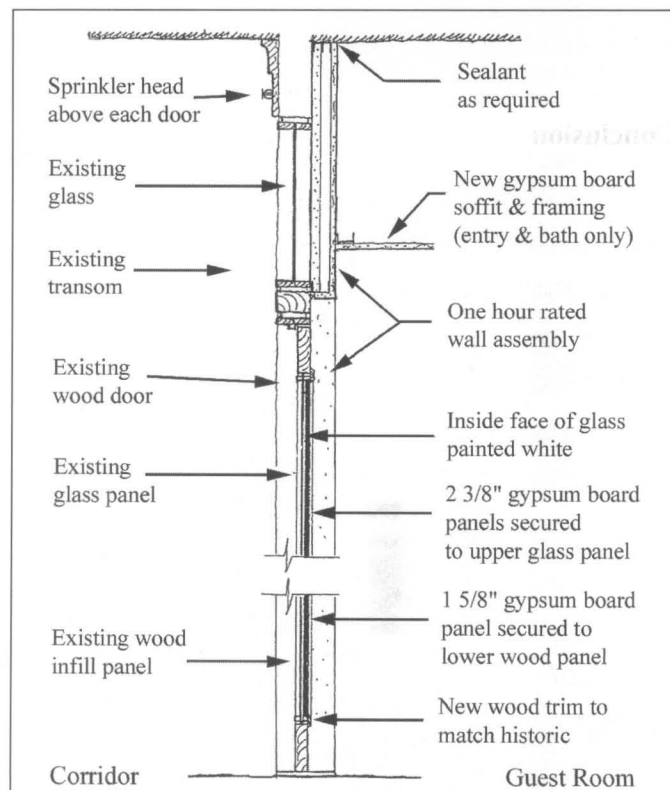
Figure 3. Typical Reliance Building door/transom section showing additional wall assembly and door panels. Drawing: Antunovich Associates.

The mahogany office doors were 2-1/2" thick with upper 1/8" thick glass and lower 1/4" thick wood infill panels. Both glass and wood panels were code deficient. To increase their fire resistance, two 3/8" gypsum boards were secured flush to the inside face of the glass and a single 5/8" sheet was used on the lower wood panel (see figure 3). New wood molding stained to match the original was placed around the border to secure and mask the edge of the added material. Mirrors were installed on upper panels facing the hotel rooms while lower panels were painted brown

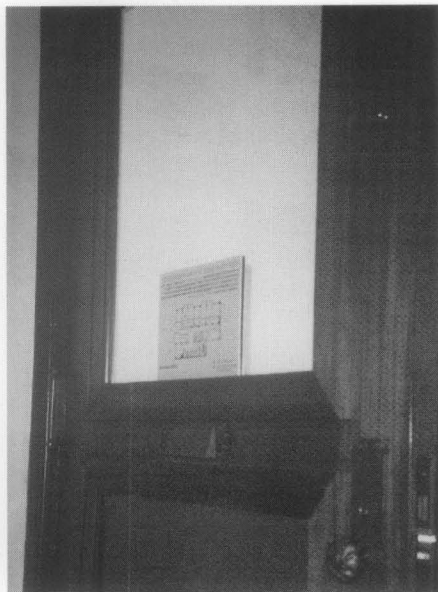
Figure 4. View of a Reliance Building office door from inside guest room. Upper and lower door panels have gypsum board secured to back with new molding. A mirror was affixed to the upper panel while the lower panel was painted to match original material. Photo: Chad Randl.

(see figure 4). Like the sidelights and transoms, the original glass was back painted with a white latex paint to conceal the infill panels from the corridor. Intumescent paint was applied between the door and frame to provide an effective smoke barrier and compensate for small irregularities in the fit of the historic doors. The mail slots were sealed and filled with a fire-rated putty. Further fire protection was provided by the installation of a sprinkler head on the corridor-side wall above each door. These heads were in addition to those specified by the building code.

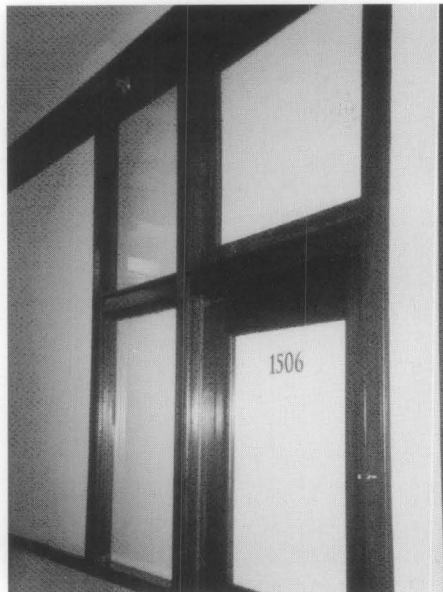
Figure 5. Completed Reliance Building corridor showing historic door panel, sidelight and transom. Photo: Chad Randl.

All surviving glass (plain, fluted and florentine) was retained in the door pan-

els, sidelights and transoms (see figure 5). New plain glass was used in locations where the original was cracked or otherwise required replacement. Room numbers were lettered on the glass with gold leaf. Finally, the direction of the door swing was reversed so that they opened inward and automatic closers were added in keeping with standard exiting code requirements.

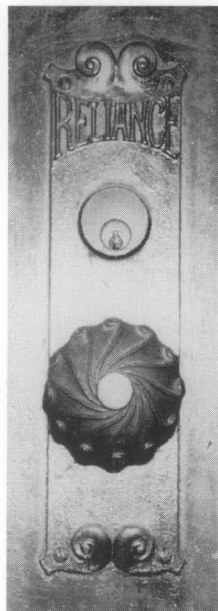
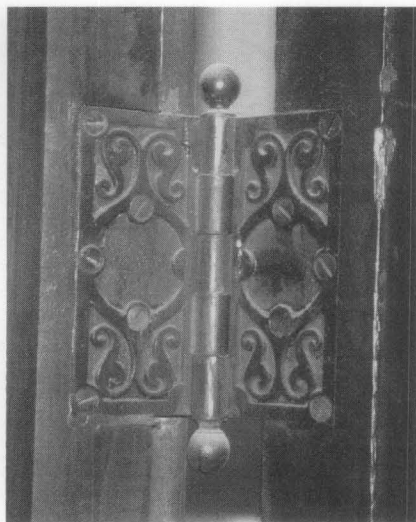
Figure 6. Original hardware including doorknobs, escutcheon plates and hinges were retained. Photos: McClier.

Retaining the doors and corridor glazing led to the preservation of a host of other features, including the mahogany trim found throughout the corridors and unique door hardware (see figure 6). Historic magnetite hinges, mail slots, doorknobs and escutcheon plates (inscribed "Reliance") were also retained.

have required replacing the historic escutcheon plates and knobs or significantly altering the door stile. Instead, a new mortise lock set appropriate to the door rating was installed with the original knob and escutcheon plate fitted over top.

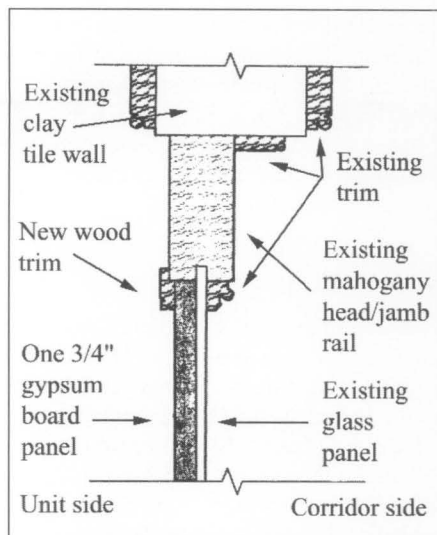
Figure 7. Section of Fisher Building door modified to improve glass panel fire rating. Drawing: Garek Stefanowski, Pappageorge/Haymes.

Door modifications paralleled those made in the Reliance Building. The interior stops were removed from the glazed areas of the doors, the original glass was cleaned and back painted, and a $\frac{3}{4}$ " sheet of gypsum board was secured against the glass (see figure 7). A $\frac{5}{8}$ " sheet of gypsum board was used

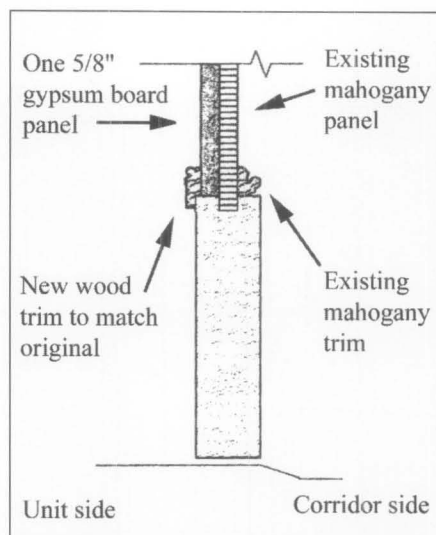
Figure 8. Section of lower wood panel with gypsum board reinforcement. Drawing: Garek Stefanowski, Pappageorge/Haymes.

behind the lower wood panel (see figure 8). Molding with profiles that were similar to those on the original door was attached at the joint between the gypsum and the original doorframe. Intumescent material was also applied to the edges of the door and doorframe (see figure 9).

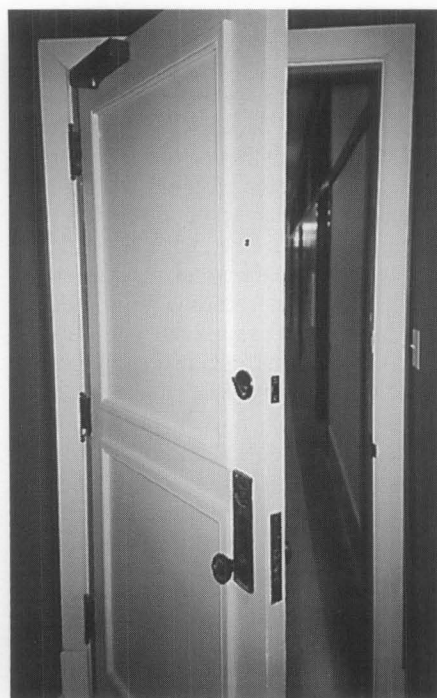
Figure 9. Fisher Building door viewed from apartment showing gypsum board infill panels, new trim and retained hardware. Photo: National Park Service File.

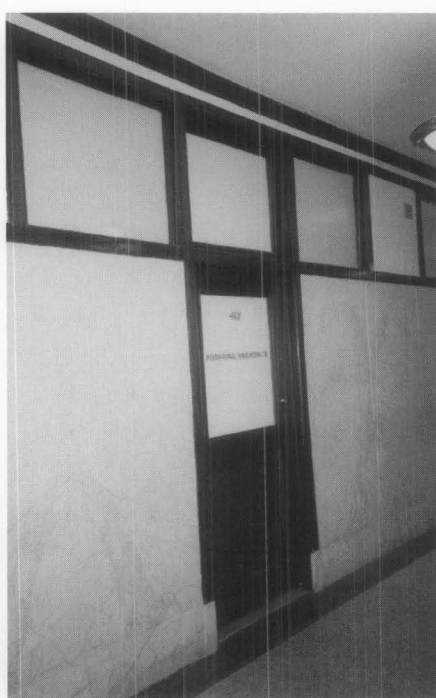
Figure 10. Completed Fisher building corridor with back painted door and tripartite transom. Photo: National Park Service File.

Following the Reliance Building model, all door hardware, including hinges, knobs, escutcheons and mail slots (where present) were preserved and incorporated into the rehabilitated doors (see figure 10). New deadbolt locks and peepholes were added to the door stiles above the original knobs. Automatic closers were added to all doors.

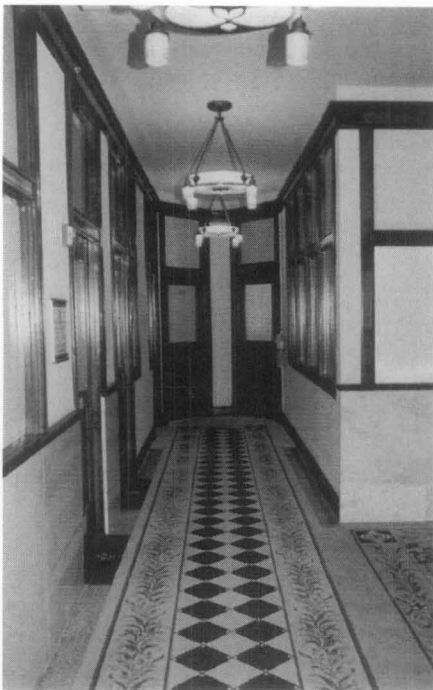
Figure 11. View of the completed Reliance Building corridor. Photo: McClier.

By introducing new fire resistant assemblies and mechanical upgrades in the already altered office spaces, there was no impact upon the scale of the corridors and the views along their length (see figure 11). Although the construction of new interior walls preserved the transoms and sidelights and the continued appearance of the corridor, it did obscure the glazed areas and their moldings from inside the former tenant space. Painting the inside face of the glass panels also resulted in a visual change in the corridor. Back painting was necessary in order to hide the gypsum infill panels, but the result lacked depth and failed to suggest the original office space within. The change was less noticeable in areas with patterned glass where the texture provided some relief from the flat, spandrel-like appearance of the new assembly. Covering the glazed panels with solid materials also darkened what were once daylight-flooded corridor spaces.
