Relationship between Density and Anatomical Structure of Different Species of *Eucalyptus* and Identification of Preservatives

Rafael C. Abruzzi^{a*}, Berenice A. Dedavid^a, Marçal J. R. Pires^b, Suzana F. Ferrarini^a

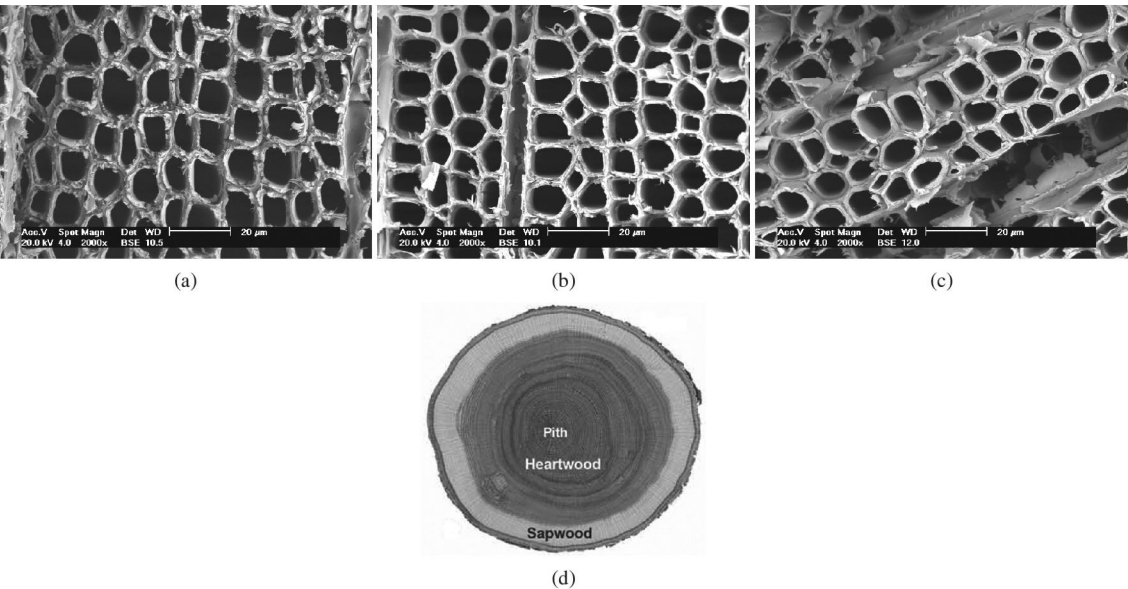
Figure 1. SEM images of *Eucalyptus grandis* samples without chemical treatment. In (a) Sapwood, (b) Heartwood, (c) Pith and (d) Typical cross-section of a trunk (Adapted from the USDA)¹³.

Microscopic analyses of cross-sections taken at random points of the pith, heartwood and sapwood were used as a parameters to relate fiber density with morphology for the species *Eucalyptus citriodora* (*Corymbia*), *Eucalyptus saligna* and *Eucalyptus grandis*. Figure 1 (from a to c) shows images of *Eucalyptus grandis* wood, indicating substantial uniformity in lumen diameter for the three regions evaluated. Similar results were found for the other species studied in new poles and those removed from the network. Average lumen diameter considering all three regions (sapwood, heartwood and pith) was used to correlate timber morphology with density.

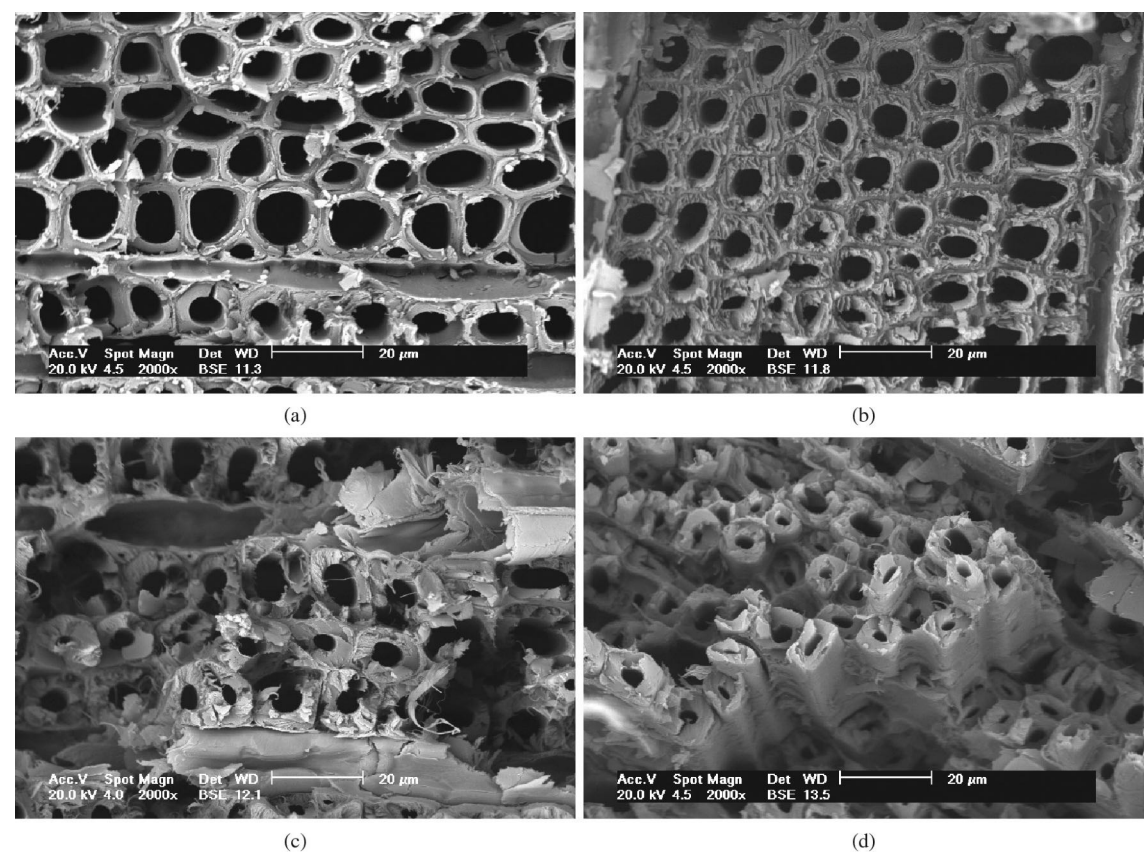
Figure 2. SEM images in cross-sections of sapwood. In (a) Pole 7, (b) Pole 6, (c) Pole 4 and (d) Pole 27.

Randomly selecting thirty poles withdrawn from the electricity network favored the occurrence of poles with varying service times and different treatments among the samples. Table 2 shows data obtained for pole number 6, 7 and 27, all CCA-treated and with different service times, and pole number 4, treated with creosote. Treatments using CCA, Creosote and CCA + Boron-Fluorine did not alter lumen diameter and variations in wood density were negligible. Service time within the electricity network also did not influence the data analyzed, likely because samples were taken from healthy areas of wood. Therefore, the data presented confirm that denser species exhibit smaller lumen diameter, regardless of the existence or type of treatment.

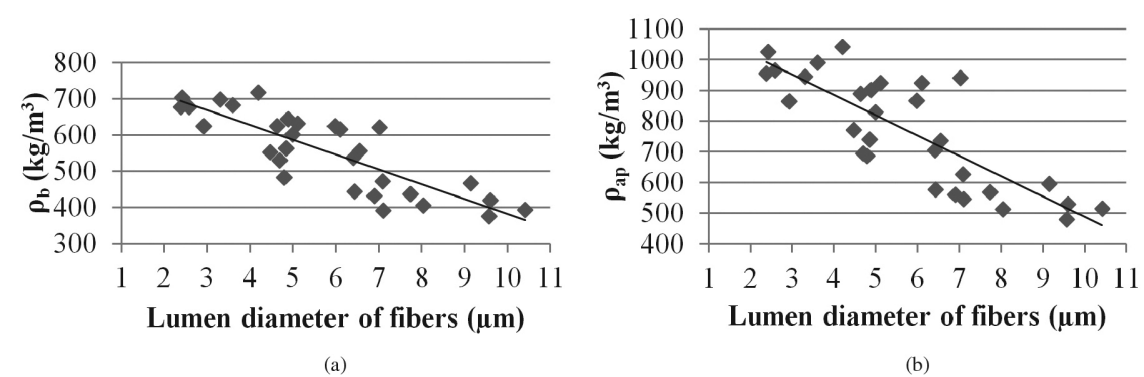
Figure 3 demonstrates the behavior of basic and apparent density, measured in laboratory, with the lumen diameter of fibers for the thirty poles removed from service. A negative correlation was found between these two variables, evidenced by the strong Pearson correlations observed. Basic density displayed more significant correlations (0.84) and *p-value* (9.27×10^{-9}) with lumen diameter when compared to apparent density (0.81 and 4.90×10^{-8}), with a significance level less than 5% in both cases. It is important to underscore that moisture is a factor that may interfere in correlations with respect to apparent/bulk density, since the latter considers damp wood, and microscope analyses were performed on dry wood.

Figure 3. Density variation with the lumen diameter of fibers. (a) Basic density and (b) Apparent density.

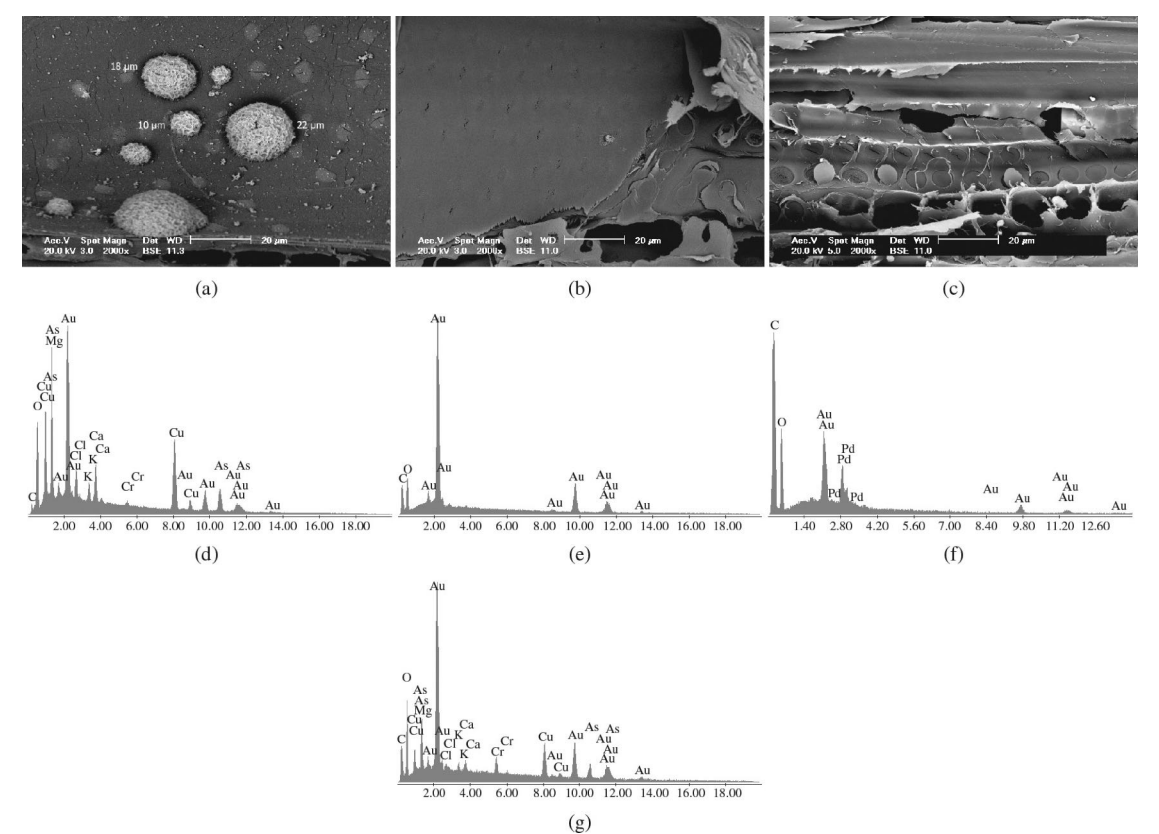
In order to locate elements of CCA in new and decommissioned poles, wood samples taken from three new poles treated with CCA and thirty poles removed from the electricity network were submitted to EDS analysis. Table 3 shows the concentrations of chromium, copper and arsenic present in the three new poles and three of those removed from service. EDS analyses conducted on three samples taken from the sapwood, heartwood and pith of a new pole (2) treated with CCA are shown in Figure 4.

EDS analyses revealed significant occurrence of chromium, copper and arsenic in only the sapwood samples for tests performed over the total area of the image, corresponding to 10 mm², and on specific regions of approximately 2 μm² over precipitates, light-colored areas and clusters. In the heartwood and pith, this technique identified none of the three CCA components. Similarly,

Figure 4. SEM images of a new pole (2) with CCA. In (a), (b) and (c) sapwood, heartwood and pith respectively. In (d), (e) and (f) EDS analysis of the total area in each of the images. In (g) EDS analysis of precipitate 1.

Figure 4a shows rounded precipitates, indicating a cluster associated to components of the preservative. Pedersen and Ottosen observed that mineral particles of chemical elements in the wood matrix may be associated or not to preservative components. Aluminum silicates and phosphates are not correlated to constituents of the preservative. Moreover, arsenic in association with calcium may form Ca-arsenate. The authors also report that a

in Figure 4g shows peaks corresponding to magnesium, potassium, chloride and calcium, suggesting that elements of the preservative are associated with wood components in the form of precipitates.

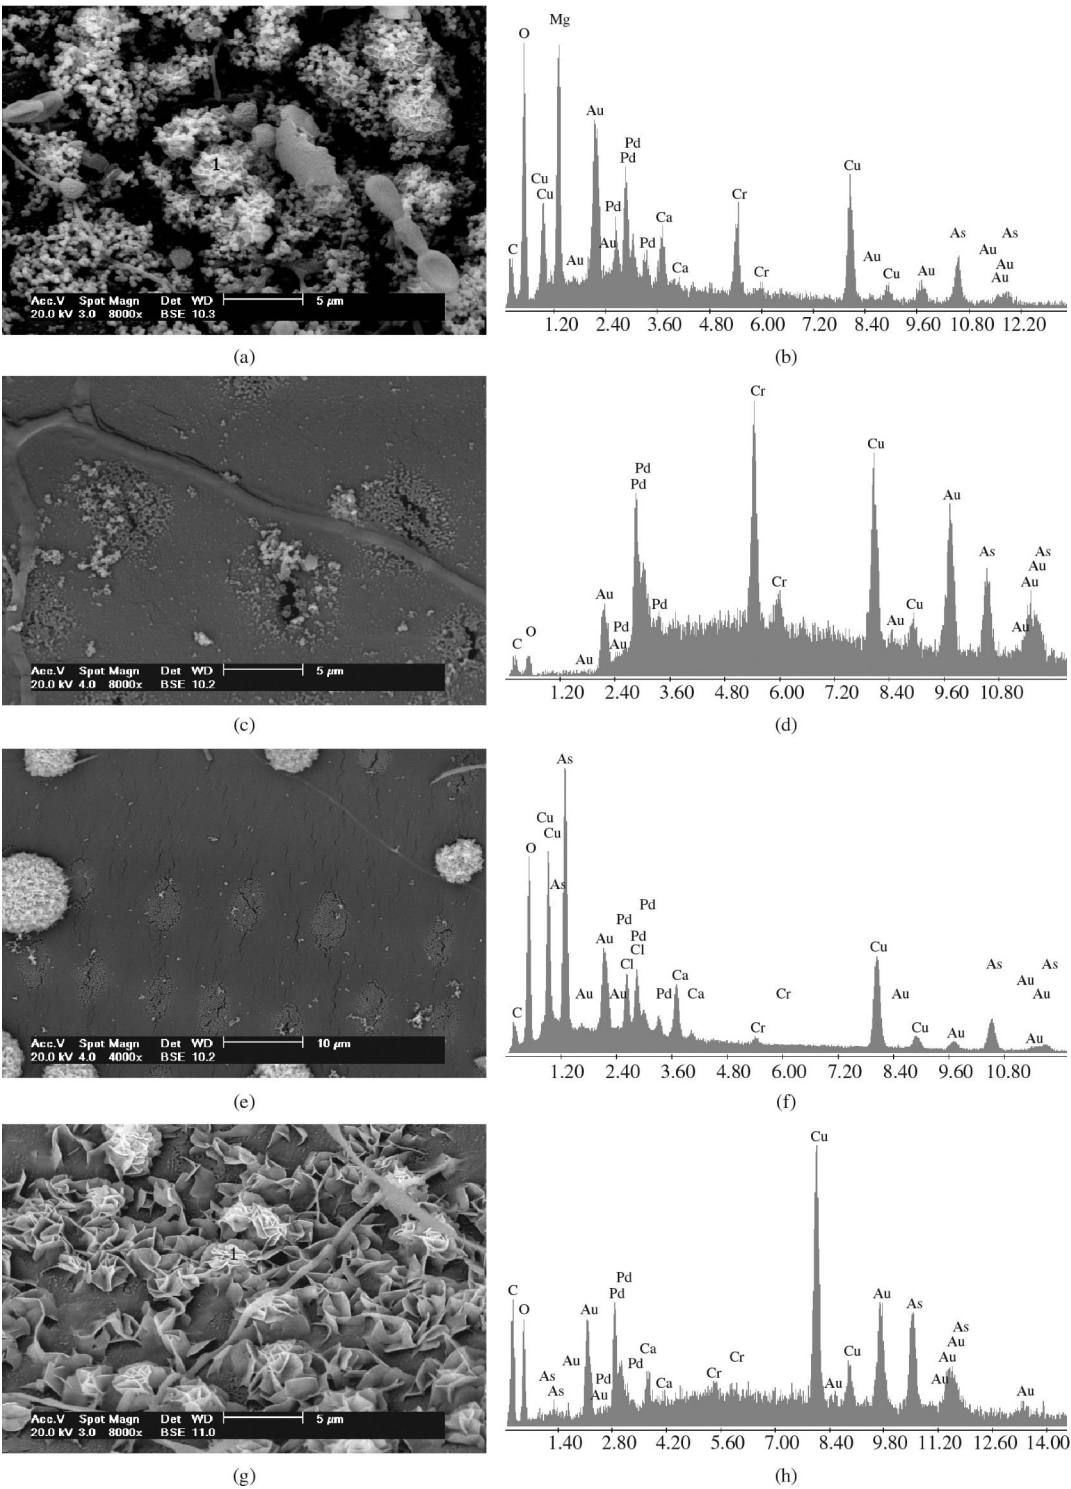
Figure 5. SEM images of the sapwood region with CCA. In (a) sample from pole (12), (b) EDS analysis of the precipitate in region 1. In (c) sample from pole (15), (d) EDS analysis of region 1. In (e) sample from pole (16), (f) EDS analysis of the total area of the image. In (g) sample from pole (27) and (h) EDS analysis of the light-colored area (1).

The methodology used in combining EDS analyses with scanning electron microscopy proved adequate in identifying CCA components in new poles and as such, was also applied to test poles removed from service. In both the new and decommissioned poles, chromium, copper and arsenic were detected only in sapwood samples, even for poles with several years of service. This confirms the effectiveness of chromium as a fixing agent for the fungicides copper and arsenic as reported by Van den Broeck⁸, partially preventing their diffusion and dispersion, since evidence of these elements was not found in the heartwood and pith, because in the heartwood according Costa⁵ formation occurs in the vessel tiles will providing a very low permeability. The sapwood exhibited several formations of preservative associated with wood components in the form of individual precipitates of varying sizes, clusters, in light-colored areas or impregnated in the timber, as shown in Figure 5.

The Figure 5 depicts a sample from the pole (12) subjected to EDS testing (Figure 5b) on a group of precipitates, in region 1. Peaks are evident corresponding to the three components of the preservative (copper, chromium and arsenic), though more intense for copper as well as magnesium and calcium peaks, predominant elements in wood.

Elements found in clusters of the pole sample (15), Figure 5c, in region 1, are also representative of the three

CCA components, as shown by the EDS spectrum in Figure 5d; however, in this case the chrome peak is more intense than the other elements in the sample. The rounded precipitates observed in the new poles treated with CCA were also present in samples of pole (16), as per Figure 5e. EDS analysis of the precipitate in Figure 5f demonstrates that, in addition to chromium, copper and arsenic, chloride and calcium are also present.

Figure 5g corresponds to the sample from pole (27), showing rosettes formed by small panels. EDS analyses of the rosettes in region 1 show greater intensity for copper peaks, followed by chromium and arsenic. A small amount of calcium, a characteristic element in wood, was also detected. Thus, there was a predominant presence of preservative in all the samples tested, irrespective of the service life of the pole. Of the twenty-three poles treated with CCA, only one did not exhibit the simultaneous occurrence of all three preservative components, with only arsenic and chromium identified in both the matrix and precipitates.

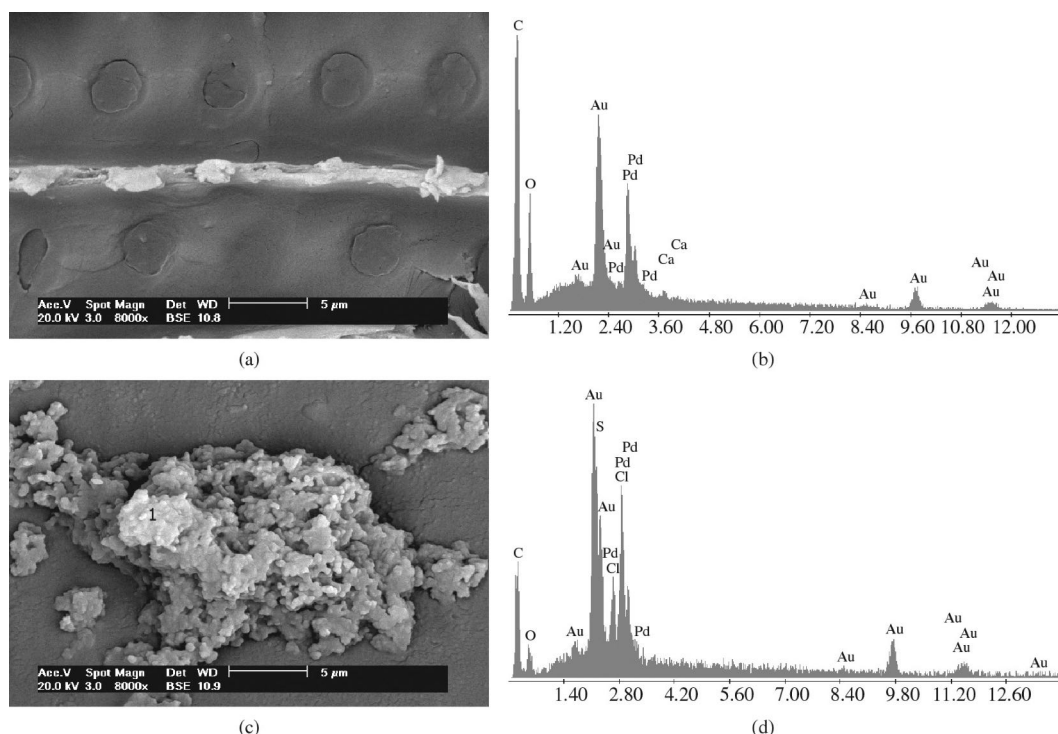
Figure 6. SEM images of the sapwood region with Creosote. In (a) SEM image of sample 4, (b) EDS on the total area for the image of sample 4, (c) SEM image of sample 29 and (d) EDS performed on the precipitate (region 1) sample 29.

calcium, chloride and sulfur were observed, as per Figure 6. Although calcium is a characteristic element of wood, sulfur is not, and has been used in conjunction with chloride to fortify phenolic substances, increasing the toxicity of creosote, which could be an indication of the presence of this preservative in wood.
