Tech Notes

Historic Garage and Carriage Doors: Rehabilitation Solutions

Bonnie J. Halda, A.I.A.

Division of Cultural Resources
Rocky Mountain Regional Office
National Park Service

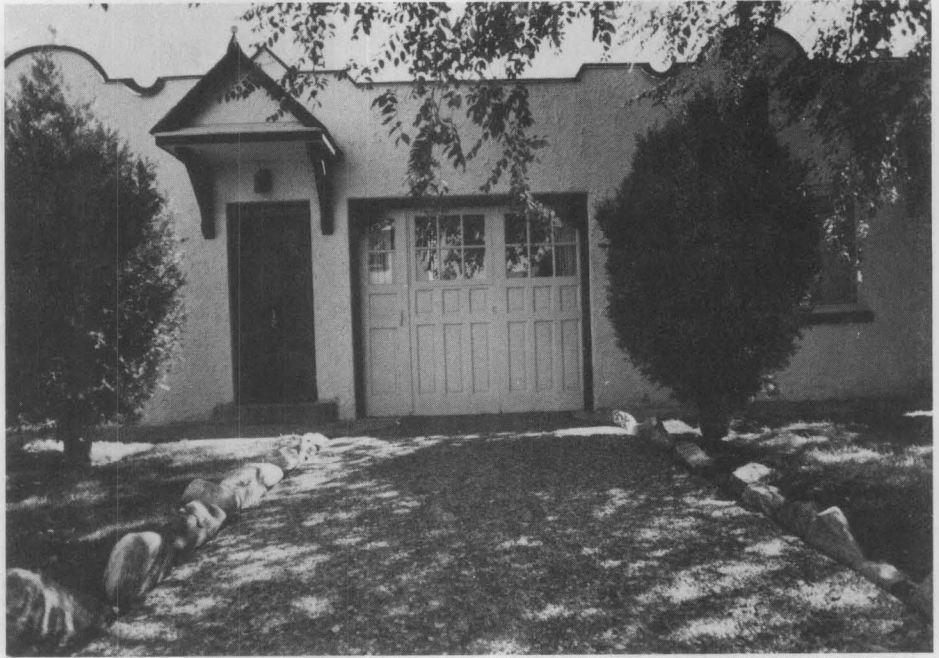
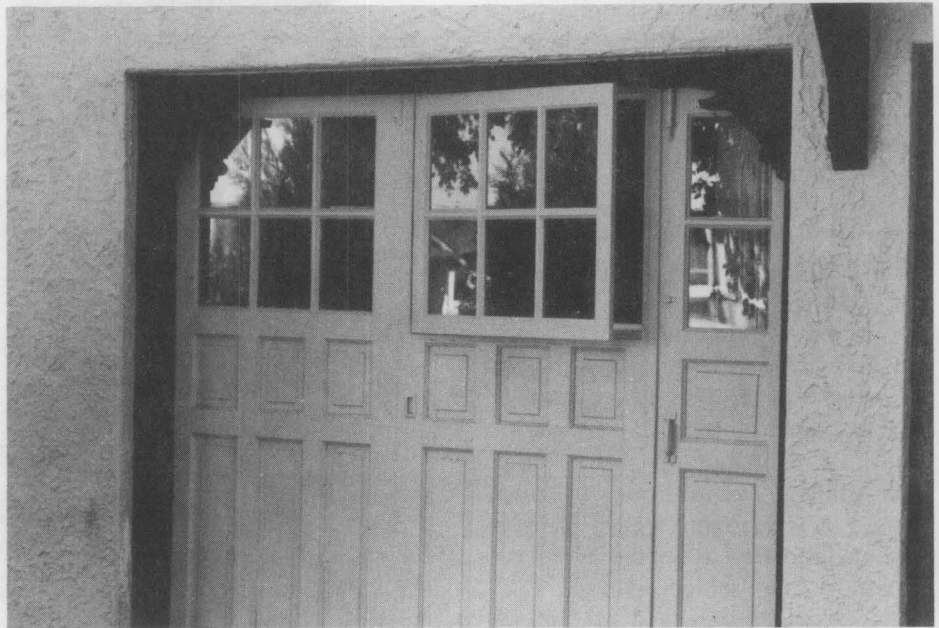
Figure 3. The new casement windows in the garage doors are visible only when the windows are open. Photos: Light Images

configuration of the removed window, and the new unit was installed flush with the plane of the surrounding garage door (see figure 2). A piano hinge allows the custom window unit to operate as an out-swinging casement (see figure 3). The piano hinge is only slightly visible from the exterior and all other hardware is interior mounted. When closed, the new operable window appears as part of the garage door. The owner elected to leave the track hardware from the doors in place on the interior as evidence of the former garage converted to a bedroom (see figure 4).

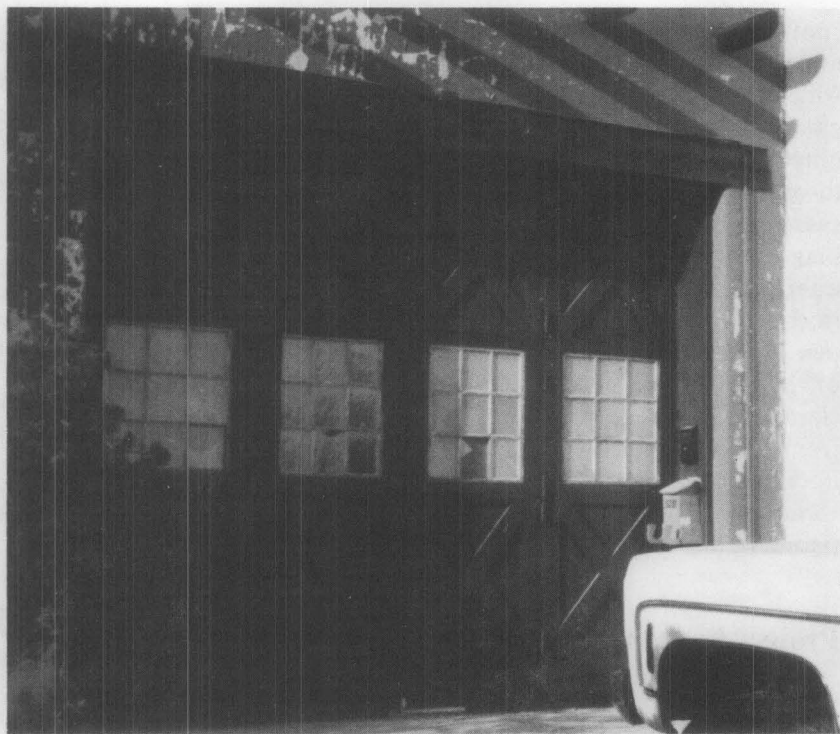
Figure 5. The historic fire truck doors, which featured wood cross-bracing and multipaned windows, played an important role in defining the historic character of the building. Photo: Chip Kaufman

The plan of the new restaurant proposed for the Monte Vista Fire Station called for the dining room to be located in the former truck bay. The dining room needed both light and views; however, the existing historic doors in the truck bay did not meet this requirement. The 14-foot-high doors featured wood cross-bracing over tongue-and-groove boards in the upper and lower third sections, and multipaned glass lights in the central third sections (see figure 5). Overhead operating hardware allowed the doors to fold open quickly in the event of an alarm. One portion of the doors had been modified to accommodate a pedestrian door, but were in otherwise good condition. The doors were recognized as significant features of the building, but their small amount of glass did not provide adequate light or views and the poor fit of the doors within the opening allowed air infiltration.

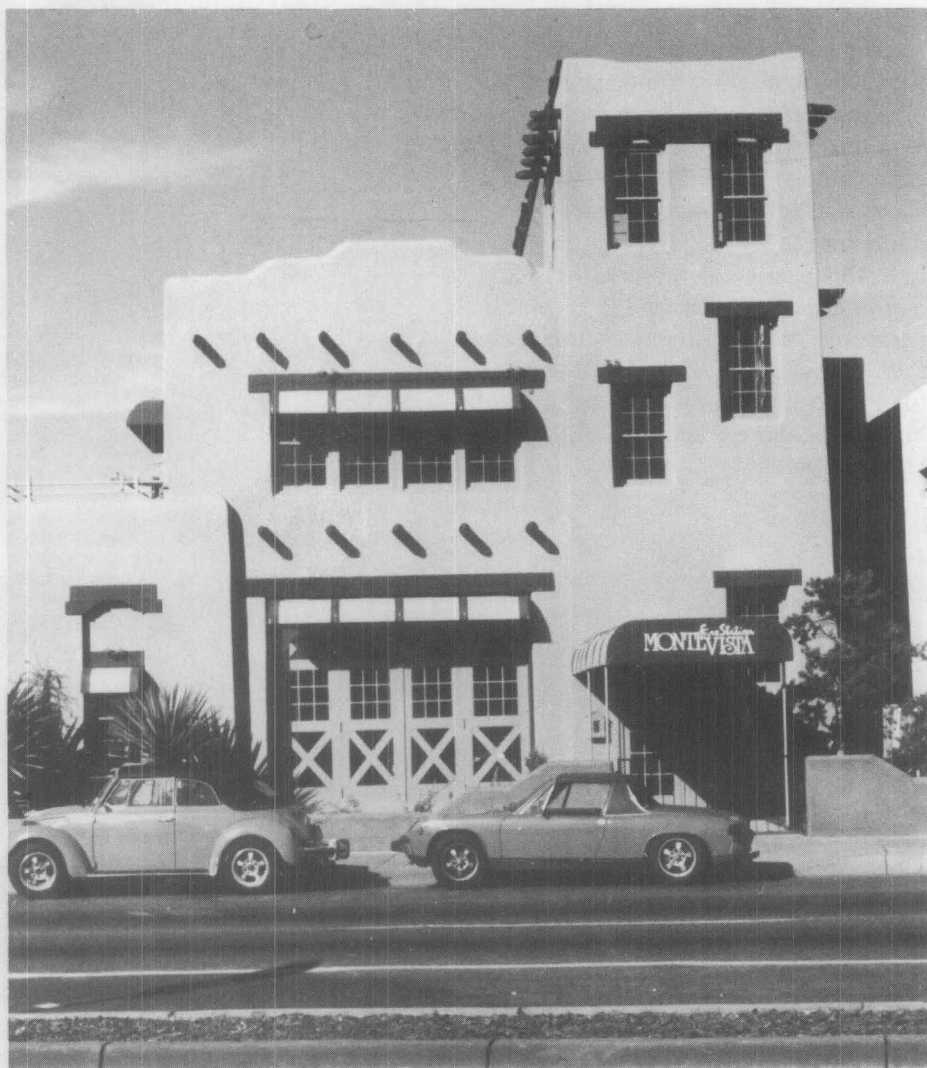
Figure 6. The historic doors were repaired and fixed in place, with the installation of glass behind the cross-bracing. Photo: Chip Kaufman

The decision was made to repair, weatherstrip, and fix in place the existing garage doors. The tongue-and-groove boards behind the cross-bracing in the upper and lower portions of the doors were removed and insulating glass was installed (see figure 6). The actual work on the doors was simple, requiring only a half of a day of labor to remove the boards and install the glass. The new glass lights, together with the glass in the central section of the doors, allows light into the interior and

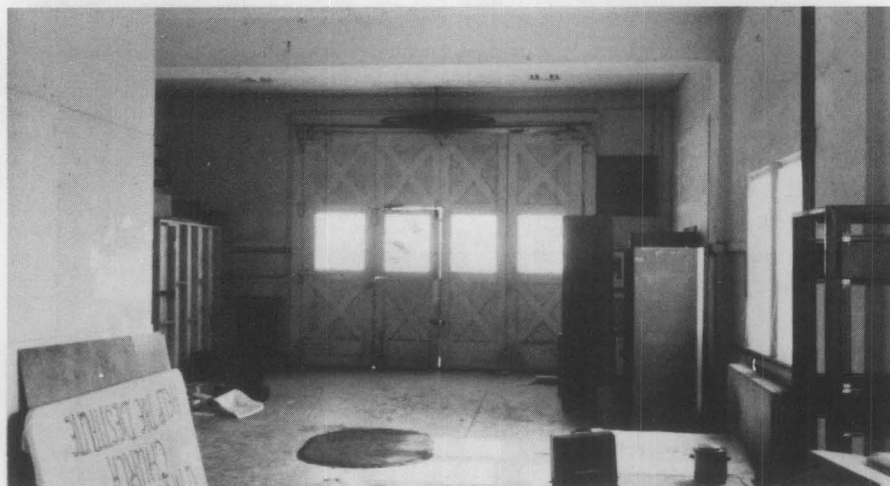
Figure 7. Replacing the tongue-and-groove boards with glass opened up the former fire truck bay while retaining the character of the doors.
Photos: Chip Kaufman

The customers using the new dining room are able to take advantage of the New Mexican sunshine as well as having pleasant views to the exterior (see figure 7). The innovative design

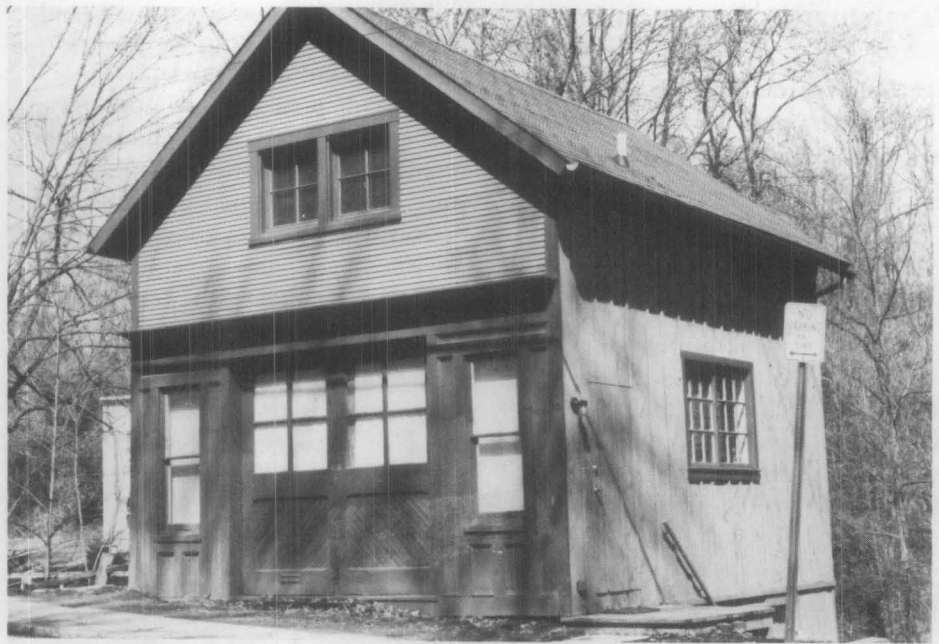
Figure 9. A new customer entrance was created through construction of a door along the side. The concealed nature of the door minimized its impact on the building's historic appearance. Photos: Charles Fisher

“hidden” entrance, utilizing the original board and batten as facing for the door (see figure 9). Since the door would be immediately adjacent to the front, there was no need to have the door serve as a highly visible entrance. The plentiful glass openings across the front and a new unobtrusive sign board were considered sufficient for successful retail use. For a second means of egress, a new stair to the basement would provide passage to the outside off the back of the building.

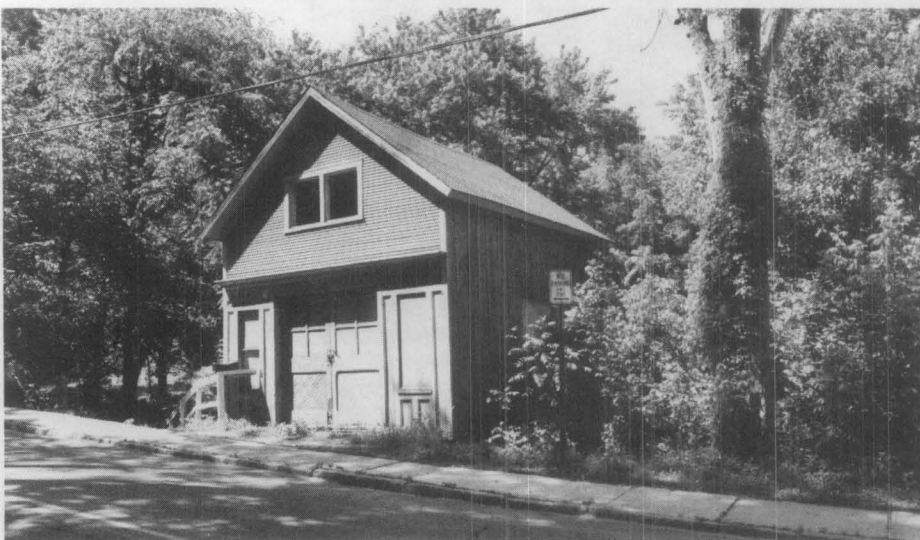
Figure 8. This 1870s carriage and wagon painters shop never had a customers' entrance other than through the carriage doors. Photo: Charles Fisher

The conversion of this 1870s carriage house to a shop necessitated creation of a customer entrance on the main level. Lacking any entrance other than through the carriage doors, a passageway needed to be created that would not alter the building's historic appearance (see figure 8). The rather formal front elevation of this utilitarian structure consisted of double-hung windows flanking the wooden carriage doors and had survived unaltered since the 19th century. The initial plan to convert one of the two windows into an entrance door would have broken the symmetrical fenestration pattern across the front and the existing doors were too large for customer use. Alternatively, locating an entrance door within one of the carriage doors would have had even a worse impact on the building's historic appearance.
