# LYNDHURST GATEHOUSE

Tarrytown, New York

WINDOWS NUMBER 3

# Exterior Storm Windows: Casement Design Wooden Storm Sash

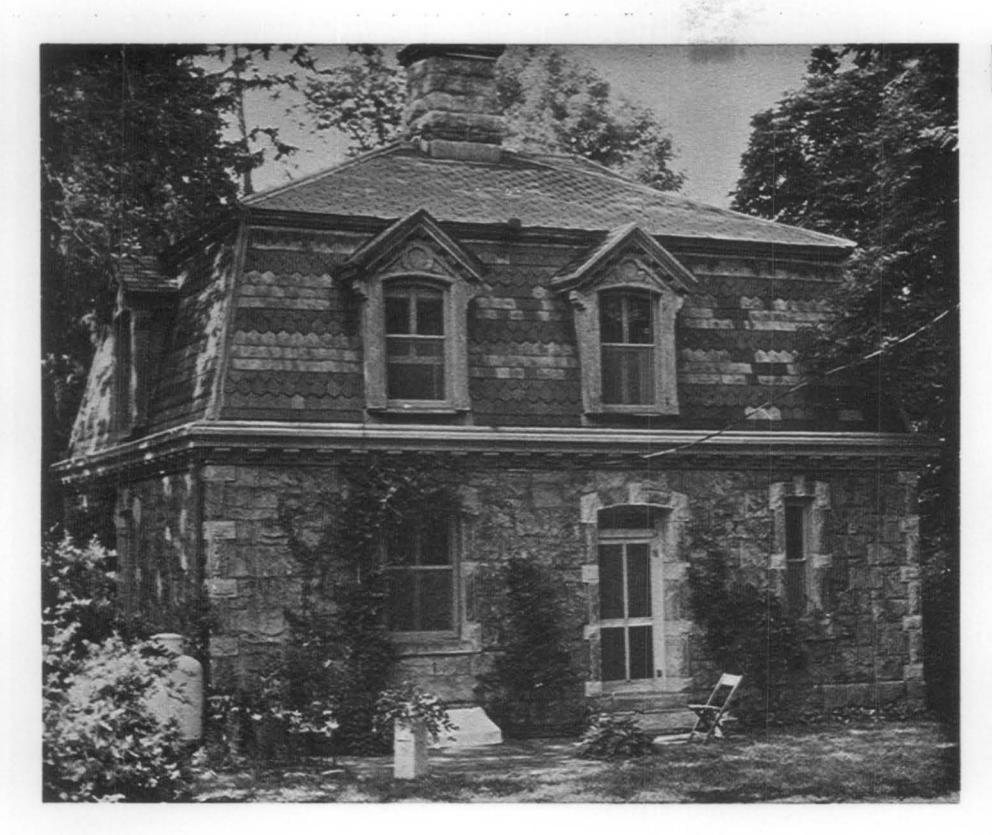
Physical damage and visual changes to historic windows should be minimized when installing exterior storm windows. Figure 1. The single casement, wooden storm window had two removable panels for screen and glass inserts. This custom design fulfilled a variety of requirements established for the project with minimum physical damage and visual changes to the historic windows. Drawing: Martha L. Werenfels

dows and attached to the existing frame (see figure 1). The arched-headed wooden storm window with one-overone glass panes matched the size of the original double-hung sash. Molding details similar to the original were incorporated in the new storm sash. Each of the two panes in the storm sash was set in thin aluminum frames and secured in the wood storm window with standard clips. This installation technique enables the storm panels to be easily removed by a person on the inside of the house and replaced during the summer with screens (see figure 2).
