CHALMERS UNITED CHURCH

Kingston, Ontario

NUMBER 14

Reinforcing Deteriorated Wooden Windows

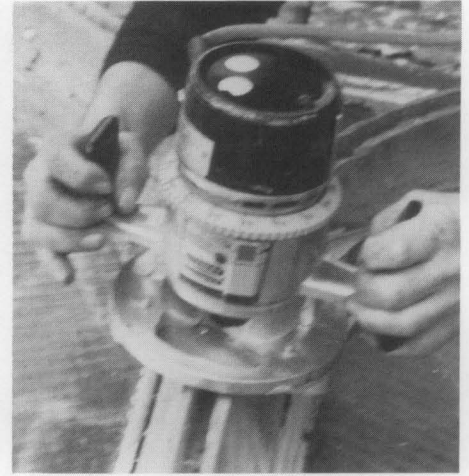
Figure 4. Once the old paint had been carefully removed, grooves were cut in the mullions using an electric router fitted with special guide rollers.

ting bit (see figure 4). Notwithstanding the usefulness of this apparatus, the real success of the operation can be attributed to the skill of the craftsman who guided the tool. The wooden mullions varied in size; on a typical $3\frac{1}{4}$ " wide mullion, the outer edge where the groove was cut was $1\frac{1}{2}$ " wide. In cutting a $\frac{1}{2}$ " groove on the outer edge, only $\frac{1}{2}$ " of wood remained on either side. A slight deviation of the tool could have seriously damaged the mullions.
