**BEATTY'S MILL
(CORAL STREET ARTS HOUSE)**
Philadelphia, Pennsylvania

Preservation Tech Notes

NUMBER 21

Replacement Wood Sash Utilizing True Divided Lights and An Interior Piggyback Energy Panel

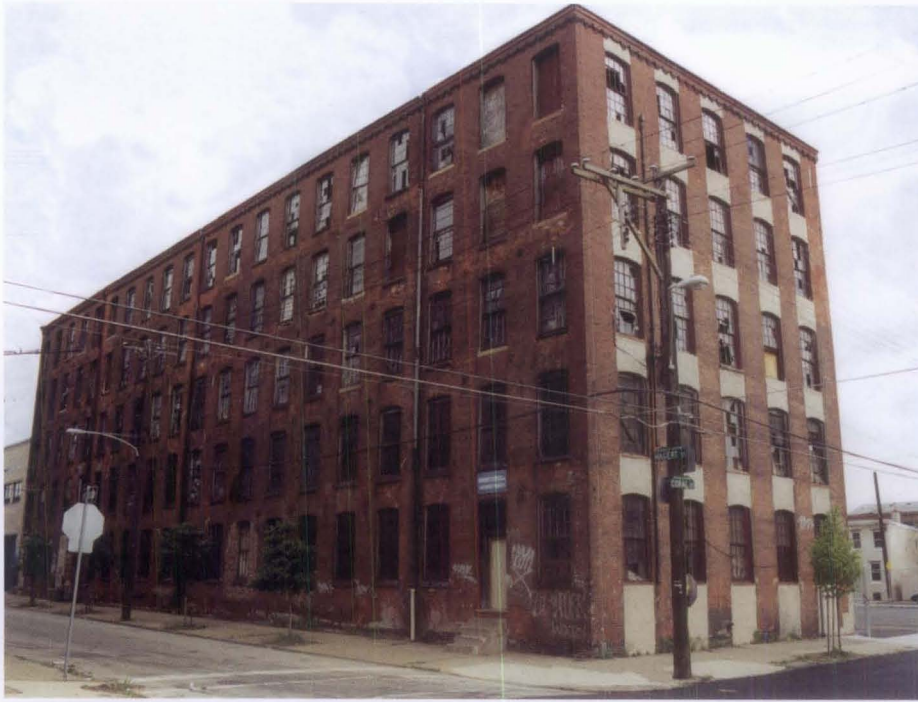
Figure 1. Constructed in 1886, the Beatty's Mill is located at a street intersection. The segmental arched windows are a distinguishing feature of the building.

The building had suffered many years of neglect, which was reflected in the condition of the windows. A condition survey determined that 40% of the sash were in poor condition; 45% were in fair condition; and only 15% were in good condition. Based on the window survey, the development team elected to replace the
