J. ARONSTEIN

HAZARDOUS FPE CIRCUIT BREAKERS **AND PANELS**

(Updated as of May 25, 2007)

Information for Inspectors and Homeowners

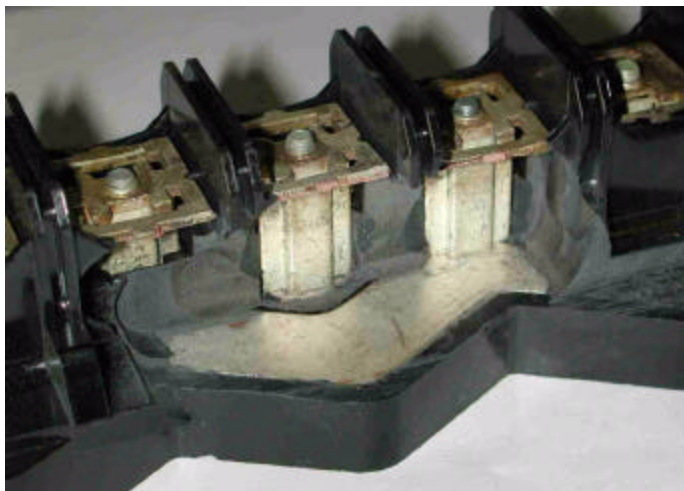
A. Cutaway - Bussbar, Post, and Stab Socket Plate.

A more serious failure of this type has been documented.¹ In that instance, the failure had been severe enough to ignite a smoldering fire on the plastic insulating material. The fundamental weakness in this design is the use of a single, relatively flimsy 8-32 screw to hold a structure together that can feed up to four half-width breakers with a total "ampacity" (rated circuit capacity) up to about 160 Amps. Figure 4 shows how the stab socket plate and post are attached to the bussbar.
