# Chapter 6

## FIRE DAMAGE OF WOOD STRUCTURES

*B. Kukay, R. White, and F. Woeste*

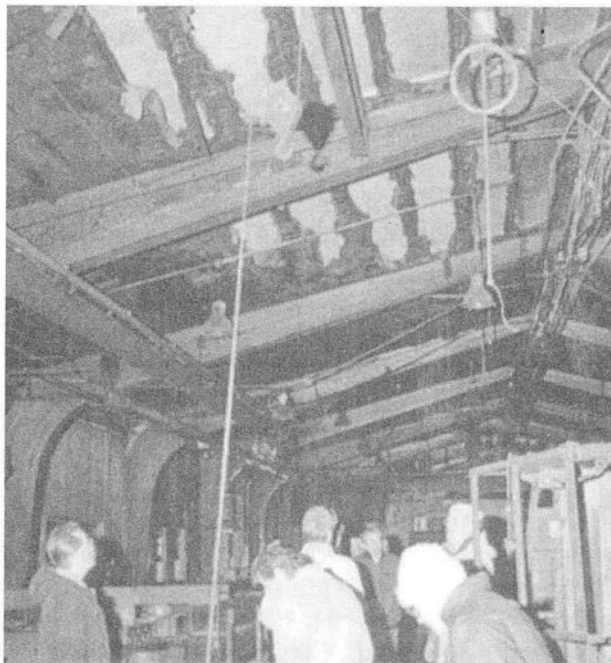
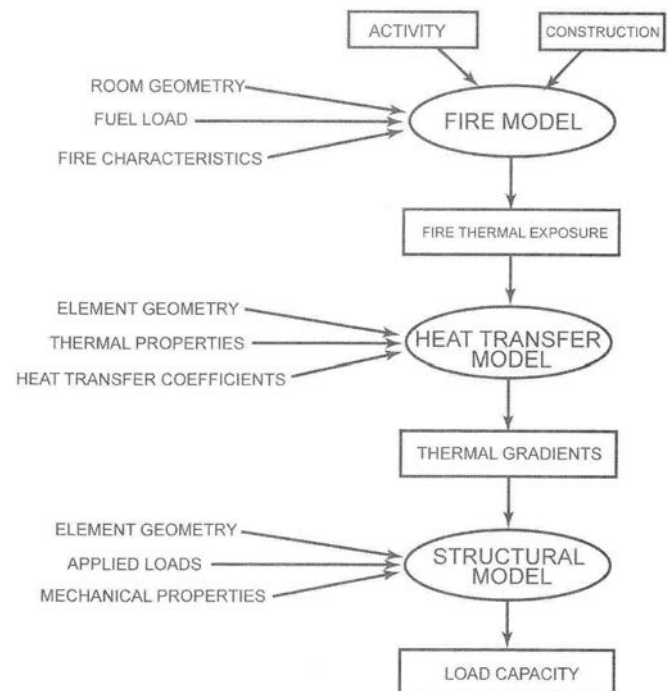
**Figure 6.1**  
A fire-damaged building at the US Forest Products Laboratory and a flowchart [1]  
for modeling fire-damaged wood members in a structural fire

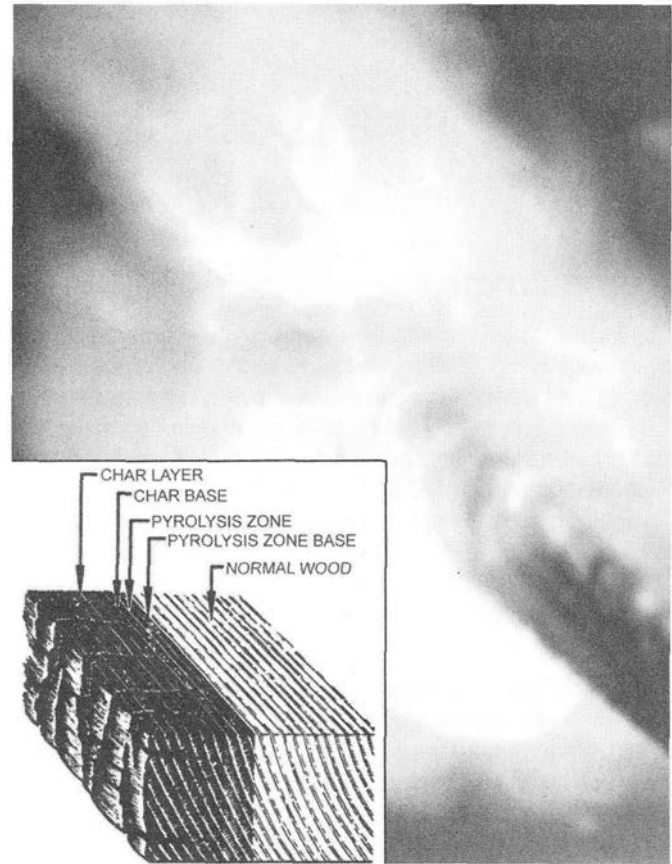
Figure 6.2  
Degradation zones in a charred piece of wood [8]

Sudden surface heating of a wood member in a fire results in surface charring and a steep temperature gradient. Thus, the stages of thermal wood degradation become zones of degradation in a structural wood member exposed to fire. In a broad sense, there is an outer char layer, a pyrolysis zone, a zone of elevated temperatures, and a cool interior (Figure 6.2). These zones of degradation reflect the temperature profile through the cross-section.

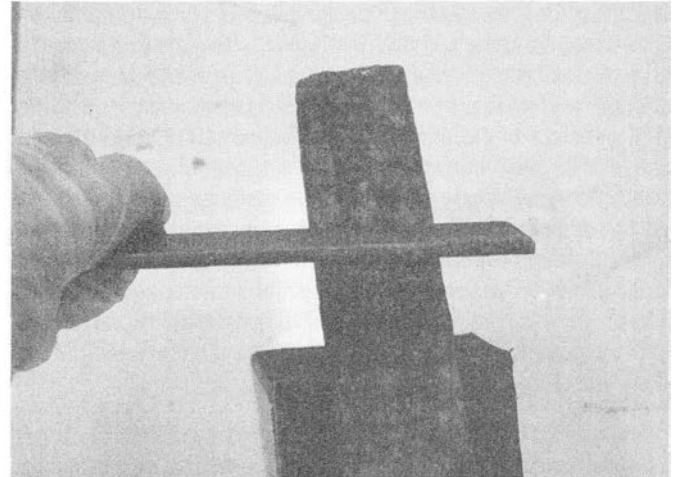
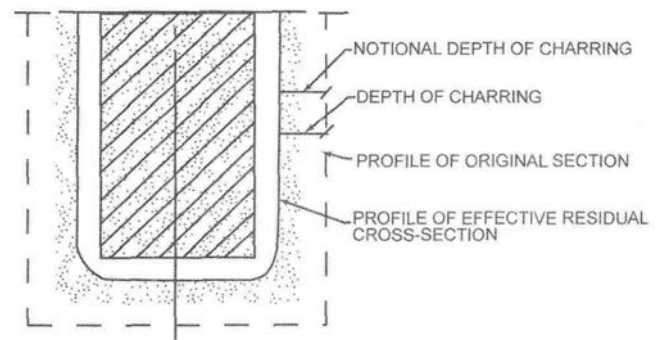
**Figure 6.3**  
**Profile of a charred piece of wood [inset (22)]**

The char layer can be easily scraped off a member that has been charred (Figure 6.3). Obviously, any charred portion of a fire-exposed wood member has no residual load capacity. The wood beneath the char layer has residual load capacity, but this residual capacity will be less than the load capacity prior to the fire. At a depth of only 8 mm (0.3 in.) beneath the char layer, the temperature is about 200°C. At 200°C, the residual strength properties still exceed 80 percent of the initial room temperature values. Members themselves that have only visual smoke damage or slight browning of the surface also have significant residual load capacity [22].

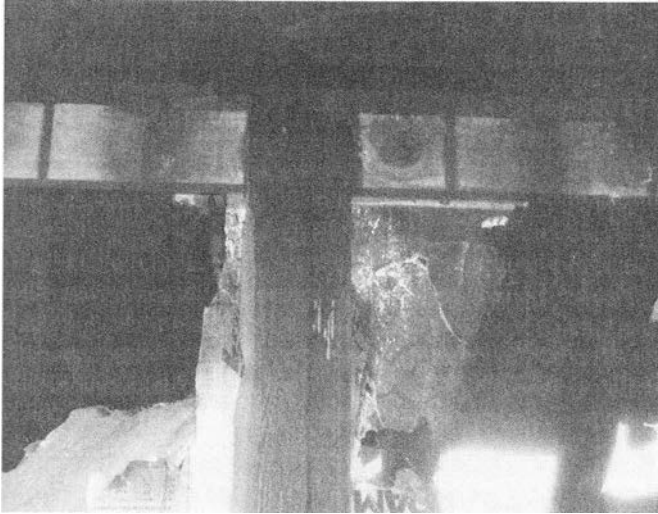
**Figure 6.4**  
Fire-damaged timber floor beam

After inspection of all affected timbers, the fire-damaged timber floor beams are about 8-inch by 12-inch (nominal) surfaced-four-sides (S4S) southern pine, and none of the timbers have grade marks. Varying degrees of degradation are present, and the most severely charred members are identified. At this point of the investigation, only the estimated char depth on the three exposed faces of the timbers needs to be determined. This step can be accomplished as the inspector carefully scrapes a small area of char on the three exposed sides to measure the char-free section dimensions. Sanding the area below the removed char isn't necessary at this stage of the investigation. For the beams examined, char depths are recorded as well as measurements on similar timbers with minor char that reveal that the timbers were probably manufactured as "unseasoned" 8-inch by 12-inch timbers at the time of construction, and the residual dimensions reflect about a ½-inch reduction for each of the three

exposed surfaces in comparison to smoke-damaged members (Figure 6.4).

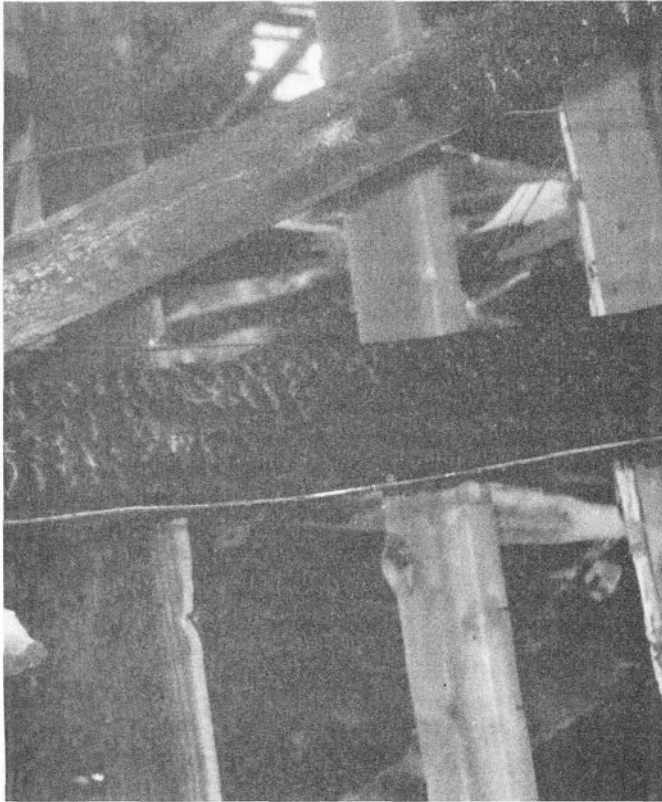
**Figure 6.5**

**Dimensional lumber, identifying degrees of degradation**

Assuming that the dimensional lumber and/or similar sized products are exposed to fire and allowed to self-extinguish, and assuming the fire is contained, lumber quality can be field verified from neighboring members (Figure 6.5). Although the ignition properties of dimensional lumber and composite materials are very similar to one another, Babrauskus [7] and Kukay and Todd

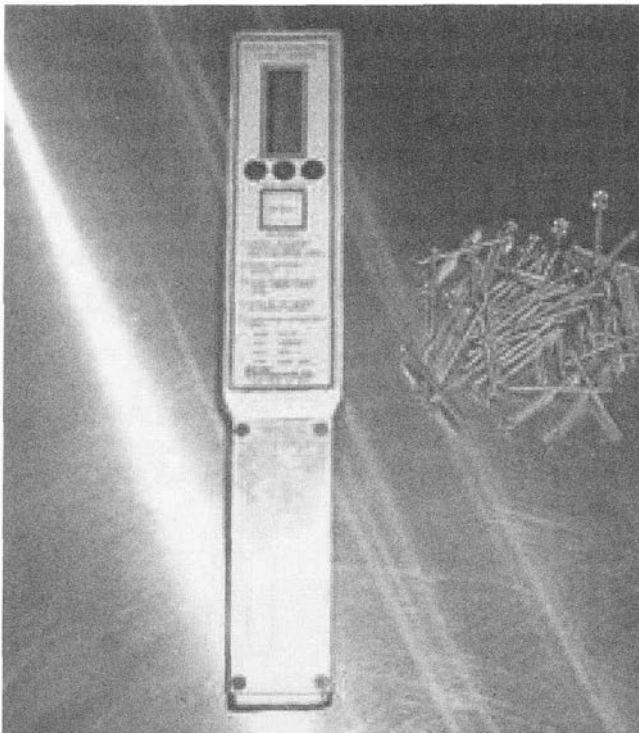
**Figure 6.6**  
**Screw-withdrawal test**

Current practice indicates the use of a digital screw extractor when the engineer is recording the maximum extraction load as a manual force is applied at a uniform rate of increase. From start to finish, each screw extraction is typically administered within 2 to 4 seconds. Digital screw extractors capable of recording the maximum extraction load to the nearest 10 pounds are sufficient. Related research specifies the extraction of  $\frac{9}{32}$ -inch by 2-inch-long machine screws from  $\frac{5}{32}$ -inch pilot holes. The machine screws are inserted to consistent depths of 1.5 inches and are measured from the un-charred surface. Because screw-withdrawal resistance is a function of insertion depth, instances may arise where it is necessary for the inspector to place a perforated 0.25-inch thick metal plate between charred members. To limit variability among screw withdrawal tests, only machine screws that are manufactured from similar lots and batches should be used throughout a post-fire investigation. A digital screw extractor is depicted in Figure 6.6.

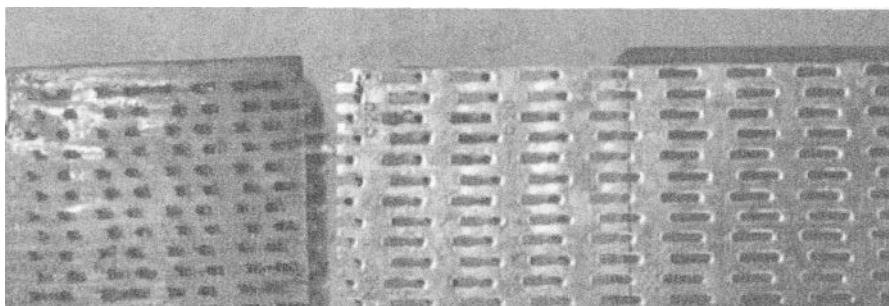
a) charred wood failure beneath plate

**Figures 6.7a and 6.7b**  
**Test specimens of metal plate connections**  
*(Courtesy of US Forest Products Laboratory)*

It is the degradation of the wood beneath a metal plate connection that results in its failure (Figure 6.7a). In situations when the heating is strictly via radiation, the metal plate may actually initially protect the wood beneath the metal plate from charring as much as the adjacent wood (Figure 6.7b). The test specimens in Figures 6.7a and 6.7b are from a project to develop a fire-endurance model for metal-plate-connected wood trusses [40, 41]. If there is damage to the plate area, the plate is discolored, or there is charring under the plate, it is recommended that the connection be considered ineffective [42].

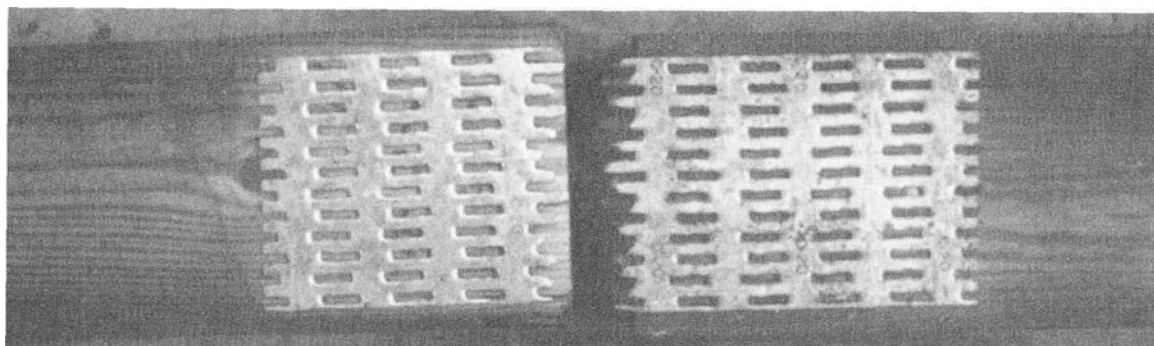
b) failure of metal plate with un-charred wood beneath plate
