16 Preservation Briefs

The Use of Substitute Materials on Historic Building Exteriors

Sharon C. Park, AIA

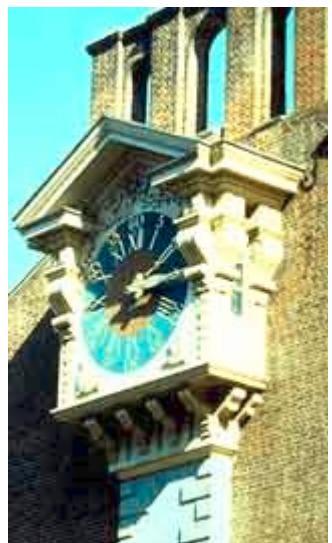
In the reconstruction of the clock tower at Independence Hall, the substitute materials used were cast stone and wood with fiberglass and polyester bronze ornamentation. Photo: NPS files.

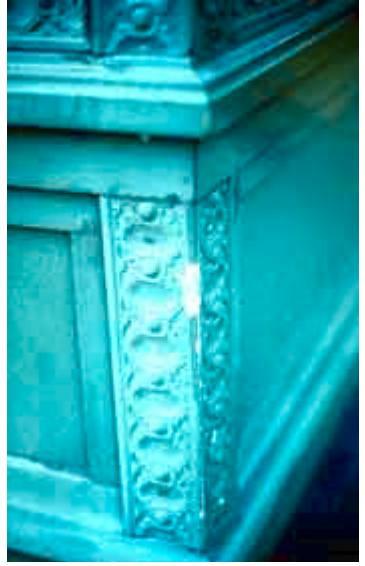
Substitute materials need to be located with care to avoid damage. The fiberglass column base has chipped, whereas the files.

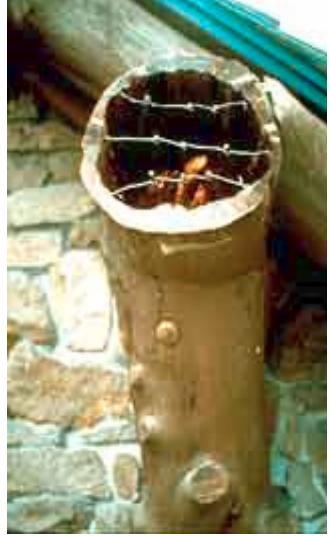
The core of a deteriorated wood outrigger was first drilled out. Photos (left and right): Courtesy, Harrison Goodall.

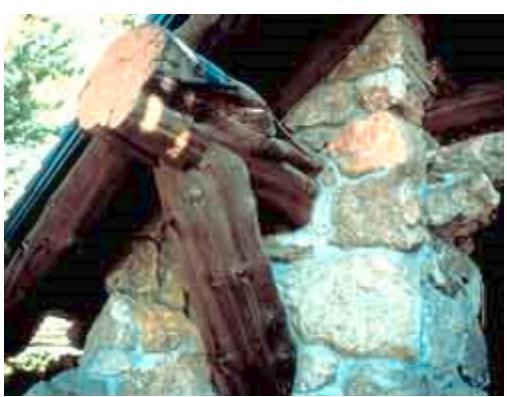
An inert material was injected into the hollow outrigger, permitting the outer wood to be retained and preserved.

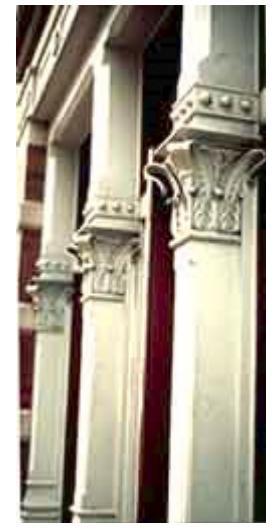
Cast aluminum has been used as a replacement material for cast iron. Photo: NPS files.

Application: Cast aluminum can be a substitute for cast iron or other decorative elements. This would include grillwork, roof crestings, cornices, ornamental spandrels, storefront elements, columns, capitals, and column bases and plinth blocks. If not self-supporting, elements are generally screwed or bolted to a structural frame. As a result of galvanic corrosion problems with dissimilar metals, joint details are very important.

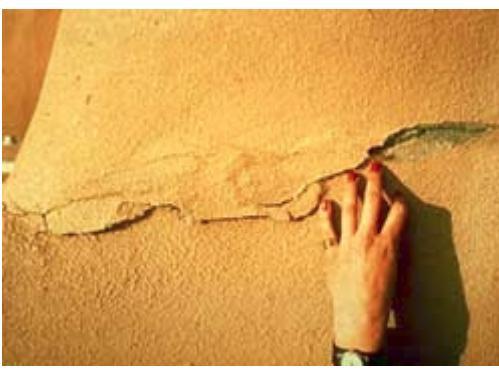
A waterproof coating is an inappropraite substitute material to apply to adobe as it seals in moisture and may result in spalling. Photo: NPS files.

Substitute materials, notably the masonry ones, may be more water-absorbent than the historic material. If this is visually distracting, it may be appropriate to apply a protective vapor-permeable coating on the substitute material. However, these clear coatings tend to alter the reflectivity of the material, must be reapplied periodically, and may trap salts and moisture, which can in turn produce spalling. For these reasons, they are not recommended for use on historic materials.

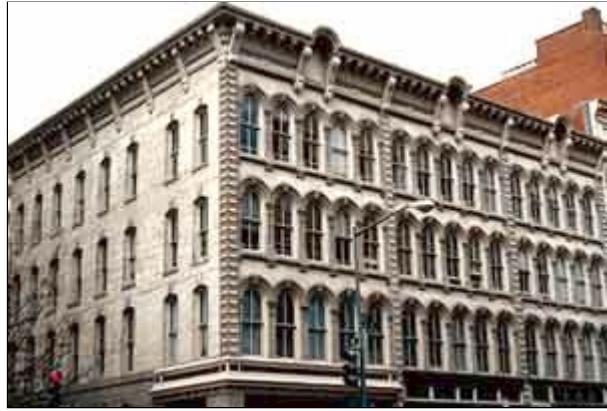
The historic cornice was successfully replaced with a fiberglass cornice. Photo: NPS files.

Application: Fiberglass, a non load-bearing material attached to a separate structural frame, is frequently used as a replacement where a lightweight element is needed or an inaccessible location makes frequent maintenance of historic materials difficult. Its good molding ability and versatility to represent stone, wood, metal and terra cotta make it an alternative to ornate or carved building elements such as column capitals, bases, spandrel panels, beltcourses, balustrades, window hoods or parapets. Its ability to
