# RIGIDITY AND STRENGTH OF WALL FRAMES BRACED WITH METAL STRAPPING

No. R1603

UNITED STATES DEPARTMENT OF AGRICULTURE  
FOREST SERVICE  
FOREST PRODUCTS LABORATORY  
Madison 5, Wisconsin  
In Cooperation with the University of Wisconsin

By E. C. O. ERICKSON, Engineer

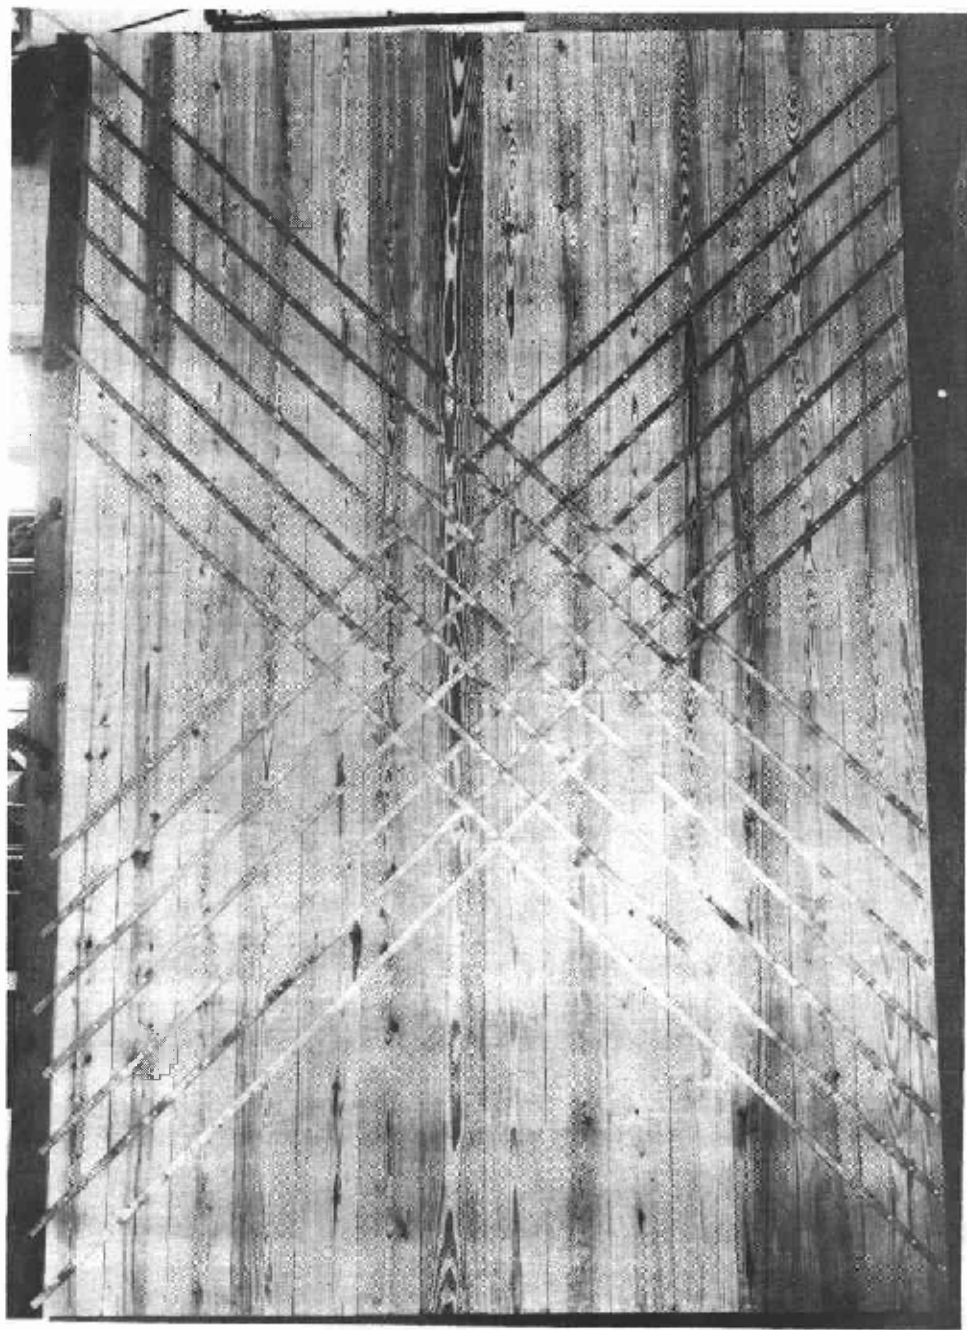
Figure 1.--Panel No. 6 with 14 metal straps, 7 placed diagonally from upper right to lower left, and the other seven from upper left to lower right. Nailed with 2 nails per board, or a total of 30 nails per strap.

except that a double system was applied to panel No. 6 (figs. 1 and 2). In order to avoid variations in initial tension, each strap was first anchored at the bottom end with one nail and then a nail was driven at the upper end while the strap was under a pull of 50 pounds applied through a spring scale. Nailing then proceeded from the bottom end to the top with nails as specified driven normal to the plane of the panel.

Each of the 7 full-length straps applied in both directions on panel No. 6 were nailed with 2 nails per 8-inch sheathing board and 1 nail in the narrow bottom board, or 29 nails per strap.

| Panel | Panel details <sup>1</sup> showing location and number of metal strap braces | | Moisture content <sup>2</sup> | | Load at 1/8-inch deflection | Rigidity factor | Maximum load | Strength factor |
|---|---|---|---|---|---|---|---|---|
| 6 | | 7 straps nailed to sheathing with 2 nails per board. 30 nails per strap. | 12.8 | 12.9 | 4,370 | 3.3 | 7,500 | 2.9 |

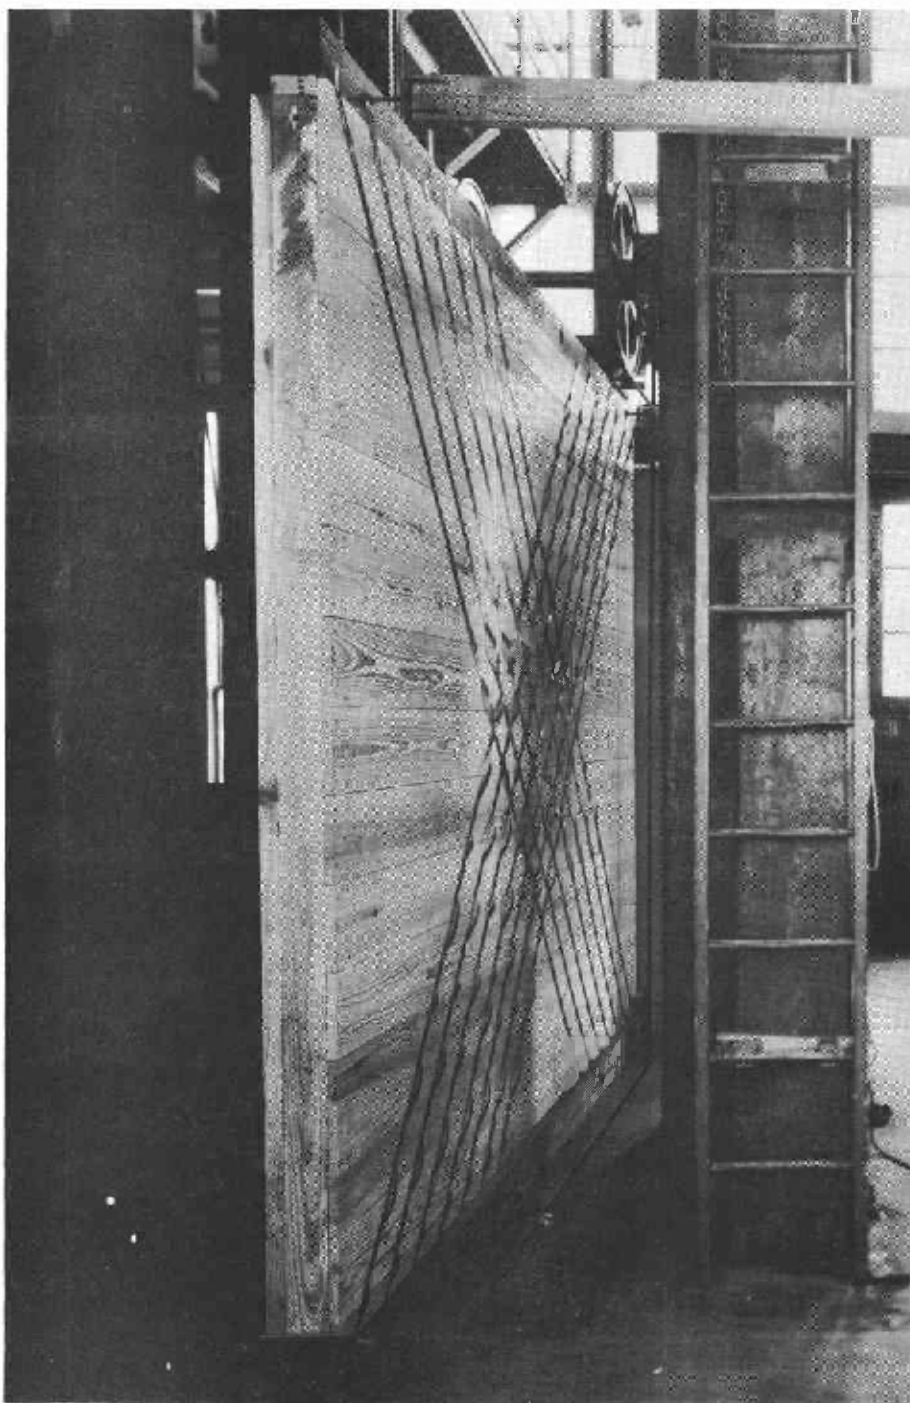
Figure 2.--Panel No. 6 after test showing tension break in straps extending from upper left to lower right and buckling of those extending from upper right to lower left.

These apparently inconsistent findings may perhaps be due to failure of straps to act together at the smaller deflections despite the care used to get uniform initial tension. On the other hand, virtually simultaneous failure at maximum load of all 7 tension straps on panel No. 6 indicates that at that stage all tension straps were in effective action and that their effects were additive. From the maximum loads on strapped panels Nos. 4 (2 straps) and 6 (7 straps) the contribution of the sheathing may be computed as about 1,900 pounds. That this is less than the maximum load (2,590 pounds) found for the unbraced panel is to be expected because when the straps broke the maximum resistance of the sheathing-to-stud nailing had not been developed. (The load on the unbraced panel at the deflection at which maximum load occurred in the panel with 7 straps was 2,150 pounds.)

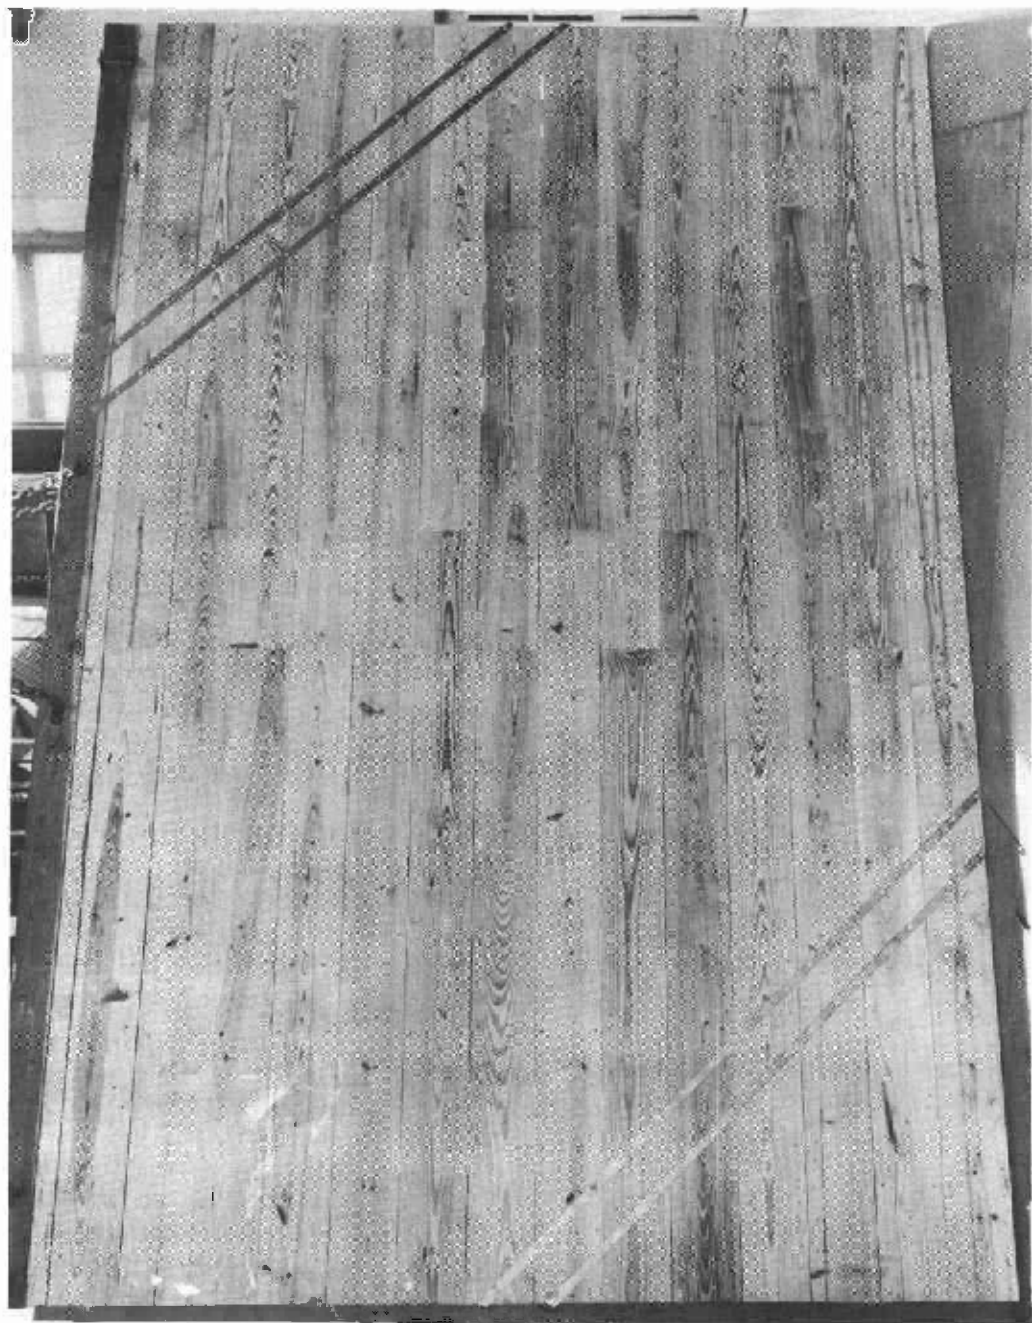
Figure 3.--Panel No. 5 with two straps at each corner nailed to sheathing  
Z M 68260 F with two nails per board.

The strapping on panel No. 5 consisted of straps placed 51 and 57 inches from each of two opposite corners of the panel as shown in figure 3 with 14 nails in each shorter piece and 16 in the longer.

In panel No. 5 diagonal straps were applied across opposite corners of the panel. The total length of these straps and the number of nails used was the same as in panel No. 4. This arrangement was much less effective in rigidity than full length straps as used in panel No. 4.

The reason for the superiority of full length straps over an equal length in shorter pieces is perhaps more readily understood when one considers their behavior. For instance, in panel No. 4 the slips between adjacent sheathing boards were nearly the same at all junctions until the first strap failure occurred, at which time the slip at the junction in line with the point of failure increased to nearly twice that at others where slips were still restrained by the action of the remaining unbroken portions of the straps. In panel No. 5 this restraining influence is not as continuous.

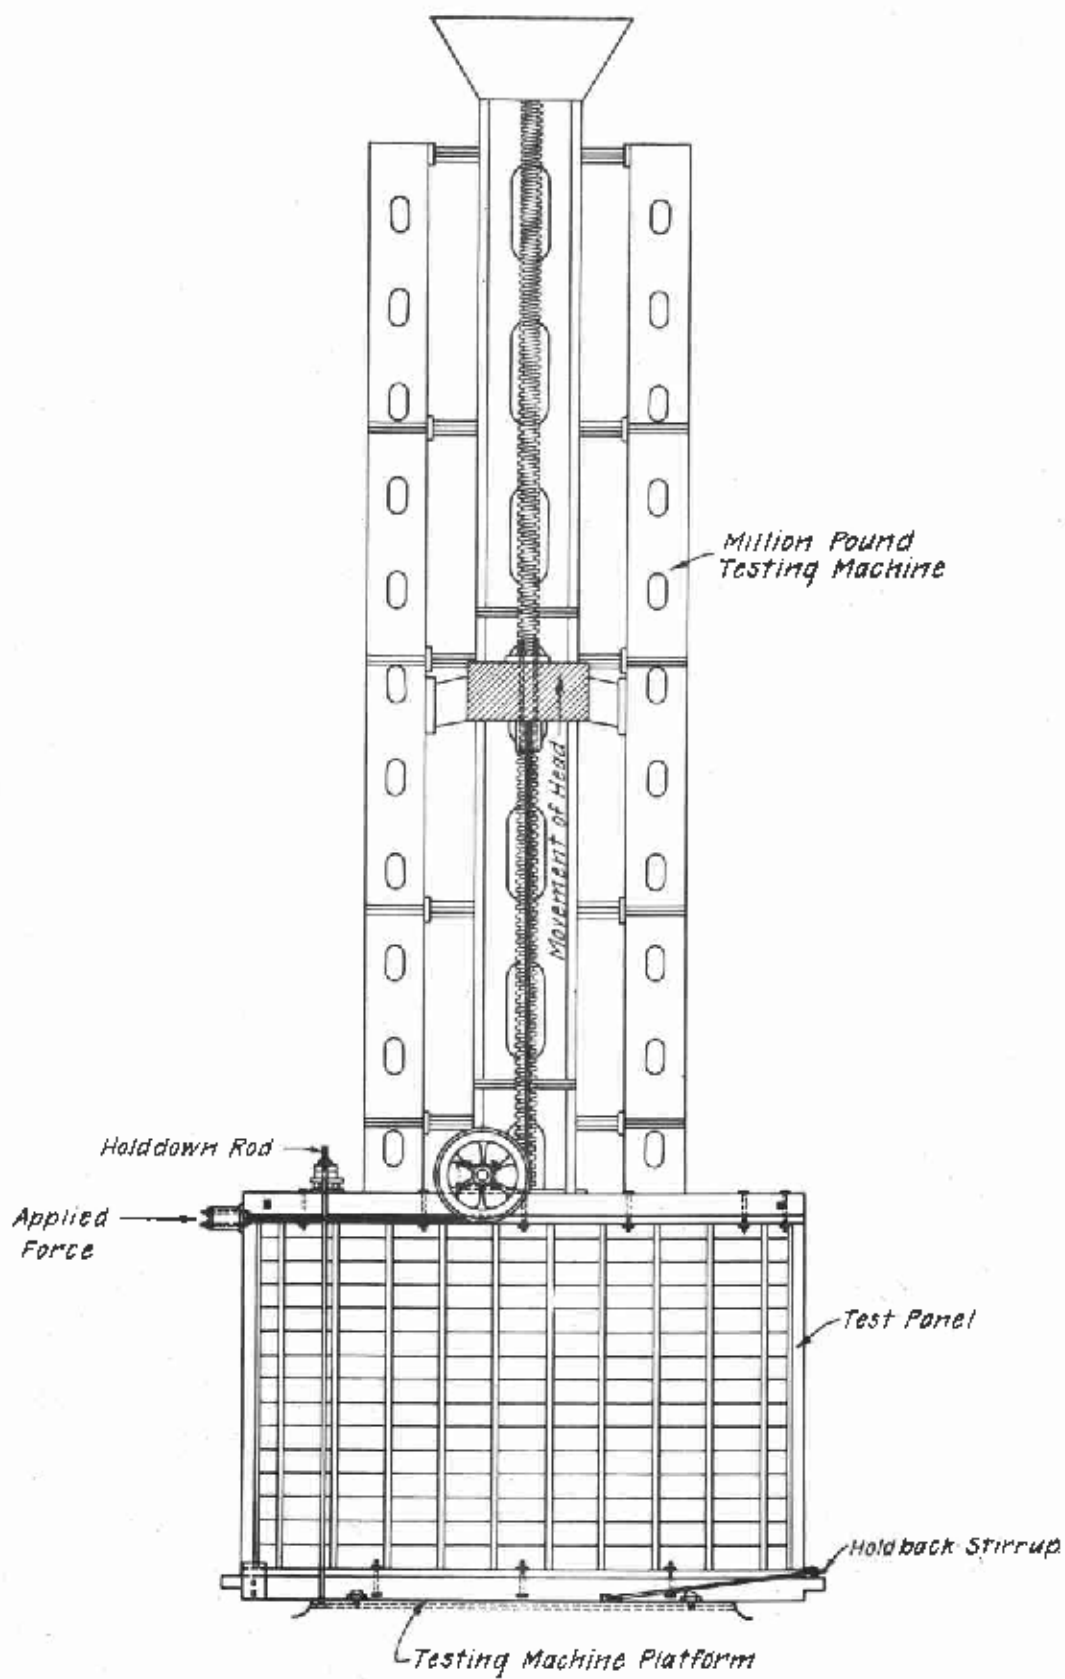
Each panel was tested as indicated in the diagrammatic sketch, figure 4. The lower or sole plate was bolted with three  $3/4$ -inch bolts to a 6- by 8-inch timber, which was keyed to the base of the testing machine to prevent sliding. A hold-back stirrup with one end framed into the base timber and the other bearing against a maple block  $1-7/8$  inches deep abutting against the lower corner of the panel, prevented the panel from sliding on the base timber.

Two horizontal struts, one near each end of the panel, attached to the heavy top timber and to a wall by swivel joints braced the top of the panel against lateral movement without interfering with longitudinal movement.

The load was applied to one end of the panel and in a direction parallel to the length of the panel, by steel cables attached to a bearing block and passing around sheaves to the movable head of the testing machine. The block was so placed as to bear against the end of the top plate and the upper  $2-1/2$  inches of the end post assembly. Vertical hold-down rods, placed one on each side of the panel and 2 feet from the end to which the load was applied, were fastened to the base of the testing machine and to a bearing plate above the heavy timber at the top of the panel, to prevent the rotation that otherwise would result from the application of the horizontal force at the upper plate. Rollers placed between this bearing plate and another plate resting on the top timber permitted free longitudinal movement of the panel.

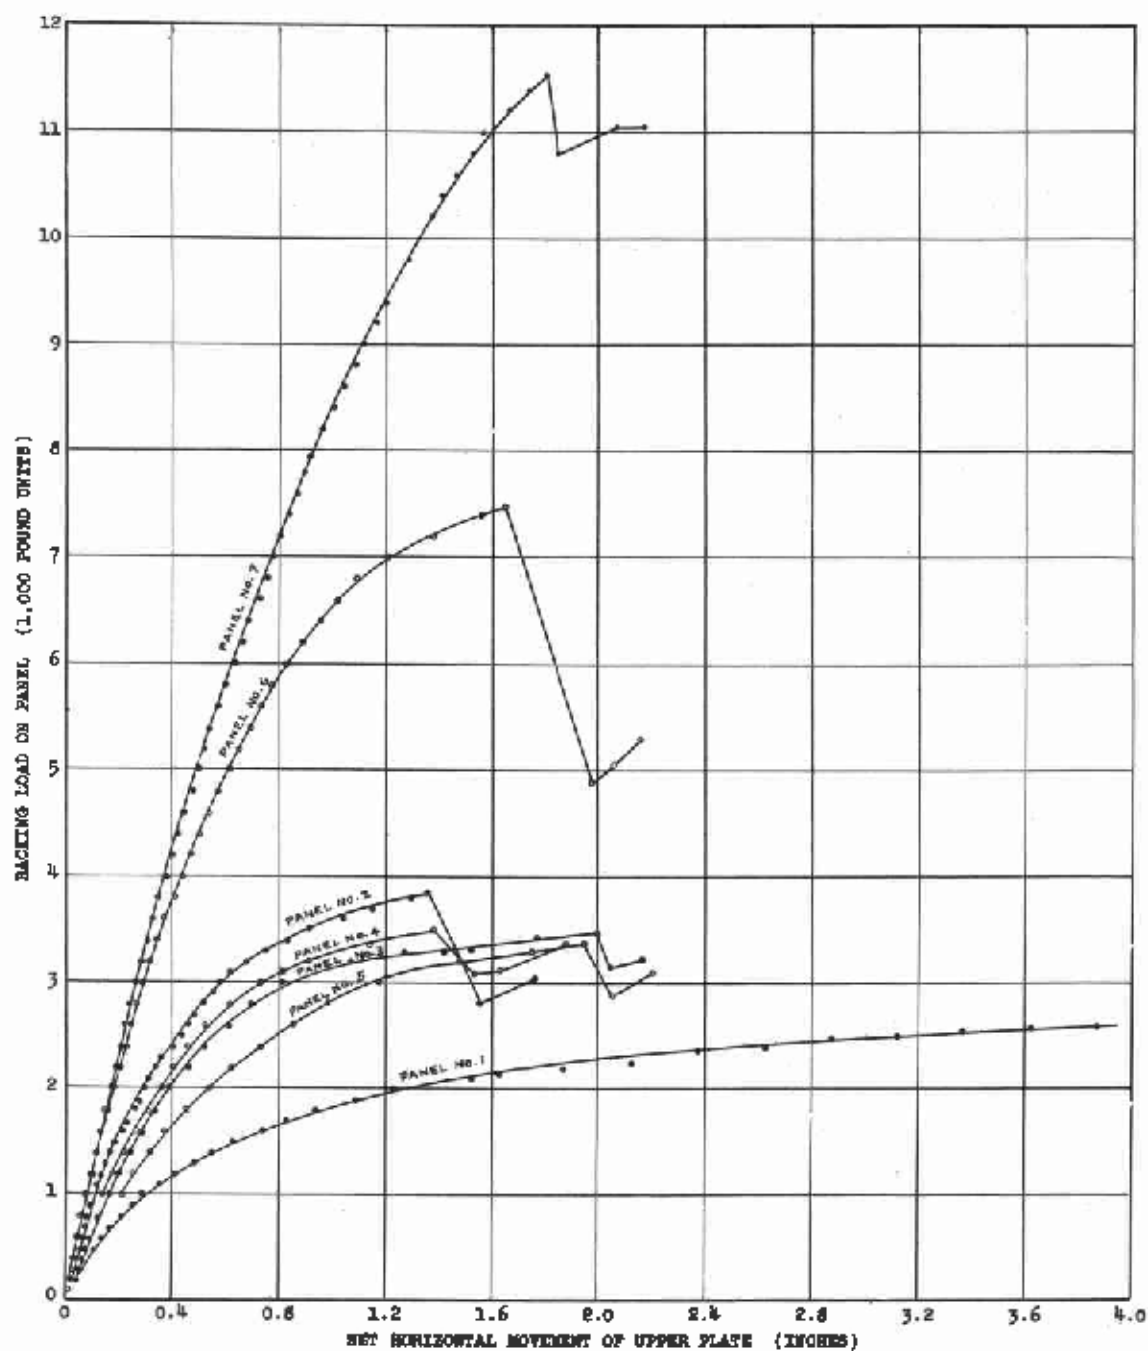
Figure 5.--Load-deflection curves of wall panels without bracing, with metal strapping braces, and with let-in wood braces.

A diagrammatic sketch and brief description of each panel, together with data from tests are presented in table 1. The comparison for rigidity between different constructions is based on the loads corresponding to a deformation or net horizontal movement of upper plate of 1/2 inch. The load at 1/2-inch deflection for each construction was divided by the corresponding load for the basic unbraced horizontally-sheathed panel No. 1, and the resulting ratio entered as the rigidity factor for the construction represented.

The data on panels Nos. 1, 4, and 6 afford an opportunity to evaluate the effect of number of straps. Based on the loads at 1/2-inch deflection as given in table 1 it is evident that 7 straps add less proportionately to the rigidity of a horizontally sheathed panel than do 2 straps. Had the 7 straps (panel No. 6) produced proportionately as great an increase in rigidity over an unbraced panel (panel No. 1) as did 2 straps (panel No. 4), panel No. 6 would have taken a load of about 5,500 pounds at 1/2-inch deflection and would have been considerably more rigid than the panel (panel No. 7) with the 1- by 4-inch let-in bracing. The actual load for panel No. 6 was, however, only 4,370 pounds and considerably below that (5,040 pounds) for panel No. 7. It may be noted from figure 5 that up to deflections of about 1/4 inch loads were not significantly less for panel No. 6 than for No. 7. It may be further noted from the data of table 1 that 7 straps (panel No. 6 compared to panel No. 1) added proportionately more to maximum load than did 2 straps (panel No. 4 compared to panel No. 1).
